Spearhead Trails

Coal Canyon at Grundy (Leetown section)

Complaint Investigation Photo Log

August 10, 2020 by DEQ Staff (Jeff Kite & Jason McCroskey)

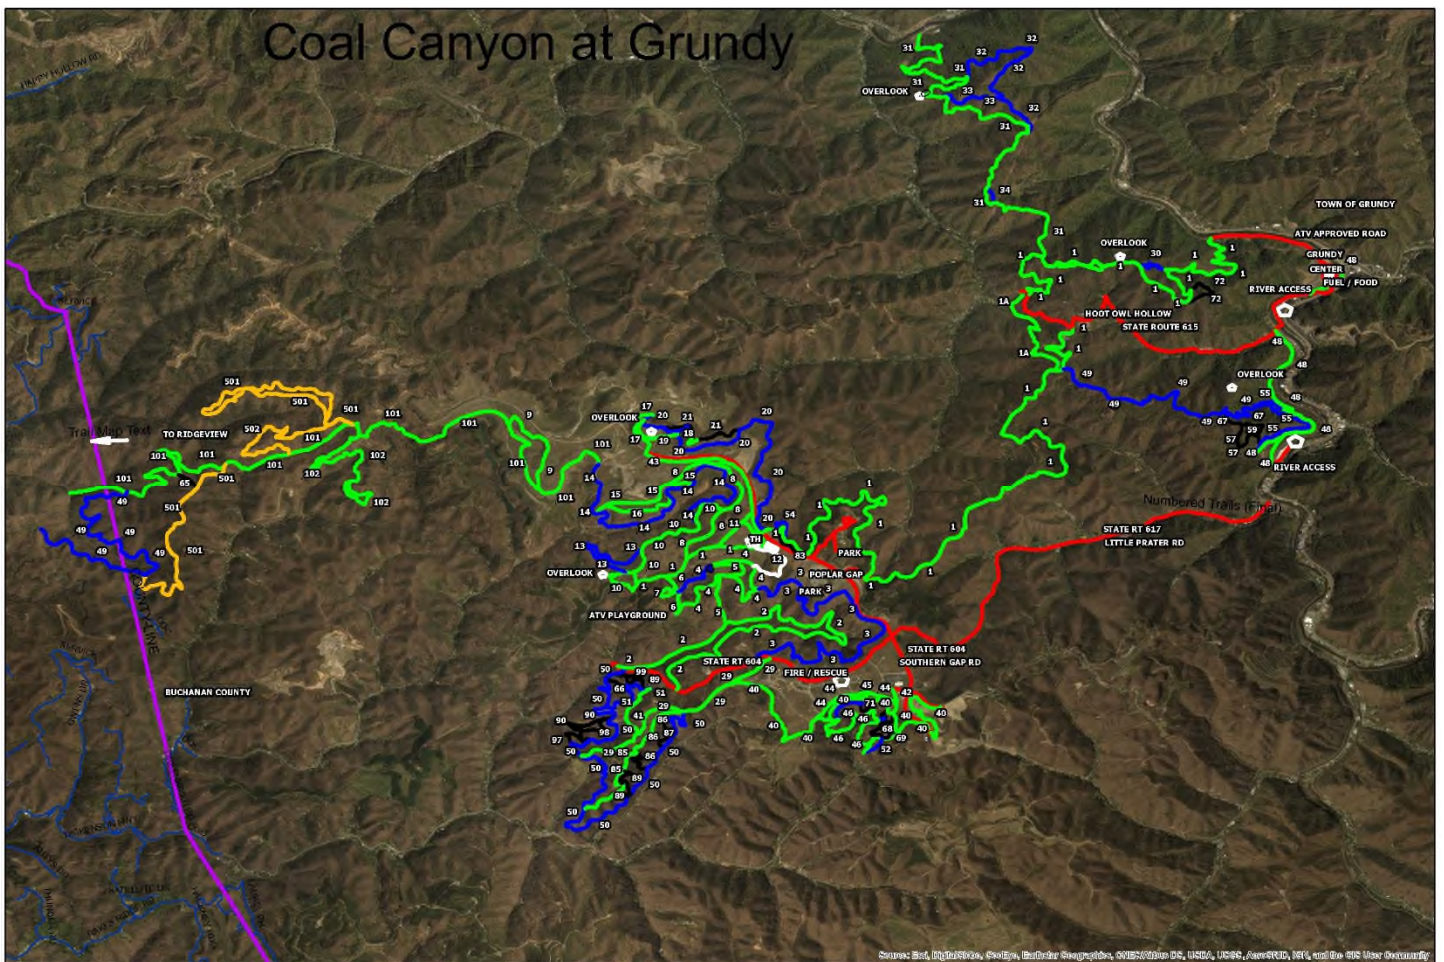
.pdf download of Coal Canyon Map from the Spearhead Trails website

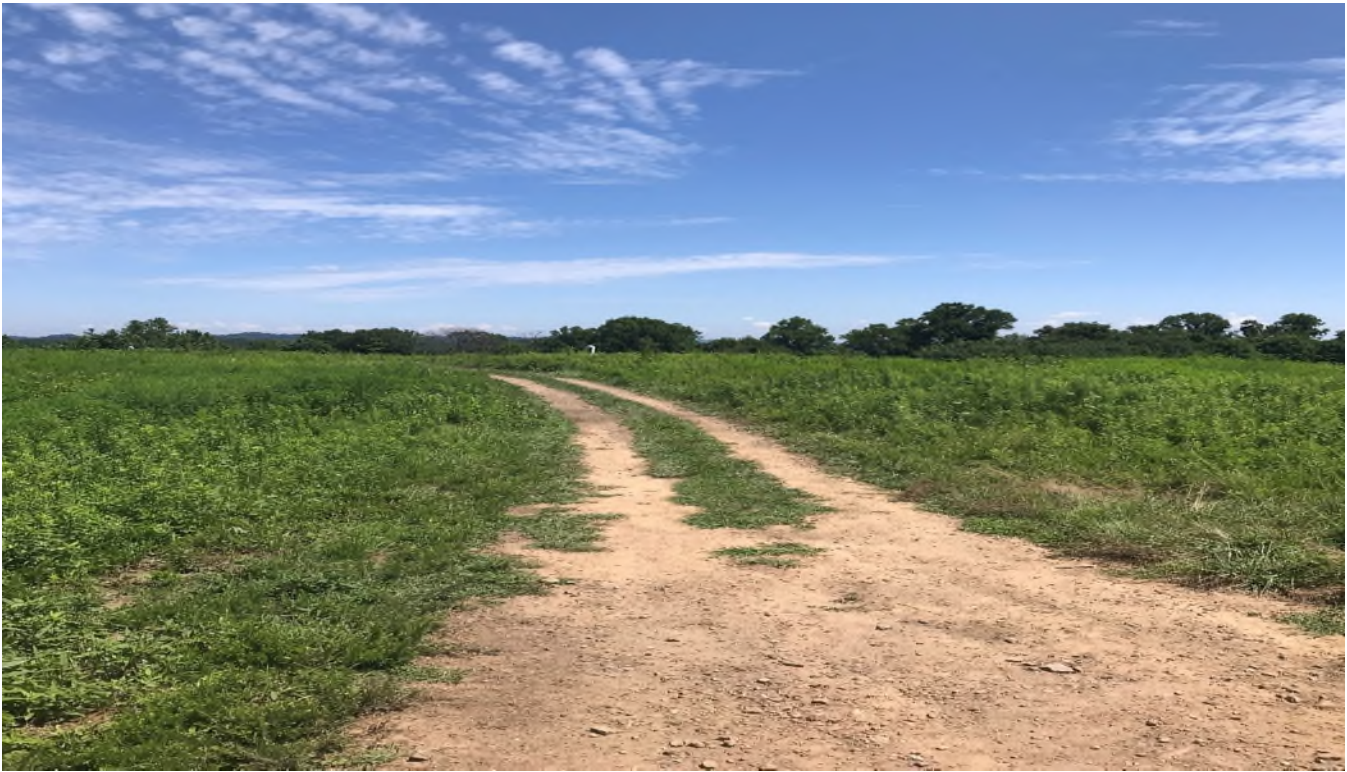
Figure 01 (Section of trail across capped landfill. No new trail construction; 37°15'58" N, 82°08'03"W)

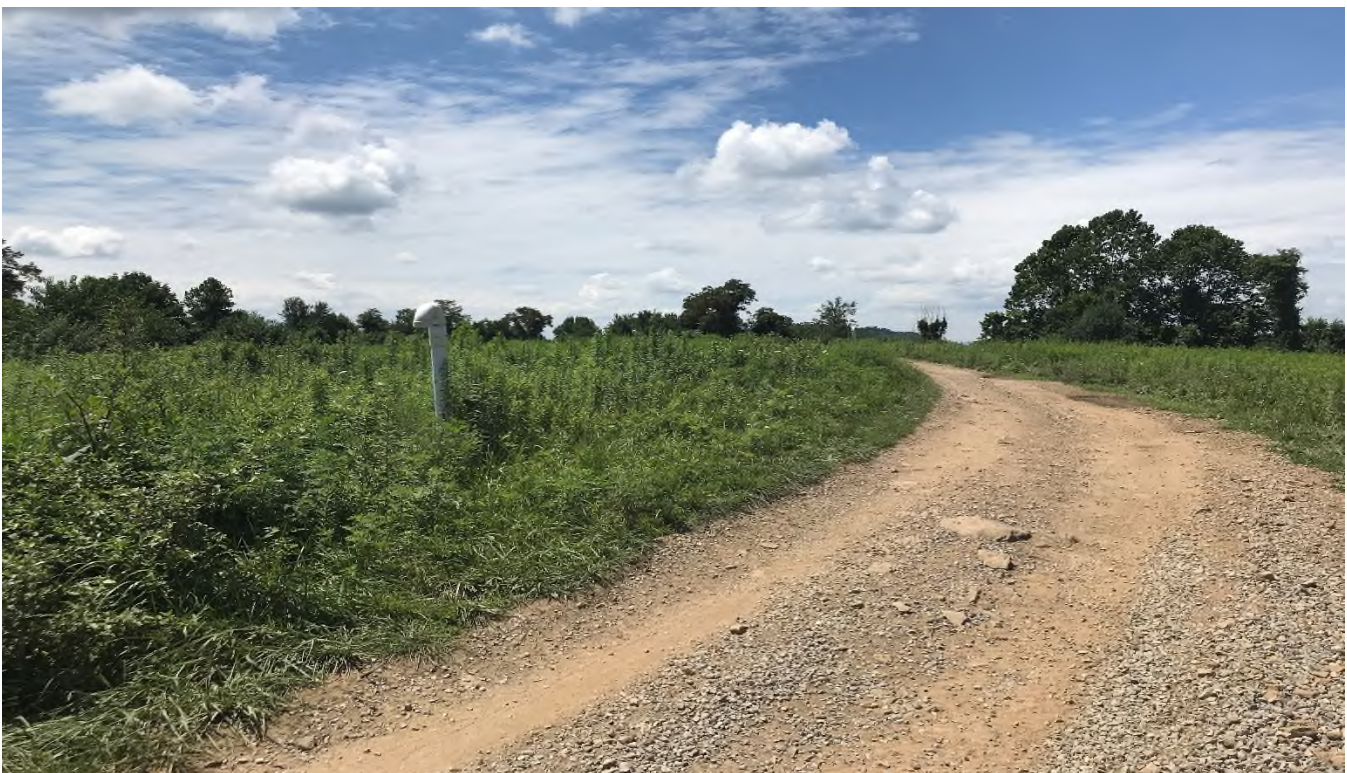
Figure 02 (Section of trail across capped landfill. Facing opposite Figure 01. No new trail construction; 37°15'58" N, 82°08'03"W)

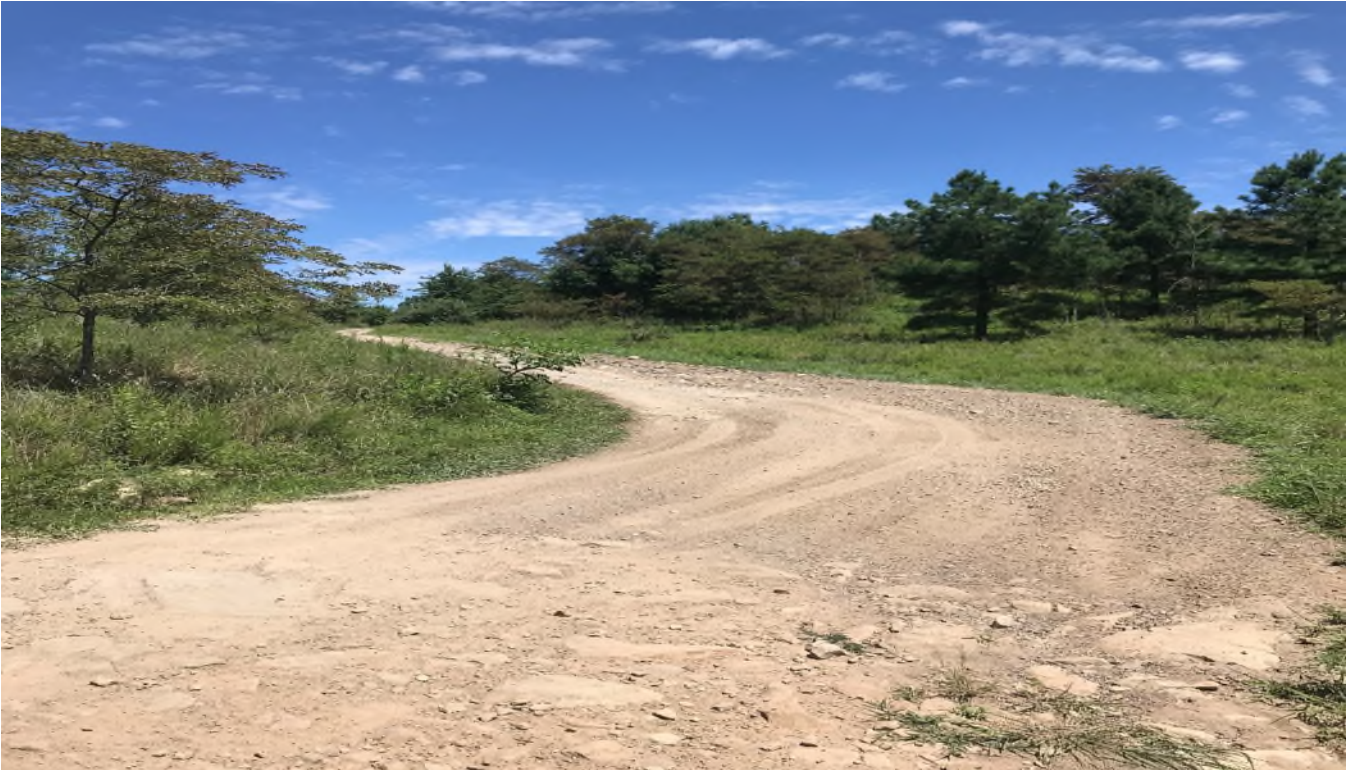
Figure 03 (Section of trail utilizing existing road. No new trail construction; 37°15'32"N, 82°08'25"W)

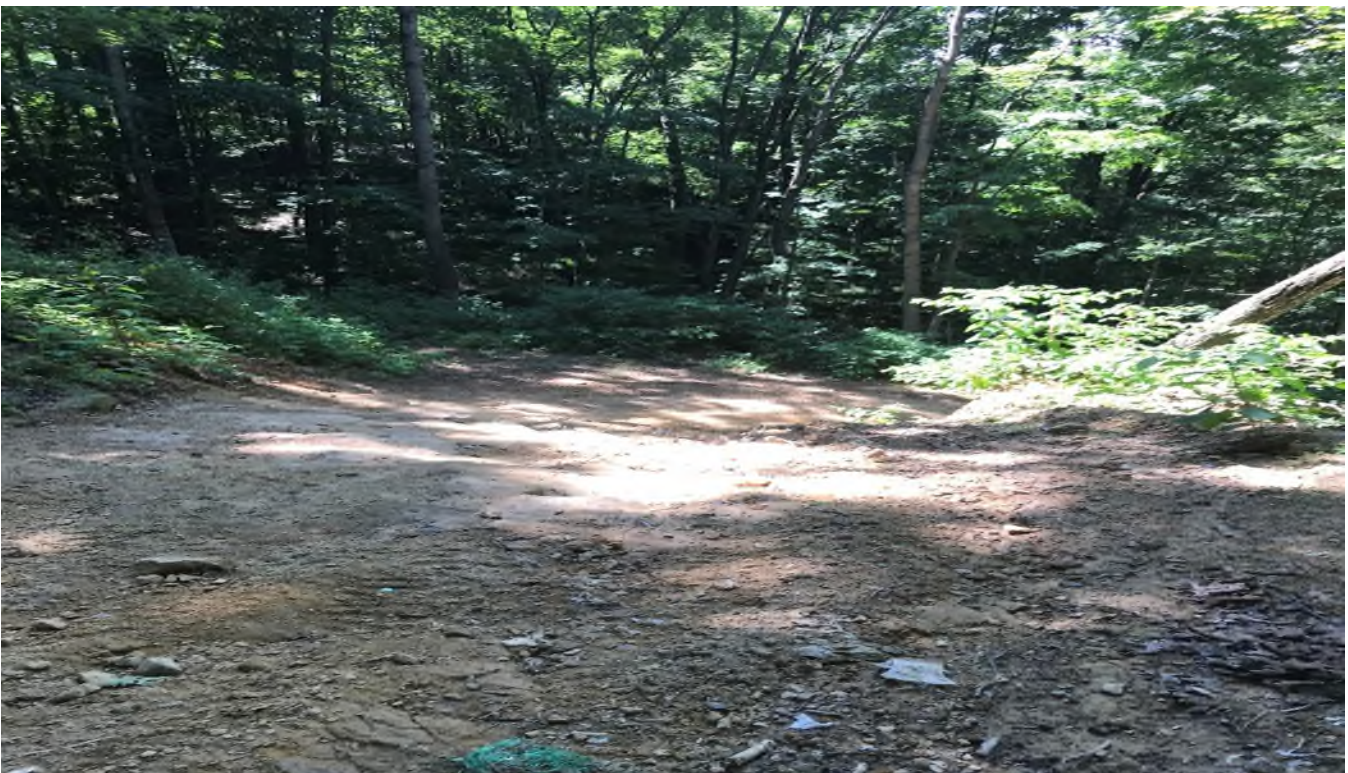
Figure 04 (New land disturbance associated with either new trail construction or widening of an existing trail. Facing downhill away from capped landfill; 37°16'06"N, 82°08'13"W)

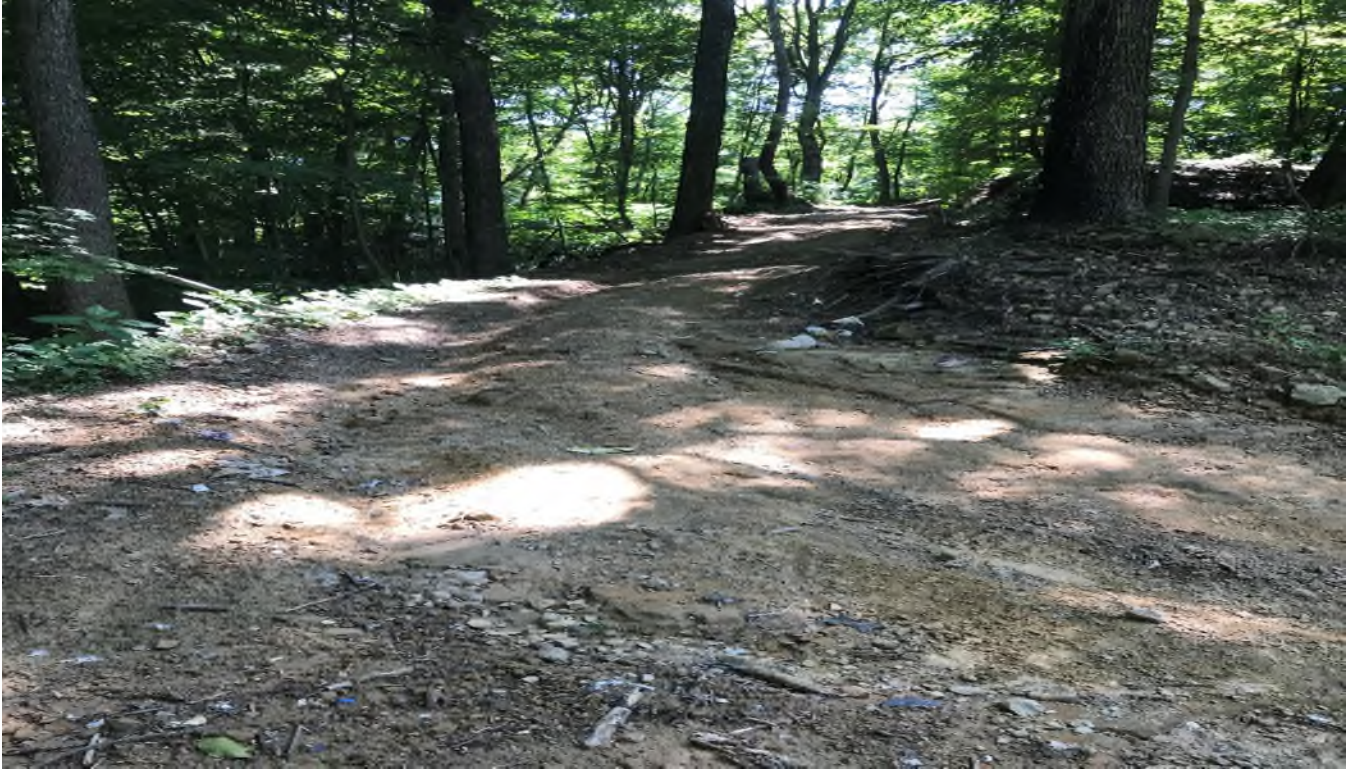
Figure 05 (New land disturbance associated with either new trail construction or widening of an existing trail. Facing uphill toward capped landfill; 37°16'06"N, 82°08'13"W)

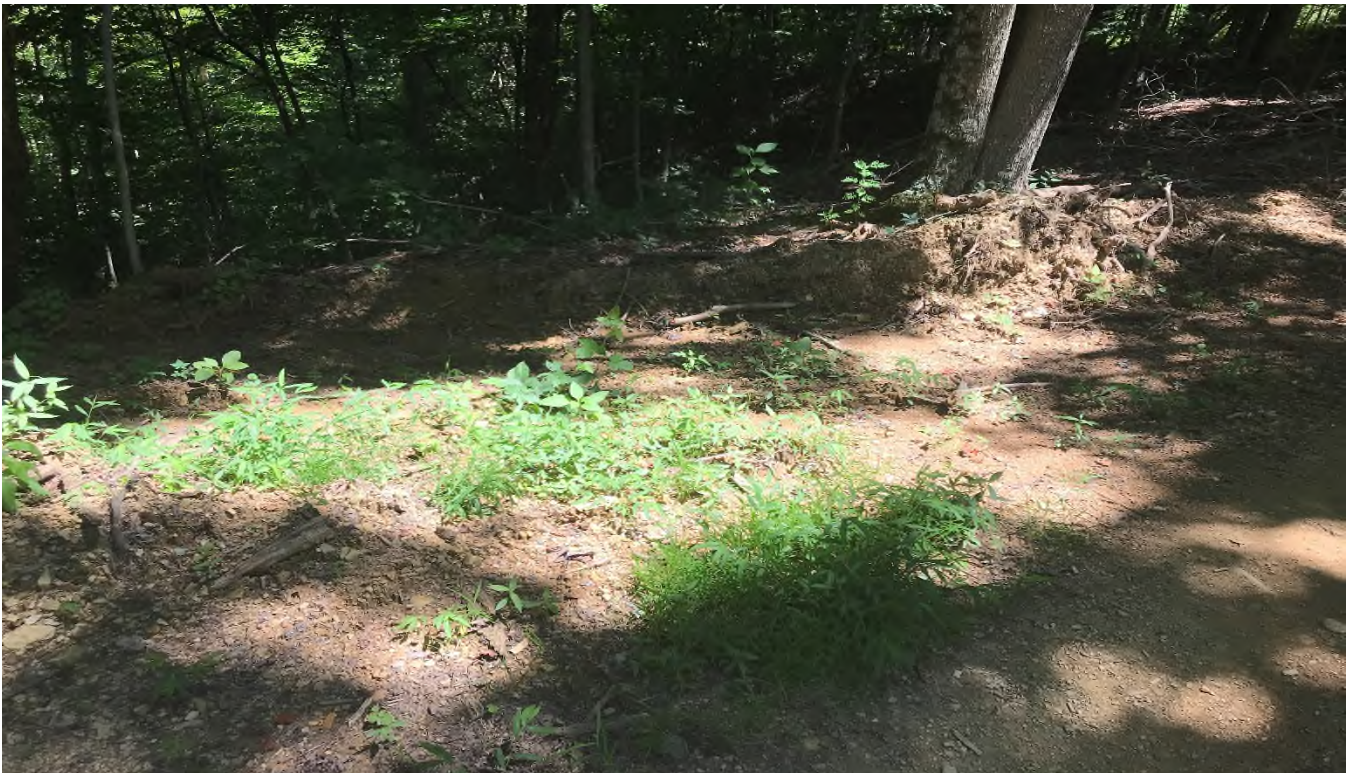
Figure 06 (Window cut on section of trail construction shown in Figures 4 and 5 sending concentrated flows over the slope; 37°16'05"N, 82°08'11"W)

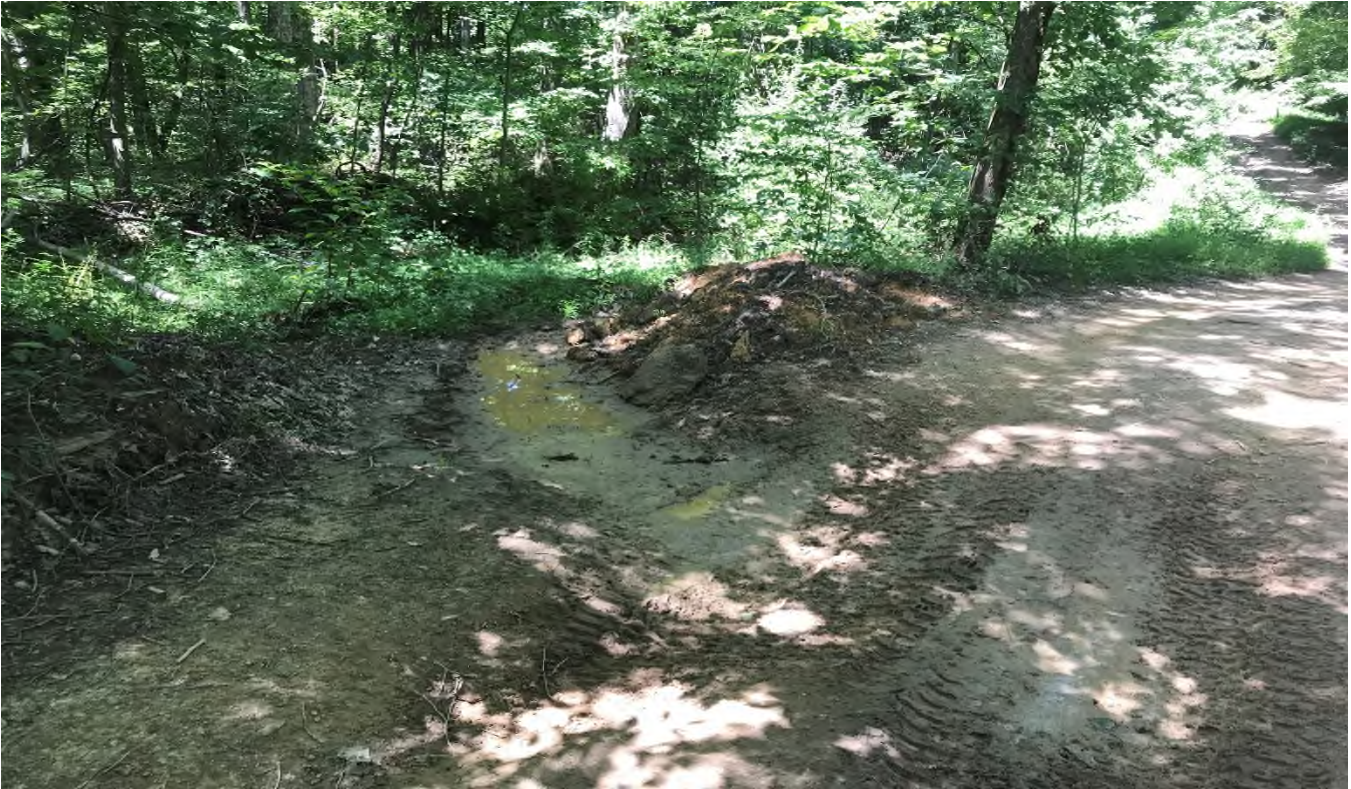
Figure 07 (Window cut on section of trail sending concentrated flows over the slope; $37^{\circ}15'56''\text{N}$, $82^{\circ}07'55''\text{W}$)

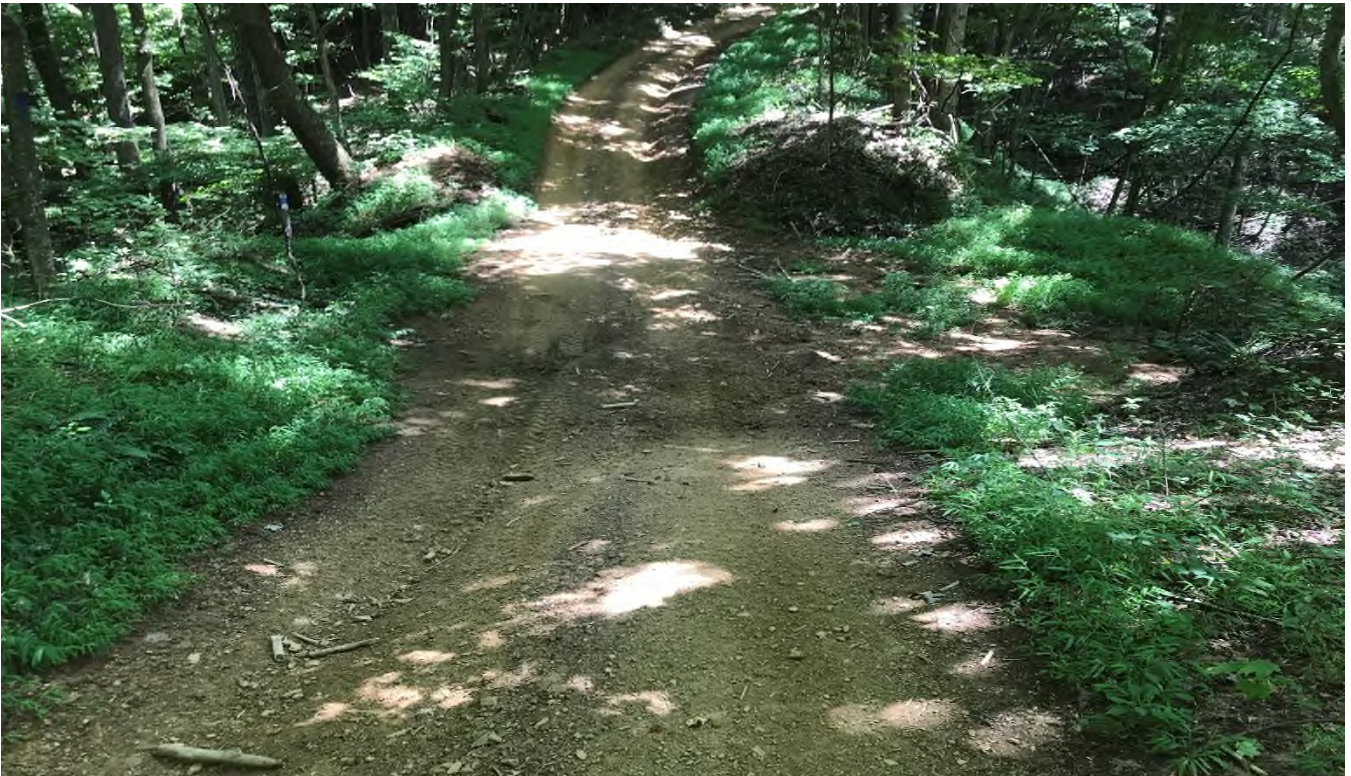
Figure 08 (Low spot in trail. Sediment flows down slope; $37^{\circ}15'49''\text{N}$, $82^{\circ}07'43''\text{W}$)

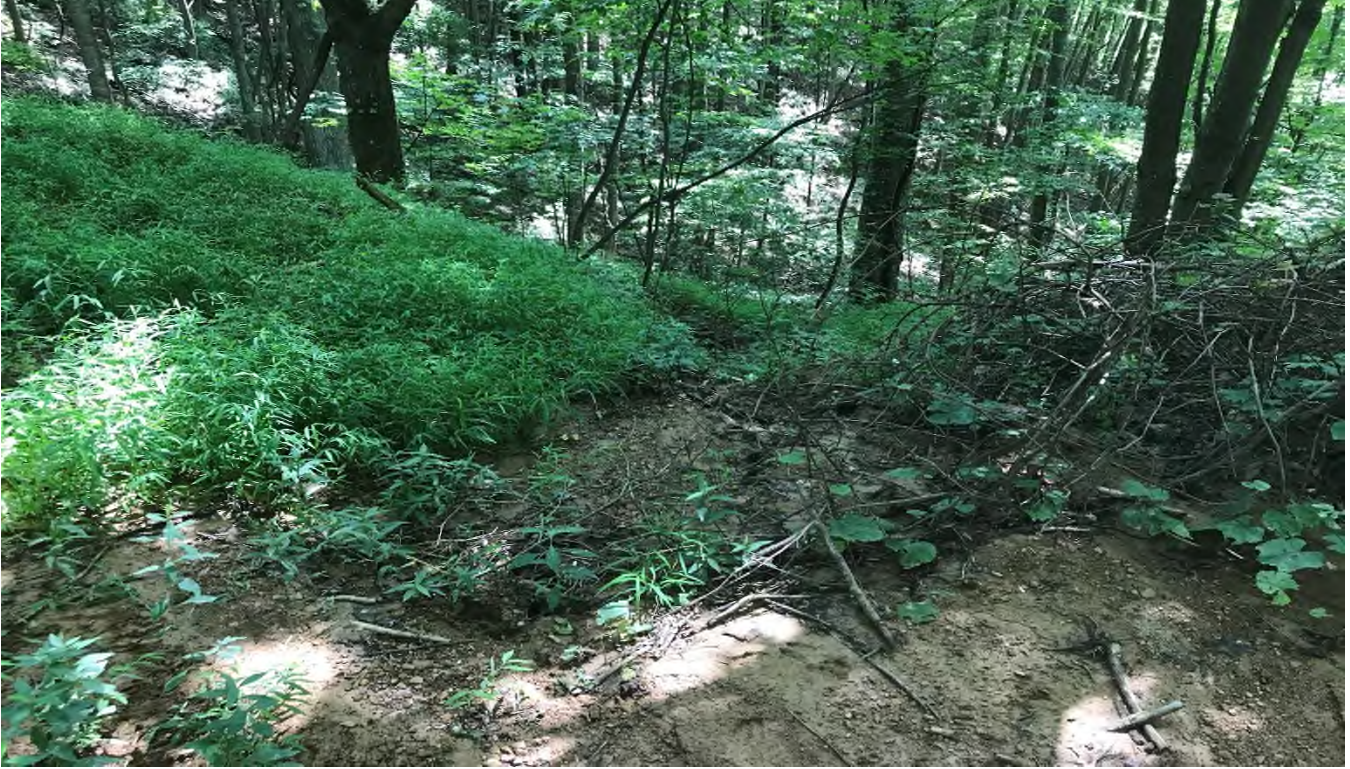
Figure 09 (Sediment loss over slope from the low spot in the trail shown in Figure 08 above; 37°15'49"N, 82°07'43"W)

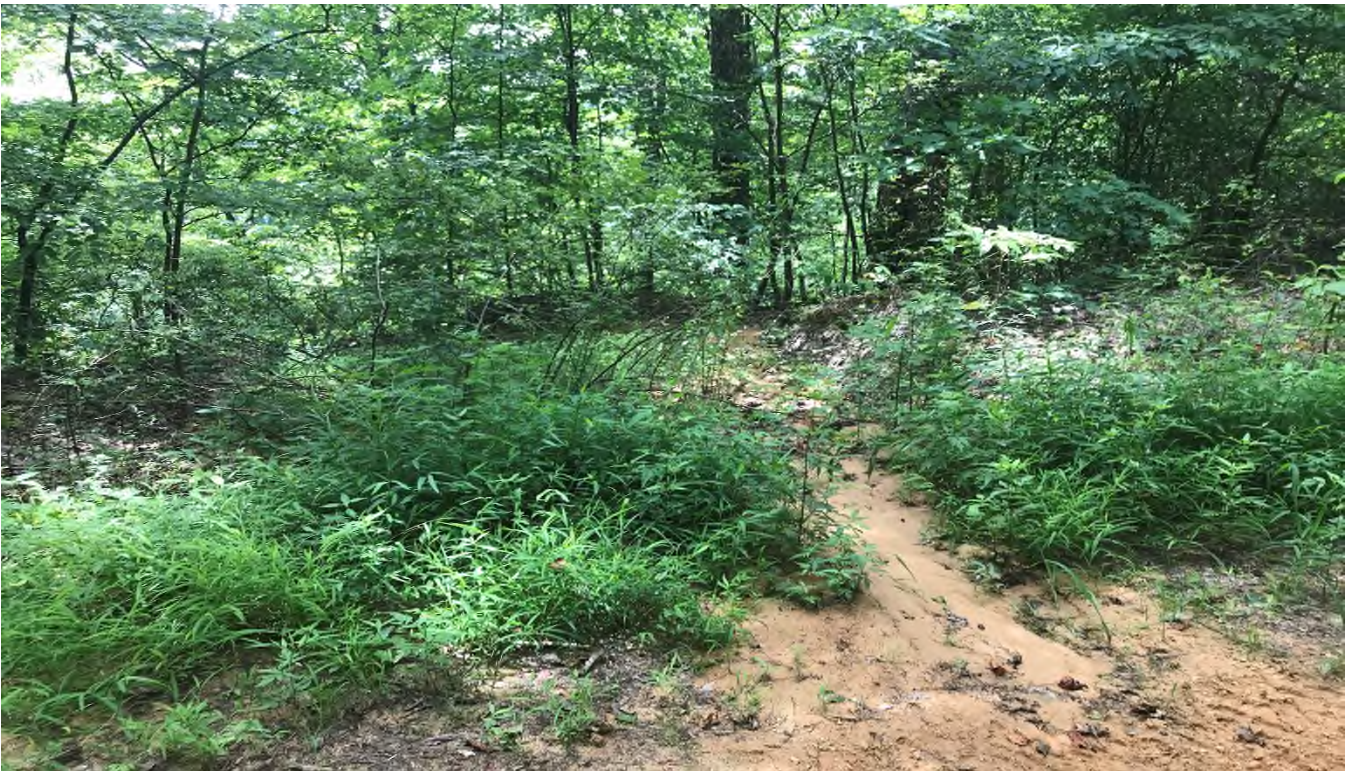
Figure 10 (Sediment loss from trail over the slope; 37°15'52"N, 82°07'52"W)

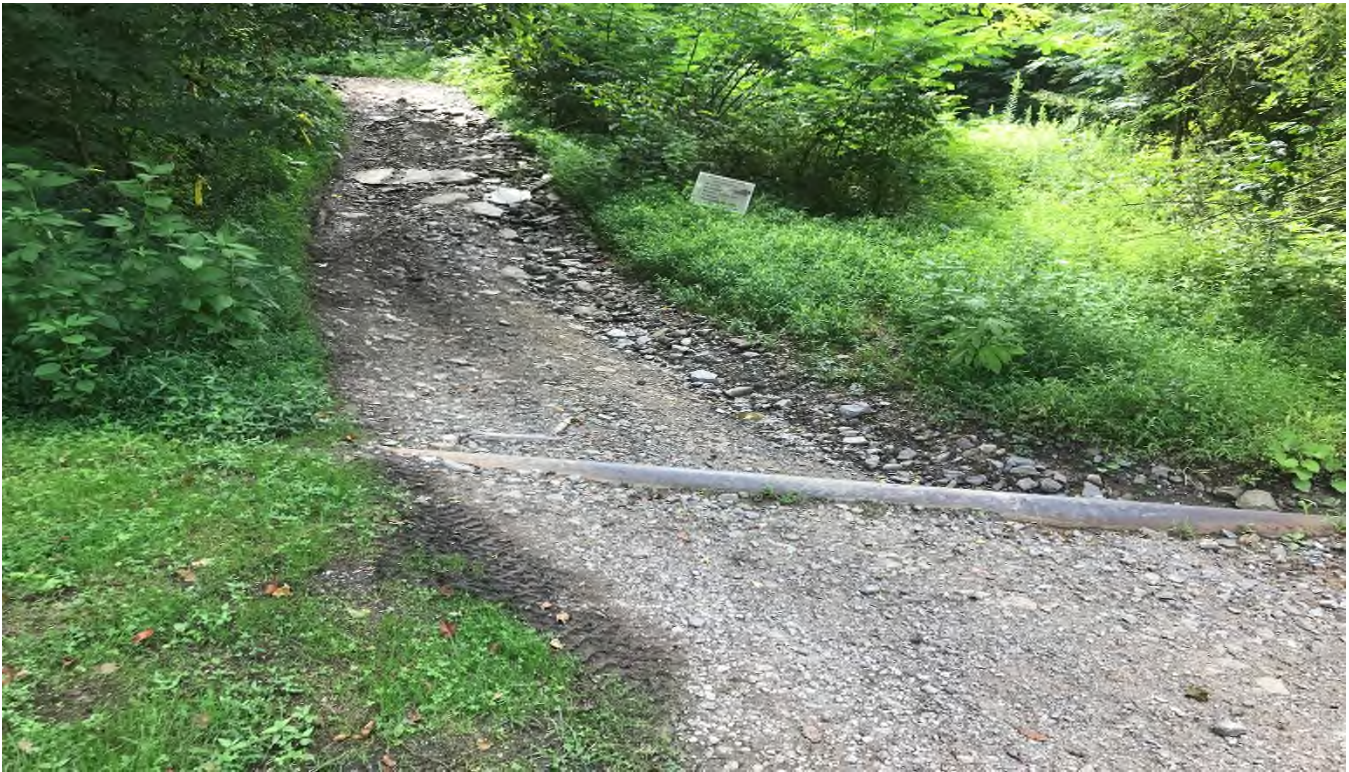
Figure 11 (Trail entrance from residential driveway on the Leetown section of trail; 37°16'53"N, 82°06'56"W)

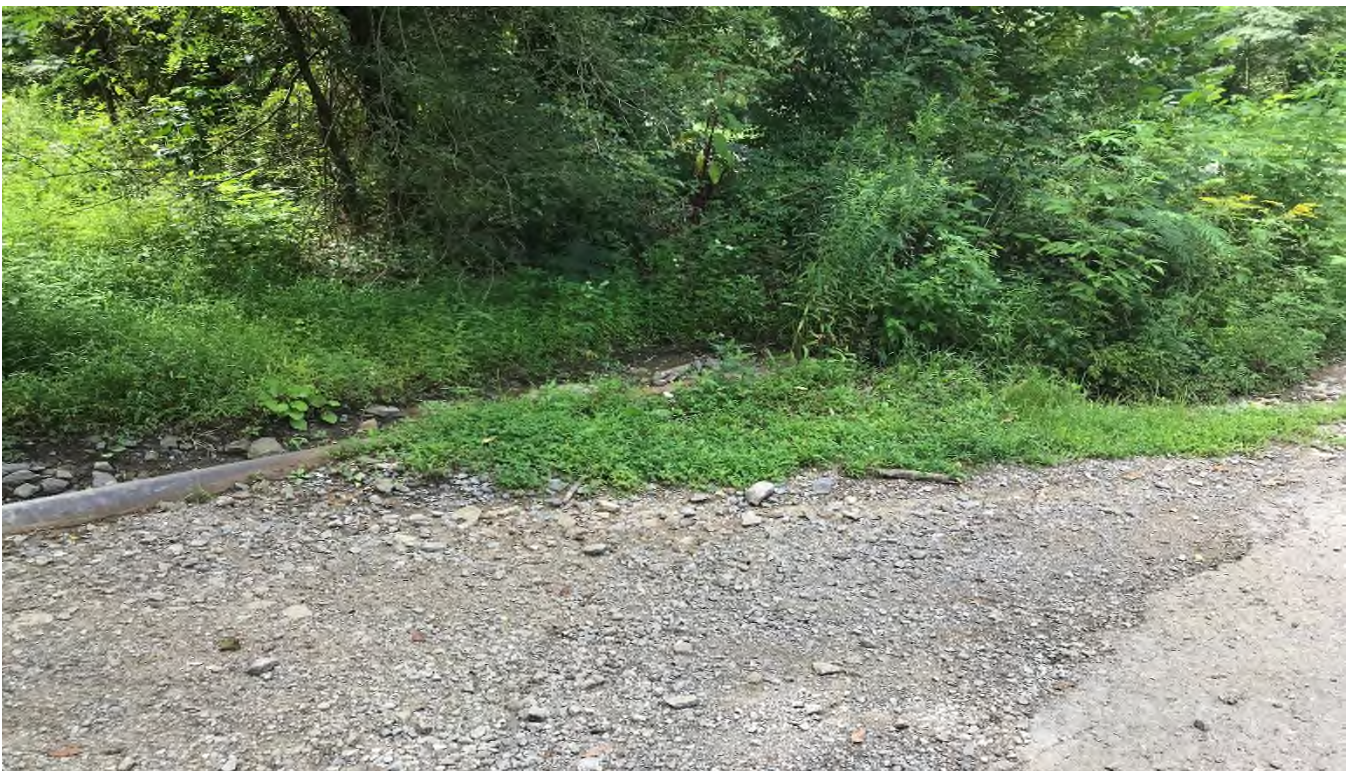
Figure 12 (Concentrated flows from entrance in Figure 11 above bypassing existing culvert, resulting in erosion; 37°16'53"N, 82°06'56"W)

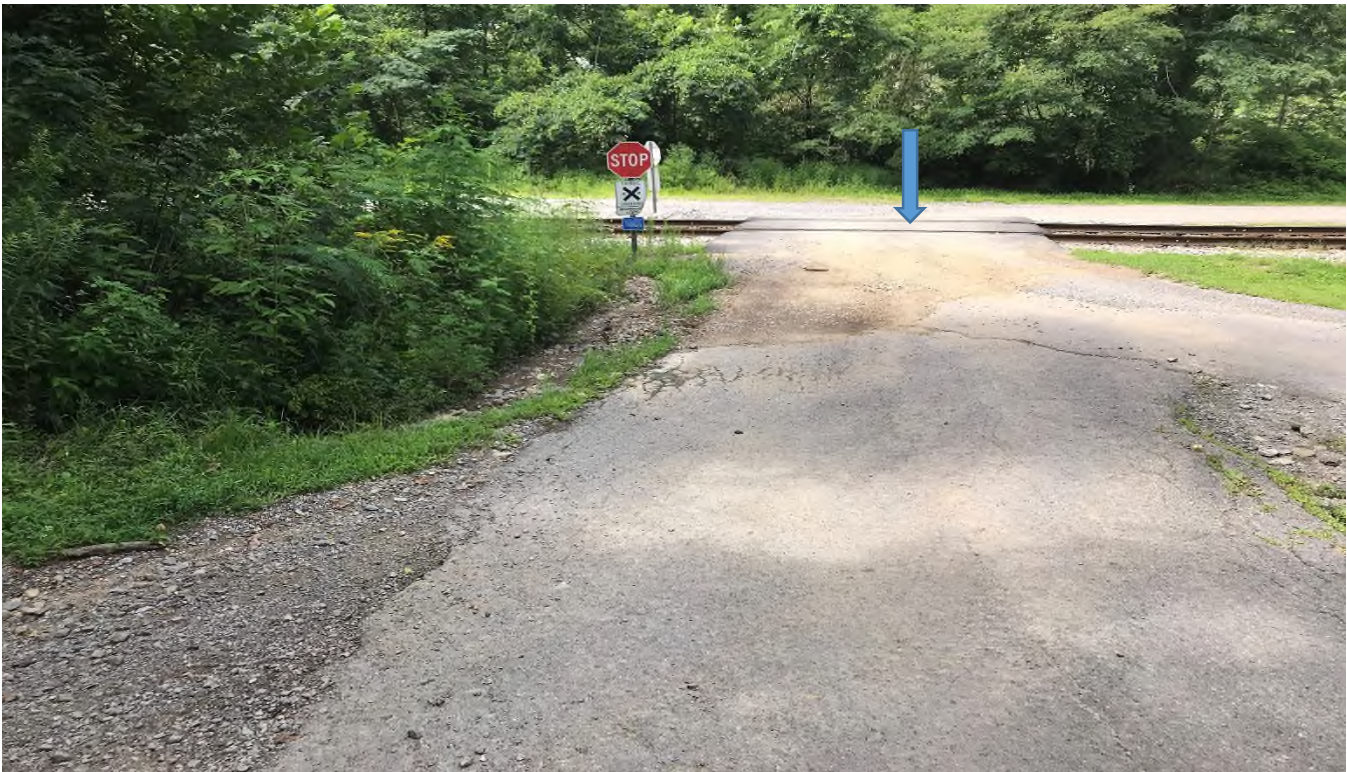
Figure 13 (Residential entrance and rail crossing down gradient of entrance and culvert shown in Figures 11 & 12 above. Sediment deposition in driveway; 37°16'53"N, 82°06'56"W)

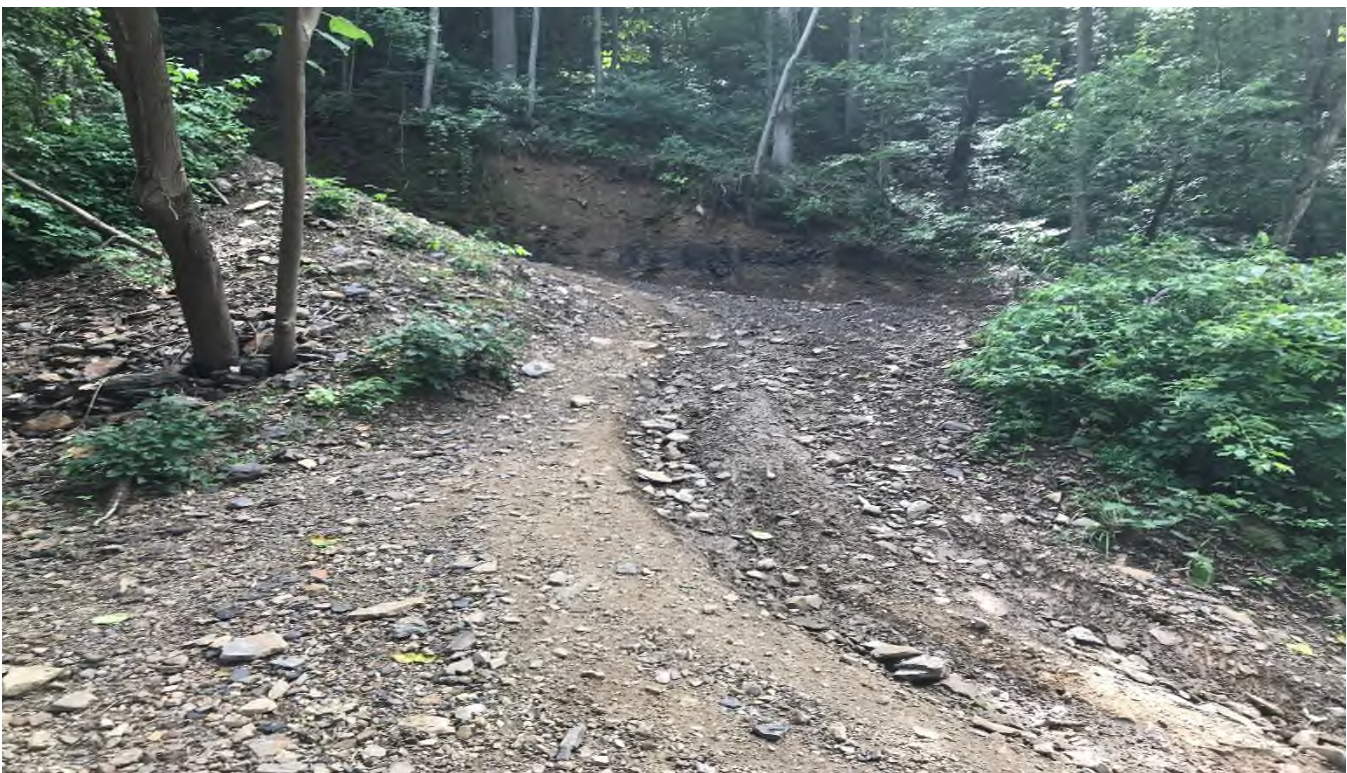
Figure 14 (New land disturbance associated with either new trail construction or widening of an existing trail immediately above entrance shown in Figure 11 above; 37°16'52"N, 82°06'57"W)

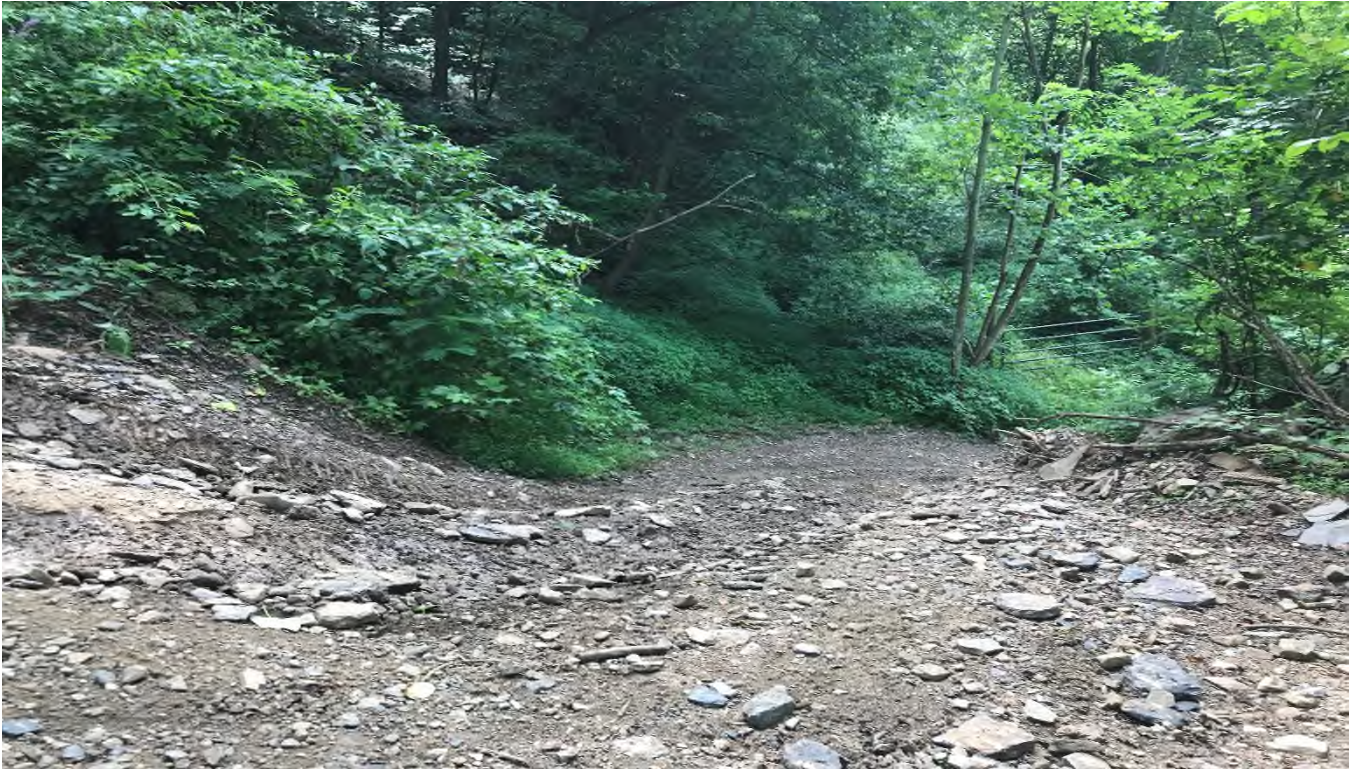
Figure 15 (New land disturbance associated with either new trail construction or widening of an existing trail. Photo taken facing downhill toward the entrance shown in Figure 11 above; 37°16'52"N, 82°06'57"W)

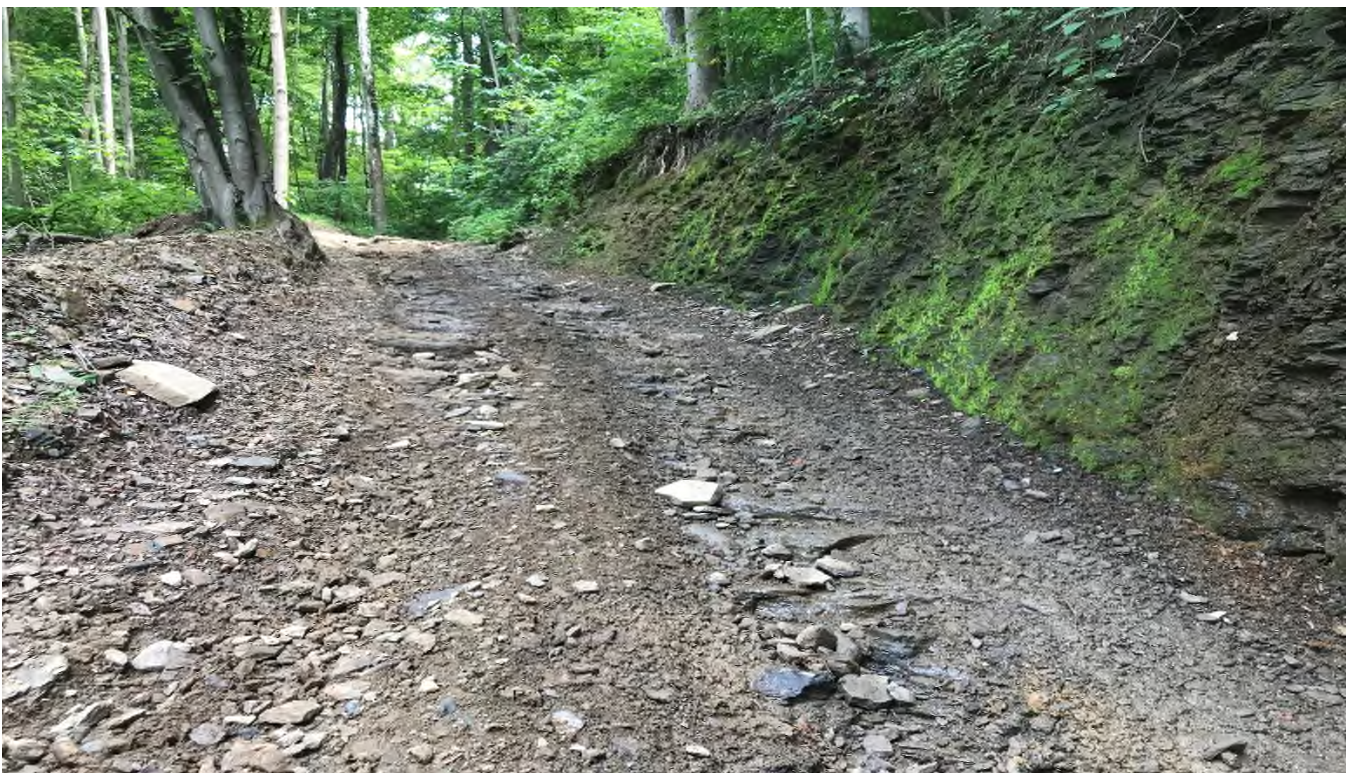
Figure 16 (New land disturbance associated with either new trail construction or widening of an existing trail. Photo taken facing uphill away from the entrance shown in Figure 11 above; 37°16'52"N, 82°06'57"W)

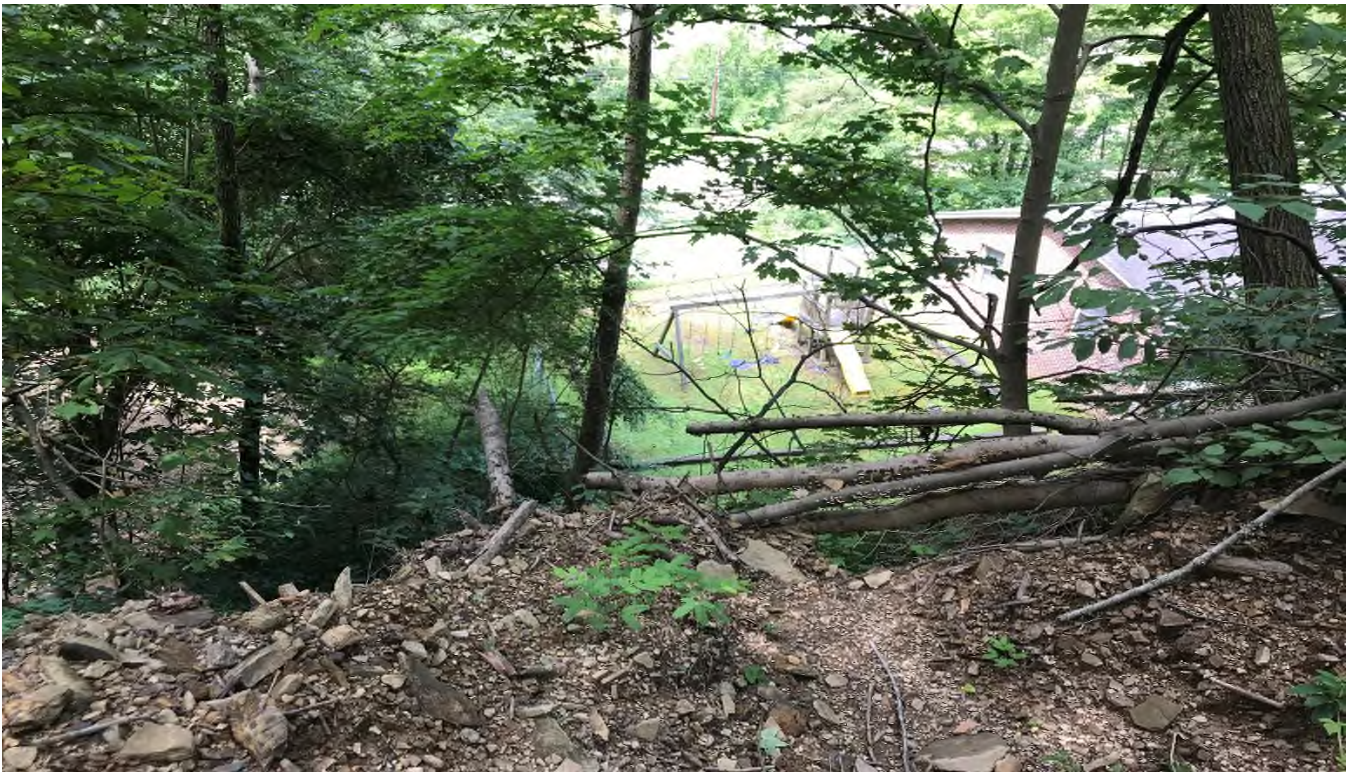
Figure 17 (New land disturbance associated with either new trail construction or widening of an existing trail immediately up gradient of the lawn of a residential dwelling; 37°16'52"N, 82°06'56"W)

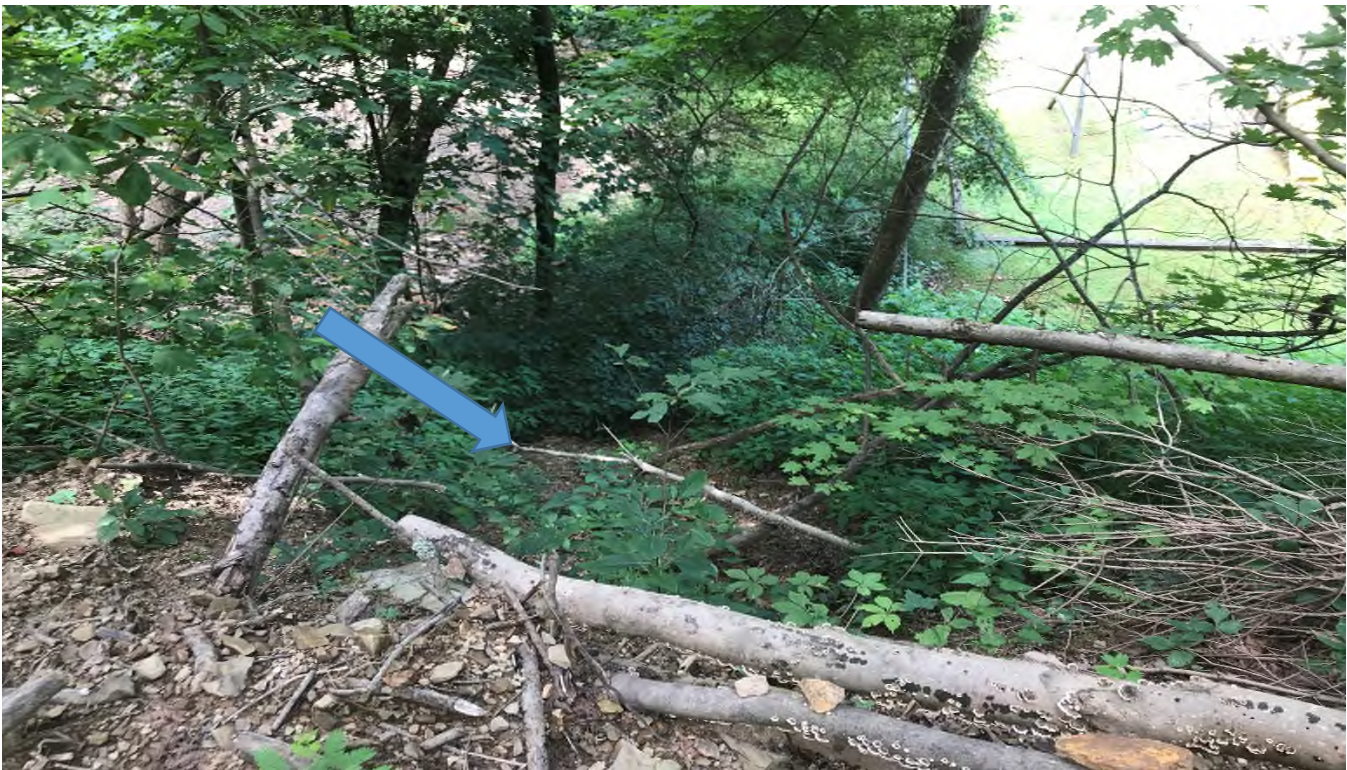
Figure 18 (New land disturbance associated with either new trail construction or widening of an existing trail. Sediment loss down the slope to the corner of the lot associated with the residential dwelling shown in Figure 17; 37°16'52"N, 82°06'56"W)

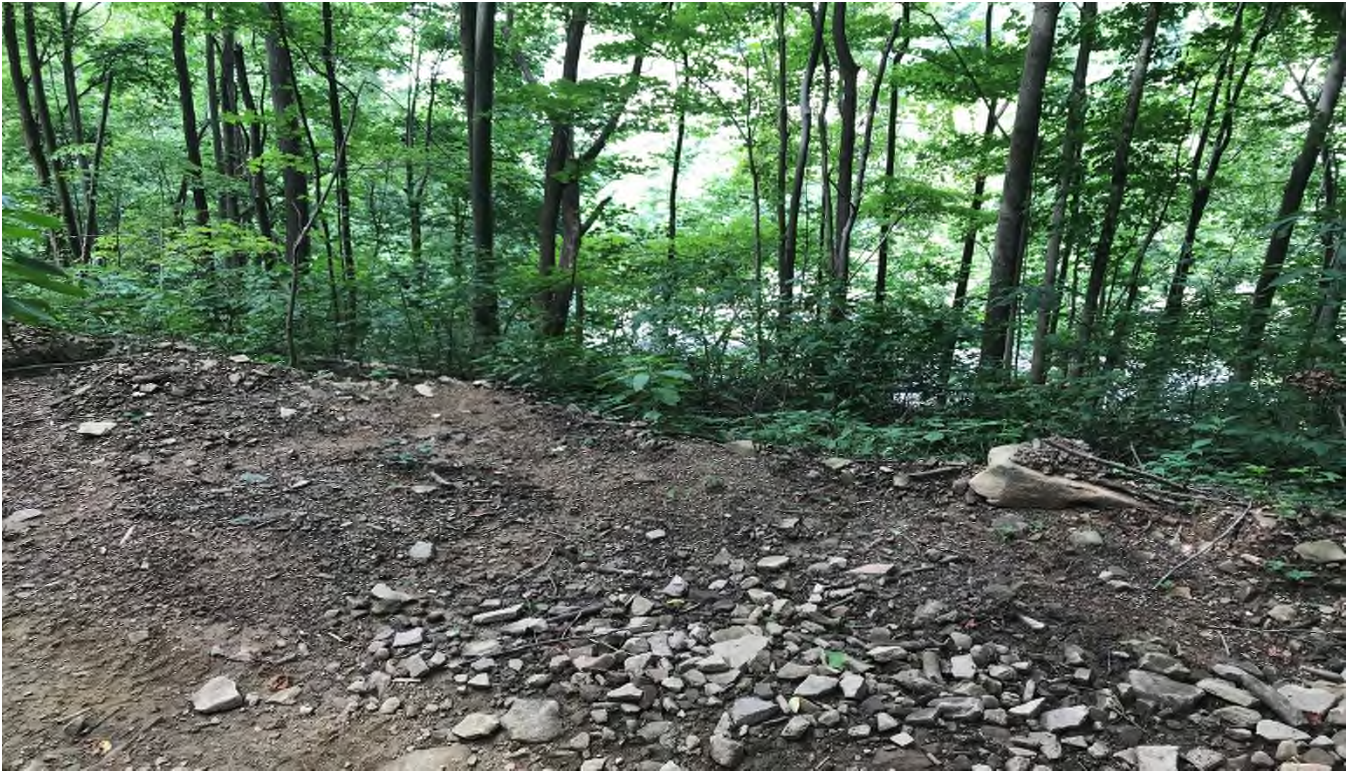
Figure 19 (Loss of sediment from trail down over the slope; 37°16'52"N, 82°06'55"W)

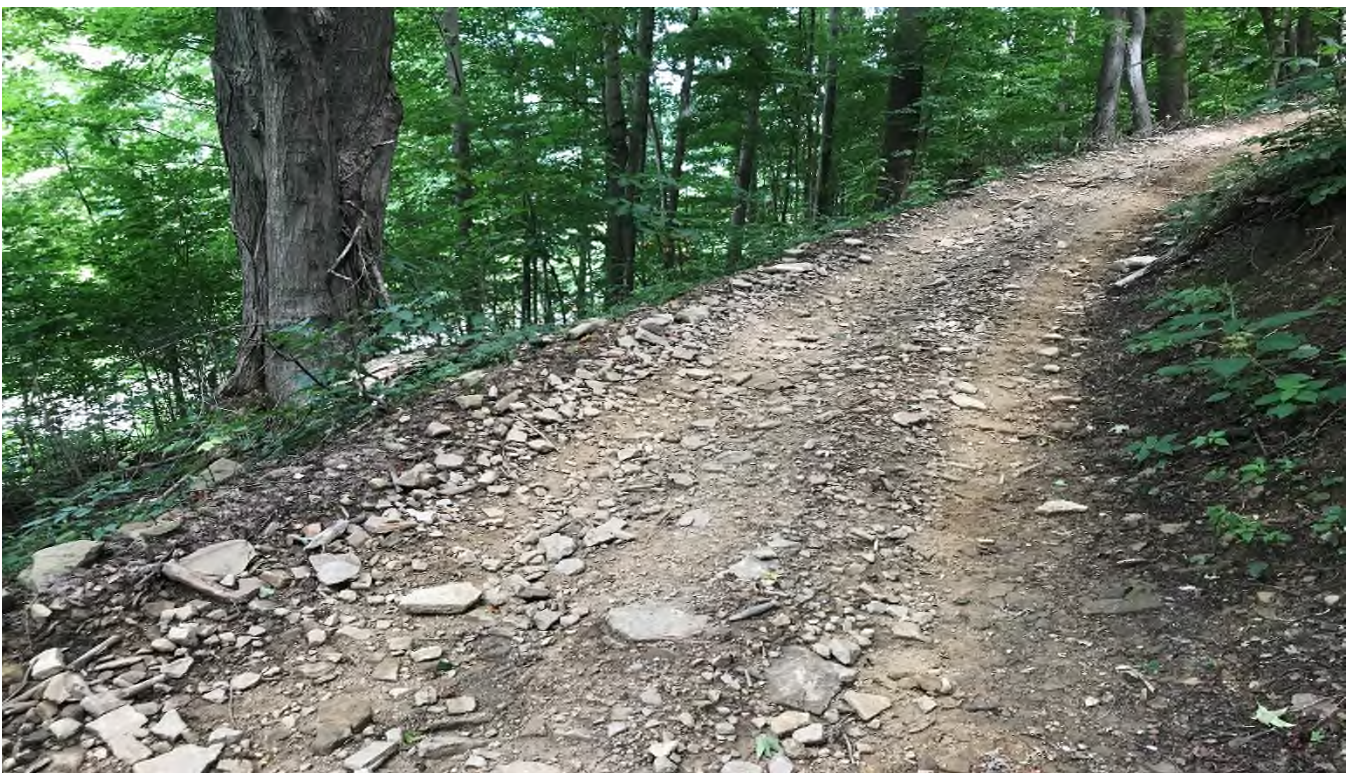
Figure 20 (Trail concentrating flows down the slope leading to the area shown in Figure 19 above; 37°16'52"N, 82°06'55"W)
