Spearhead Trails

Coal Canyon at Grundy (Leetown section)

Complaint Investigation Photo Log

August 10, 2020 by DEQ Staff (Jeff Kite & Jason McCroskey)

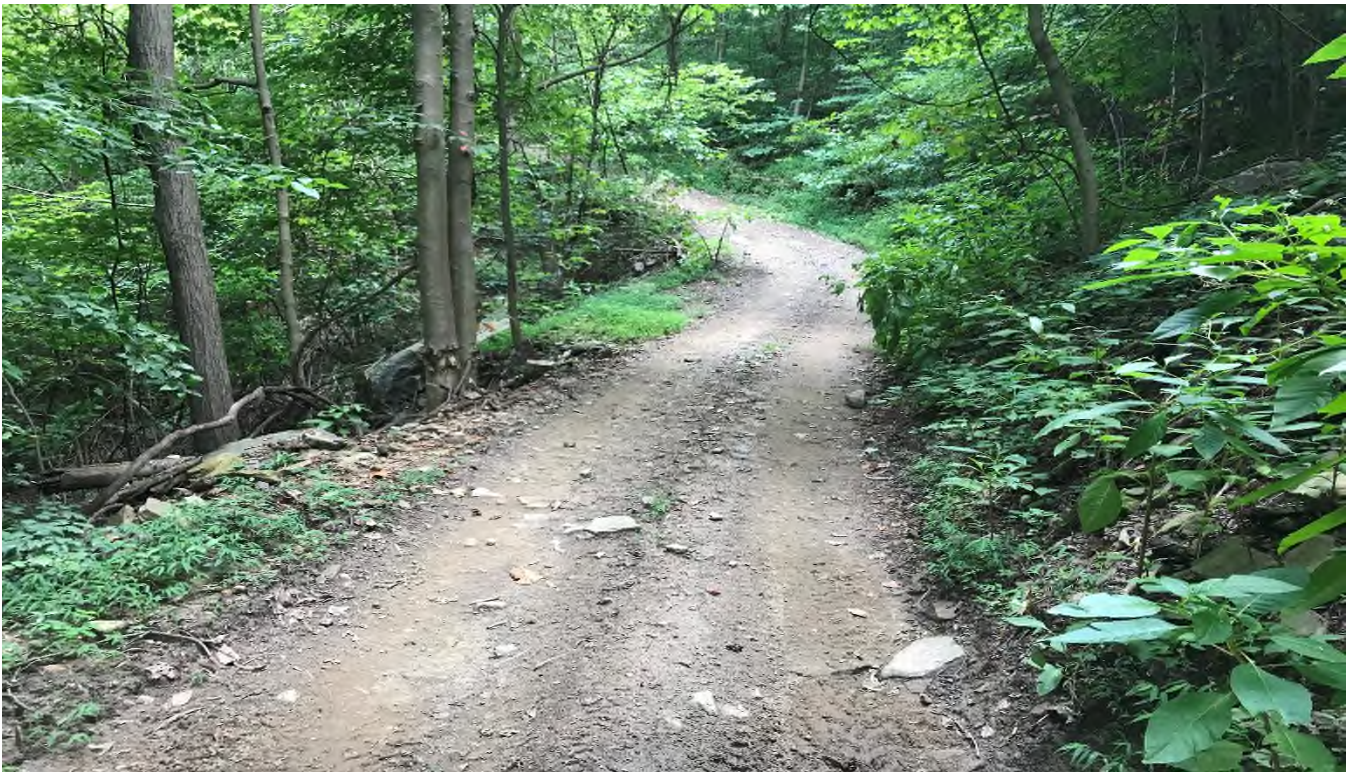
Figure 21 (Concentration of flows from the trail. Flows discharging over the slope resulting in sediment loss shown in Figure 22; 37°16'50"N, 82°06'53"W)

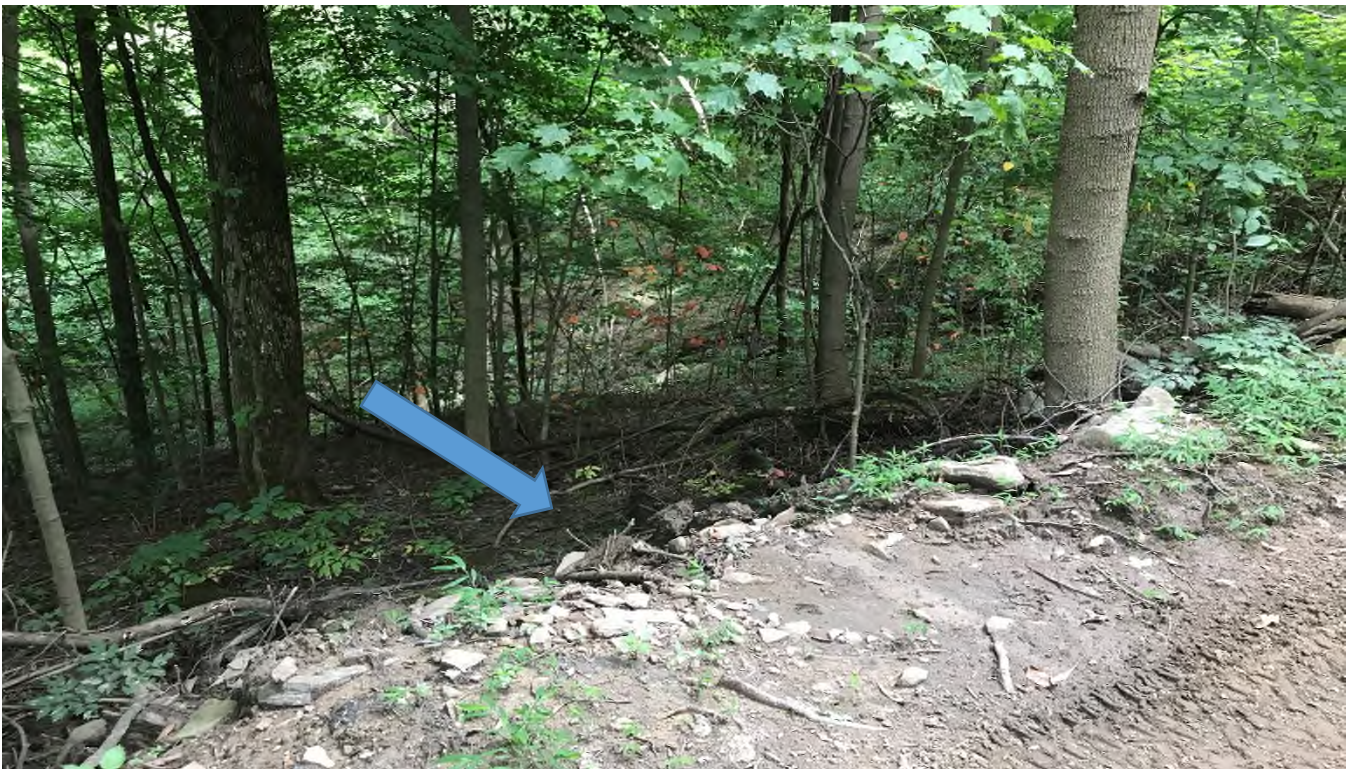
Figure 22 (Sediment loss down the slope resulting from area shown in Figure 21 above; 37°16'50"N, 82°06'53"W)

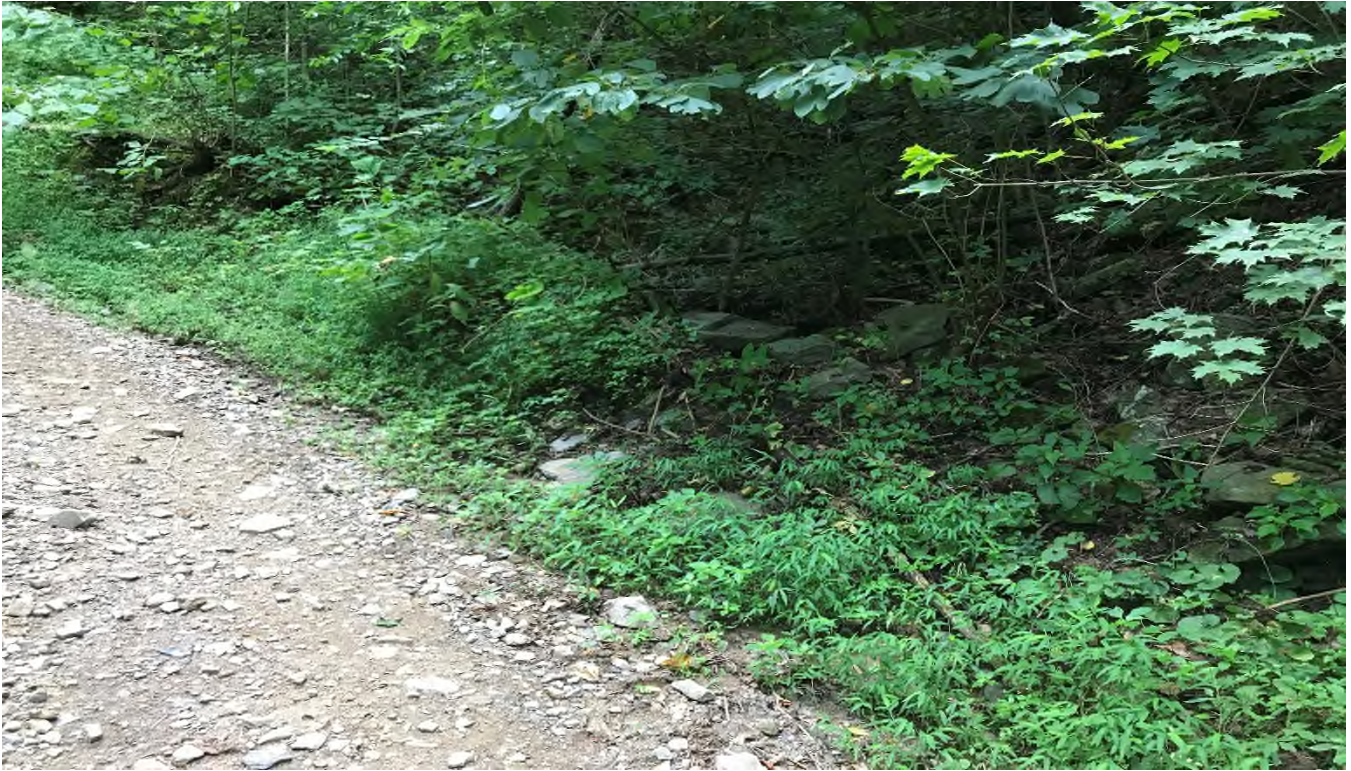
Figure 23 (Natural hollow crossed by trail with no visible cross pipe. Natural drainage intercepted by trail and conveyed down gradient away from hollow; 37°16'50"N, 82°06'53"W)

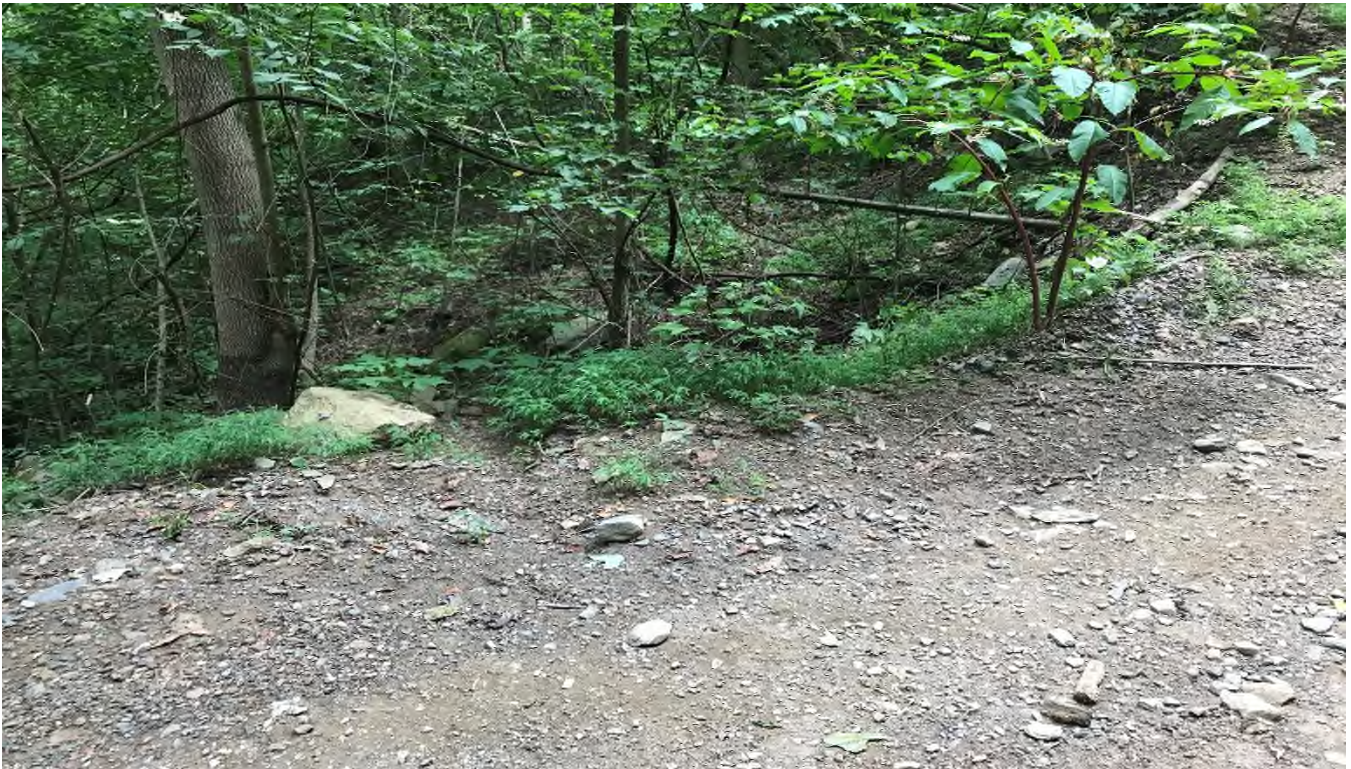
Figure 24 (Out slope of trail down gradient of natural drainage shown in Figure 23; 37°16'50"N, 82°06'53"W)

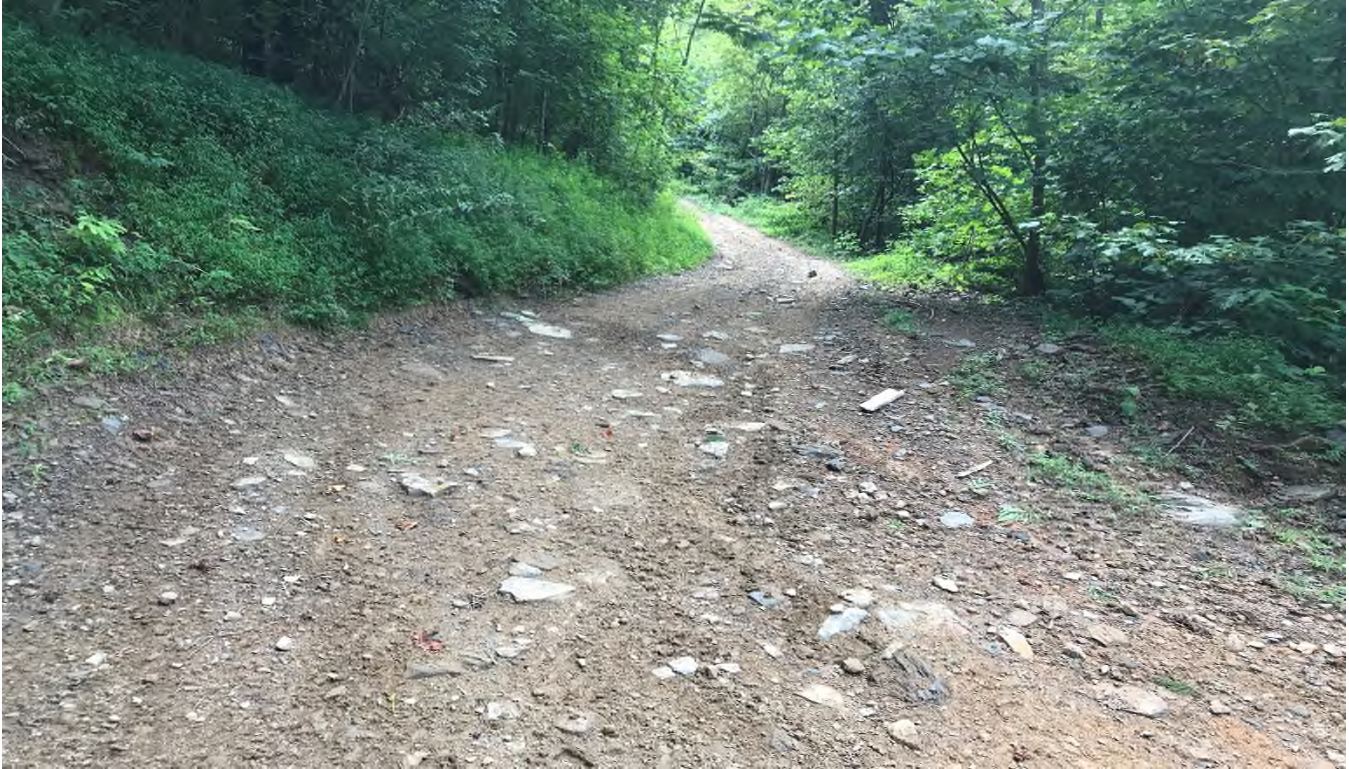
Figure 25 (New land disturbance associated with either new trail construction or widening of an existing trail leading to the area depicted in Figures 23 & 24 above; 37°16'49"N, 82°06'51"W)

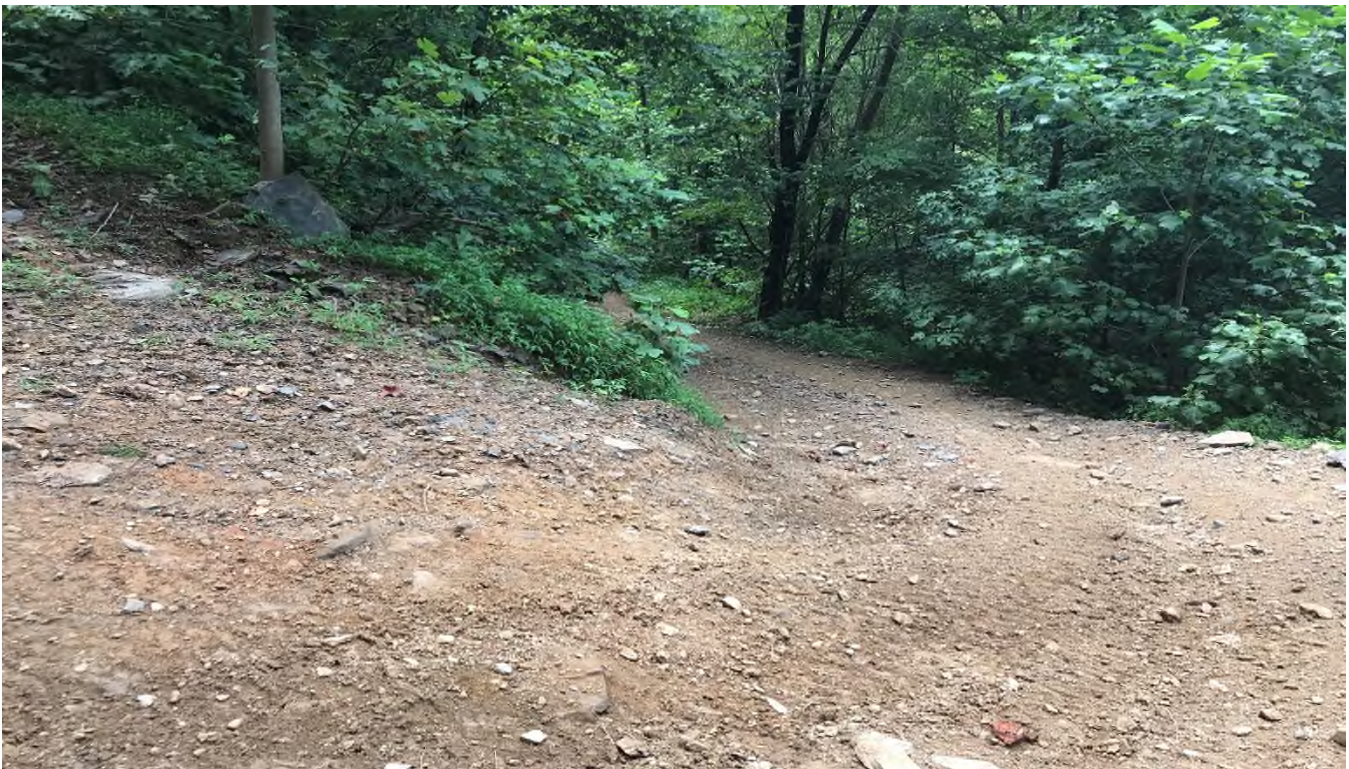
Figure 26 (Same area as shown in Figure 25. Trail switches back around the curve in this photo; 37°16'49"N, 82°06'51"W)
