**Spearhead Trials
Original Pocahontas Trail
Pocahontas, VA
Tazewell County**

Complaint Investigation Photo Log

July 1, 2020 by DEQ Staff (Jeff Kite & Jason McCroskey)

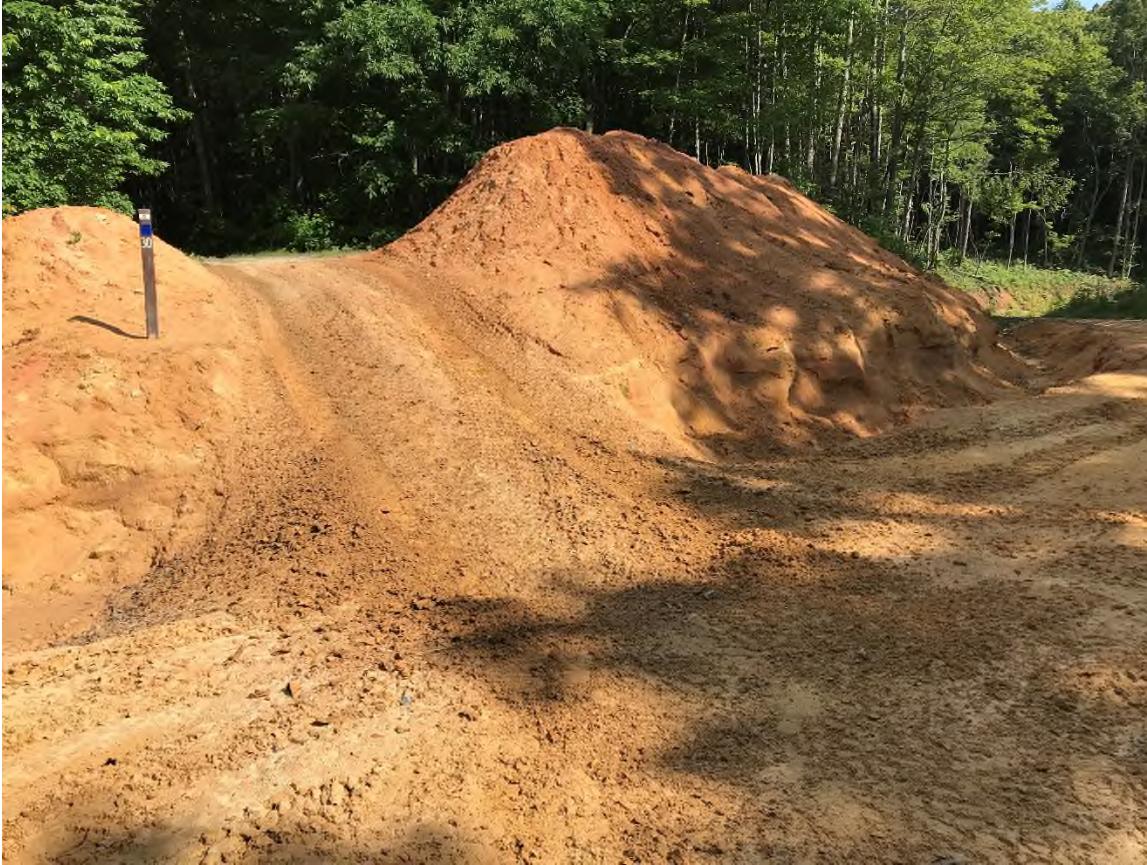
Figure 02 (Ongoing land disturbance observed on Trail 61; 37.30392°, -81.38111°)

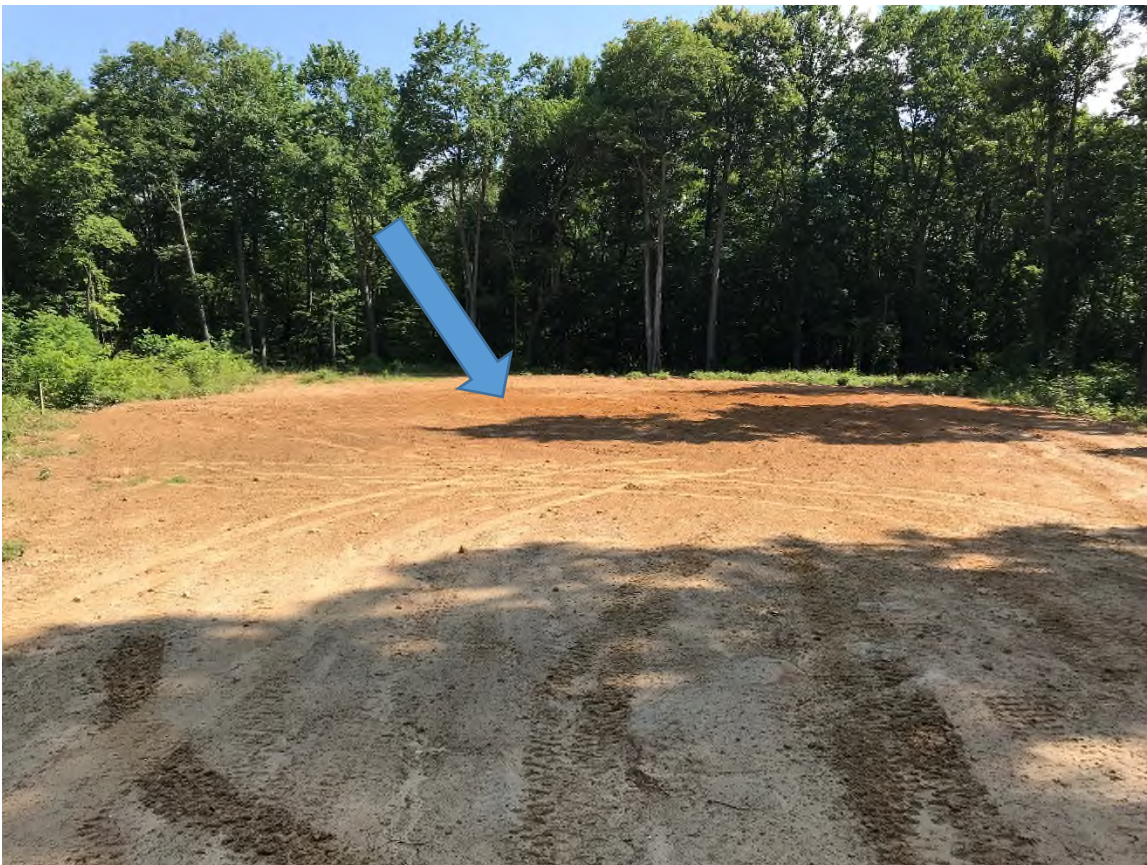
**Figure 03 (Trail 16 erosion observed which discharges to unnamed tributary of Laurel Fork;
37.30168°, -81.38256°)**

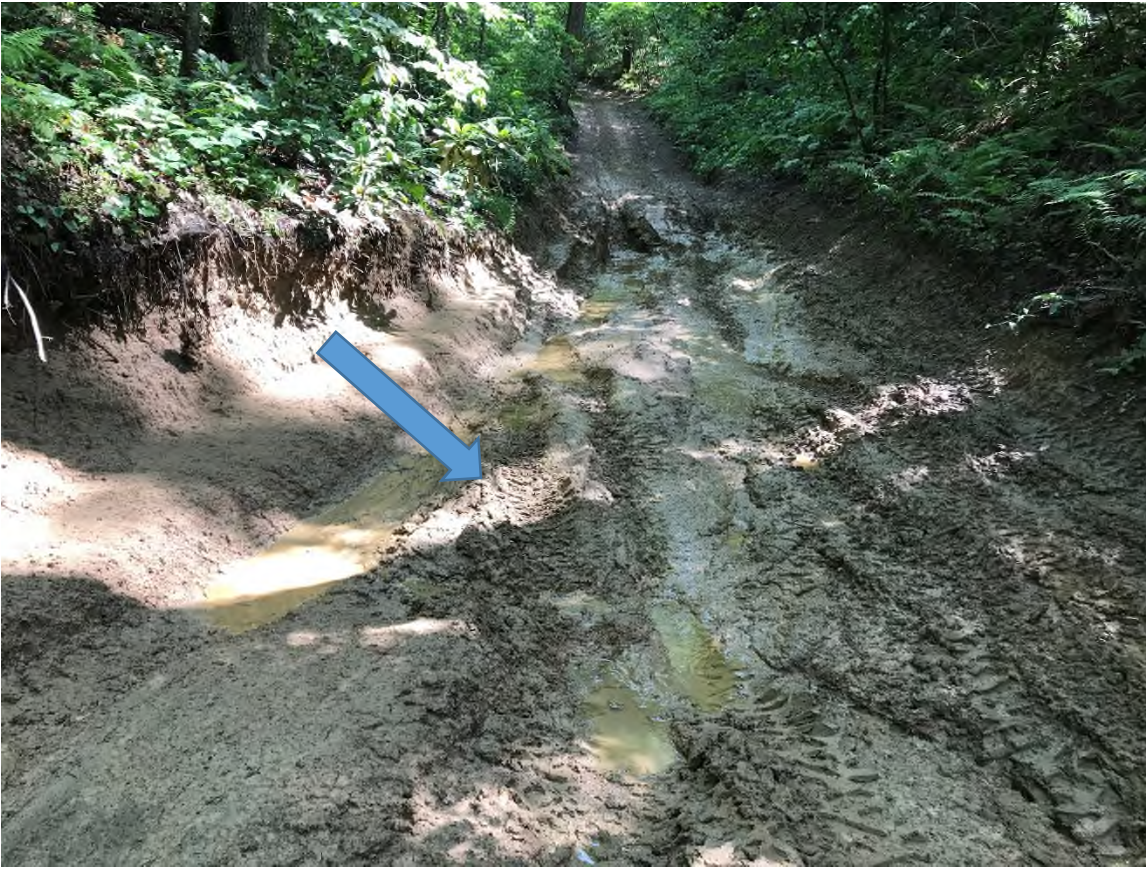
**Figure 04 (Section of Trail 16 observed running through unnamed tributary of Laurel Fork;
37.30164°, -81.38251°)**

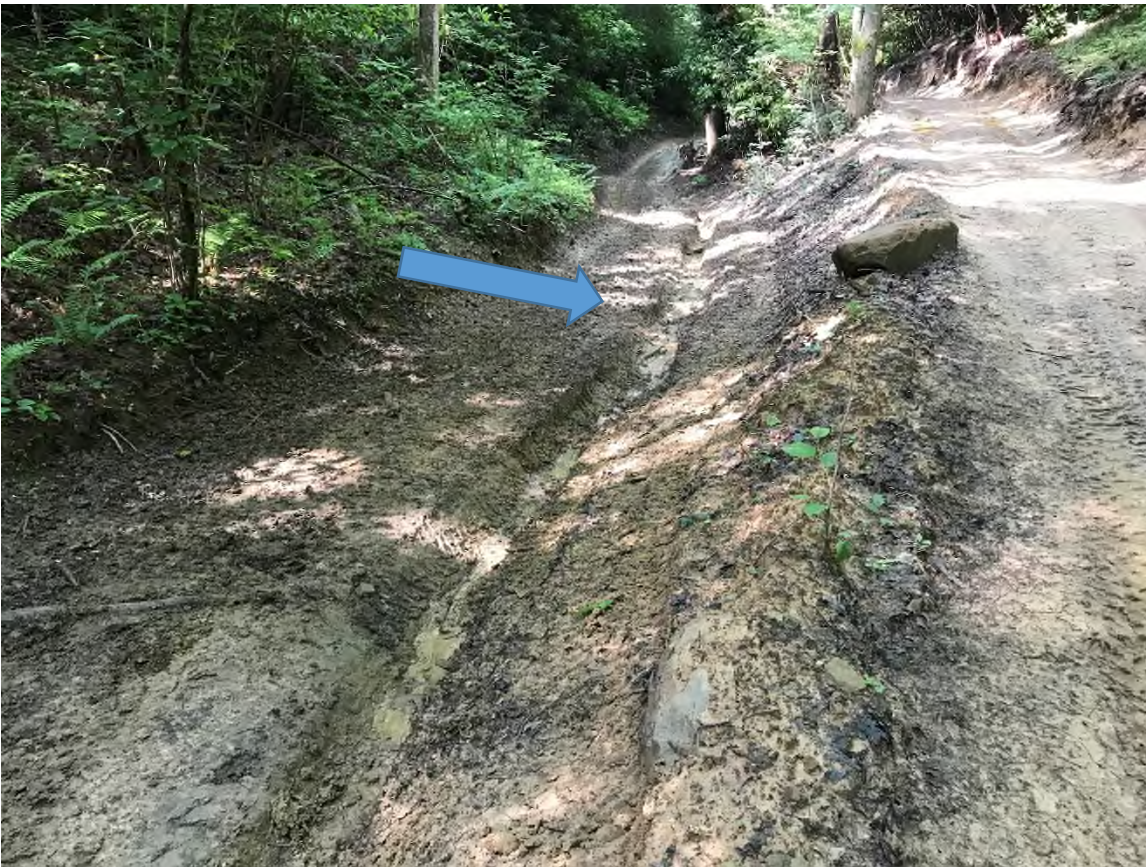
Figure 05 (Sediment deposition observed in unnamed tributary of Laurel Fork adjacent to Trail 16; 37.30110°, -81.38316°)

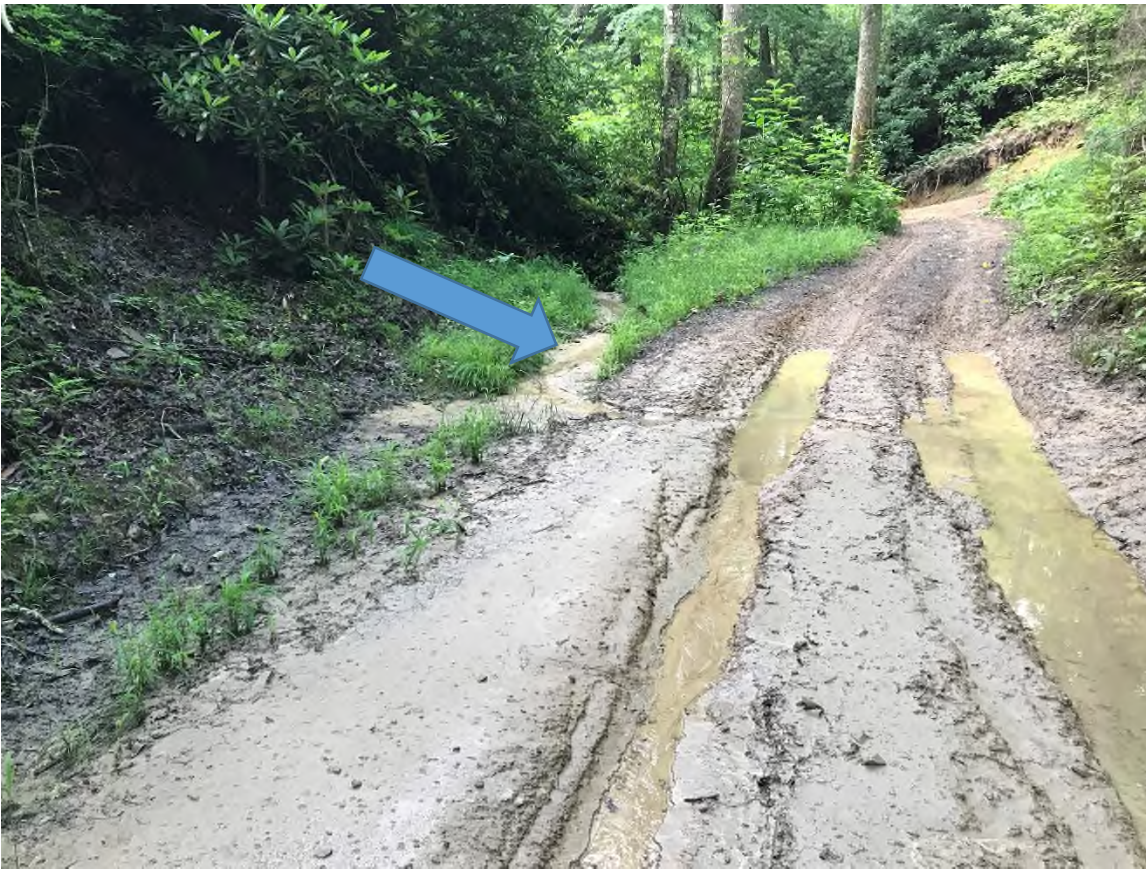
Figure 06 (Sediment deposition observed in unnamed tributary of Laurel Fork adjacent to Trail 16; 37.30075°, -81.38333°)

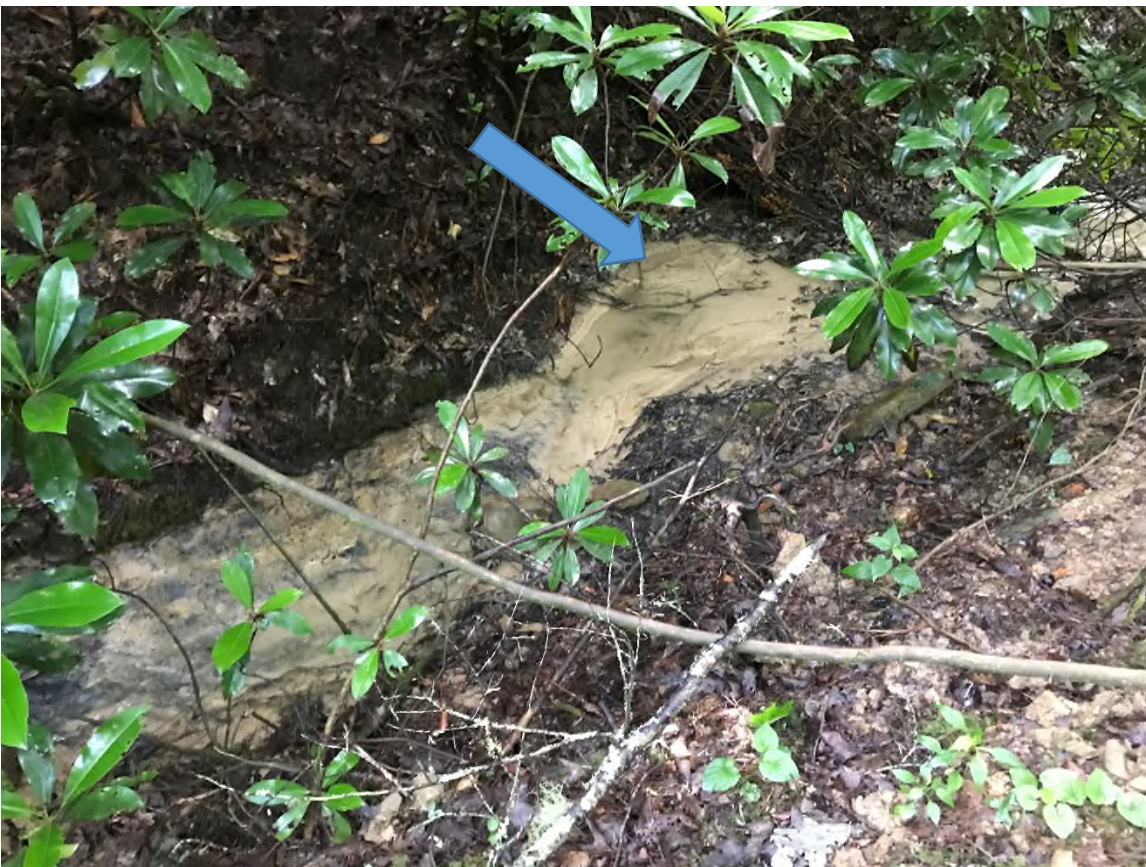
Figure 07 (Sediment deposition observed in unnamed tributary of Laurel Fork adjacent to Trail 16; 37.30051°, -81.38343°)

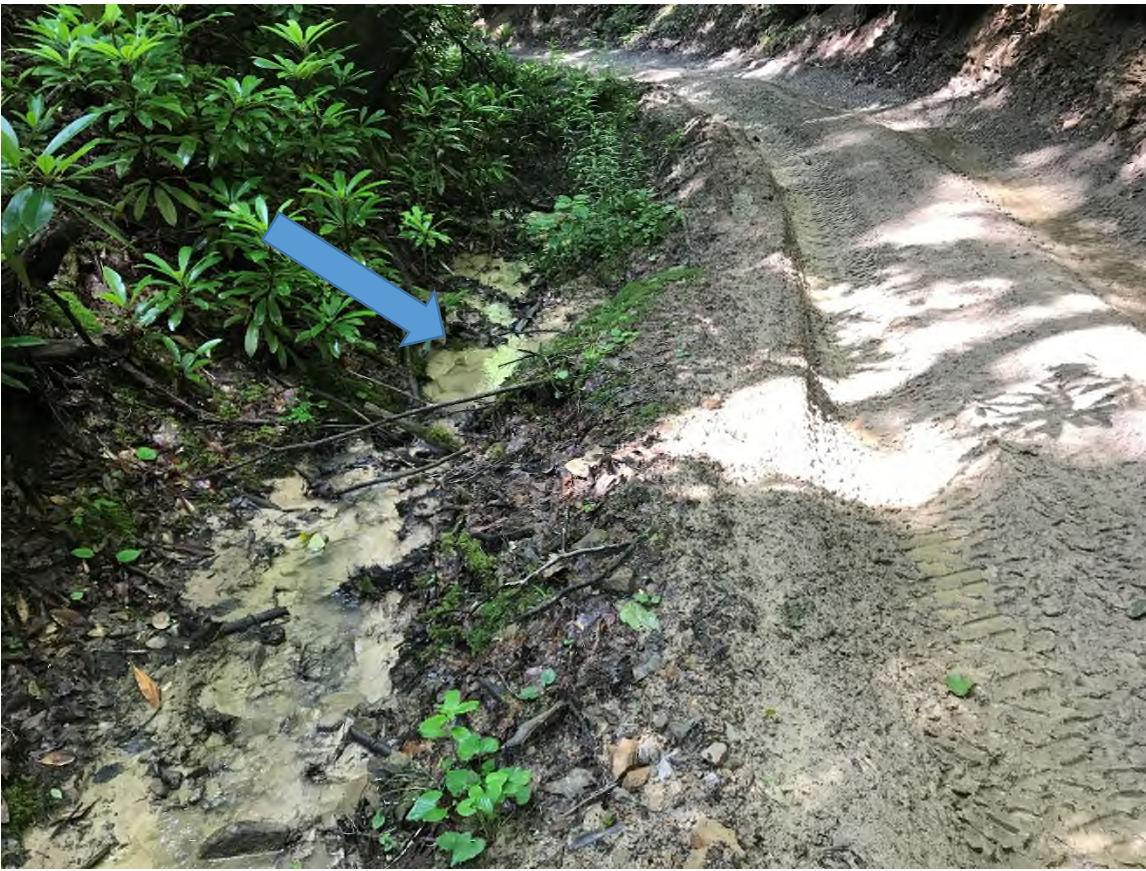
Figure 08 (Sediment deposition observed in unnamed tributary of Laurel Fork adjacent to Trail 16; 37.30019°, -81.38351°)

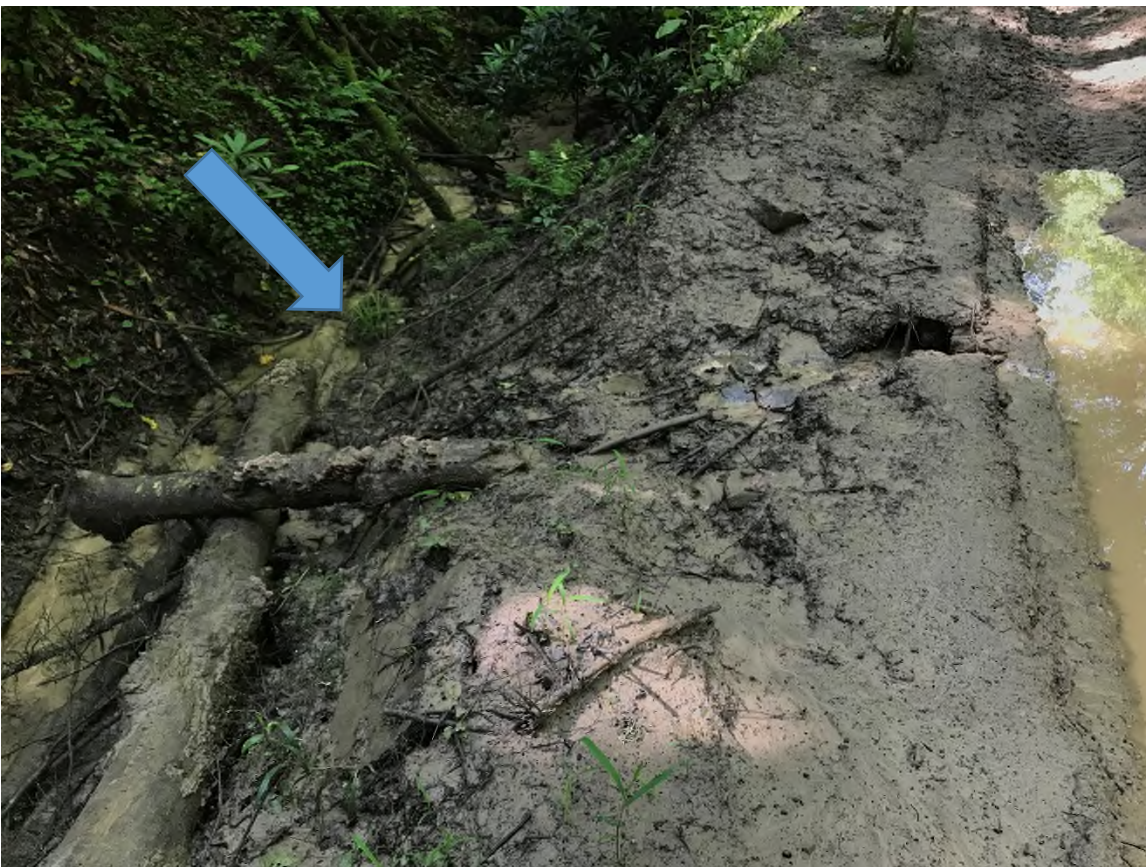
Figure 09 (Trail 16 crossing of unnamed tributary of Laurel Fork; 37.29966°, -81.38381°)

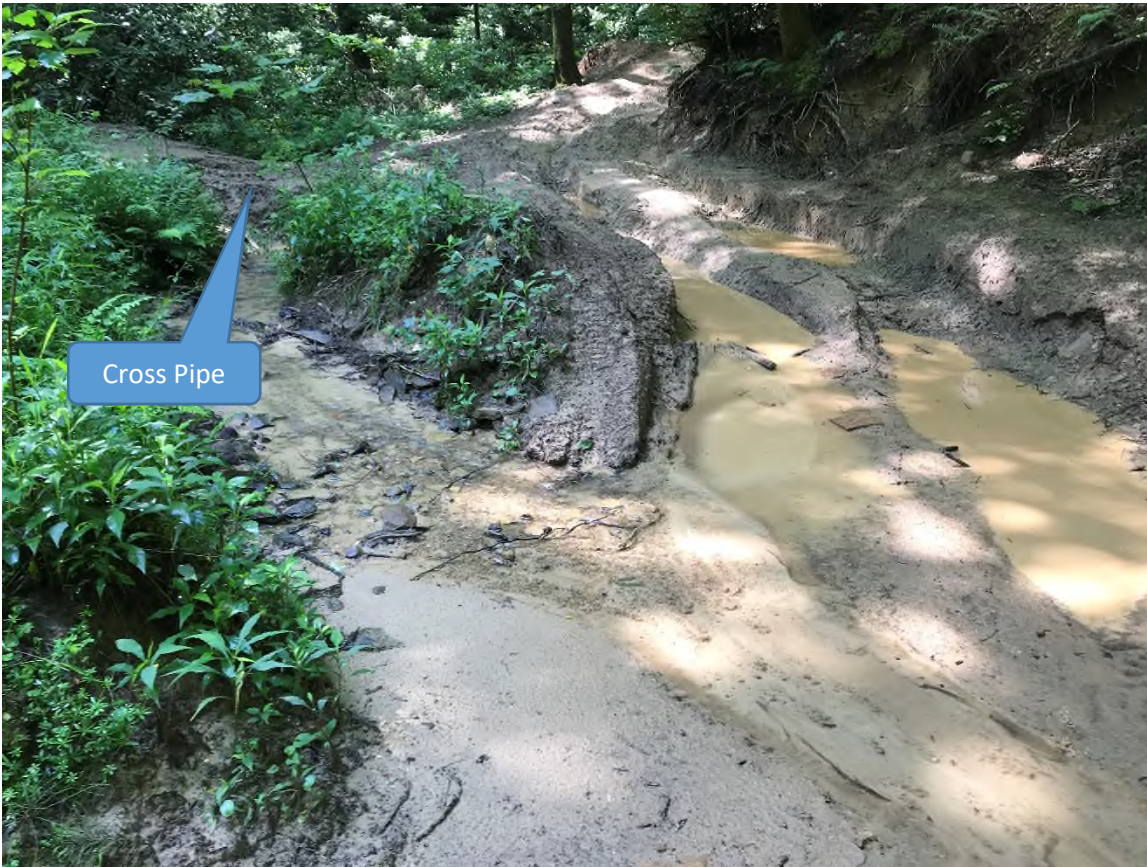
Figure 10 (Inlet of cross pipe at Trail 16 crossing of unnamed tributary of Laurel Fork; 37.29957°, -81.38358°)

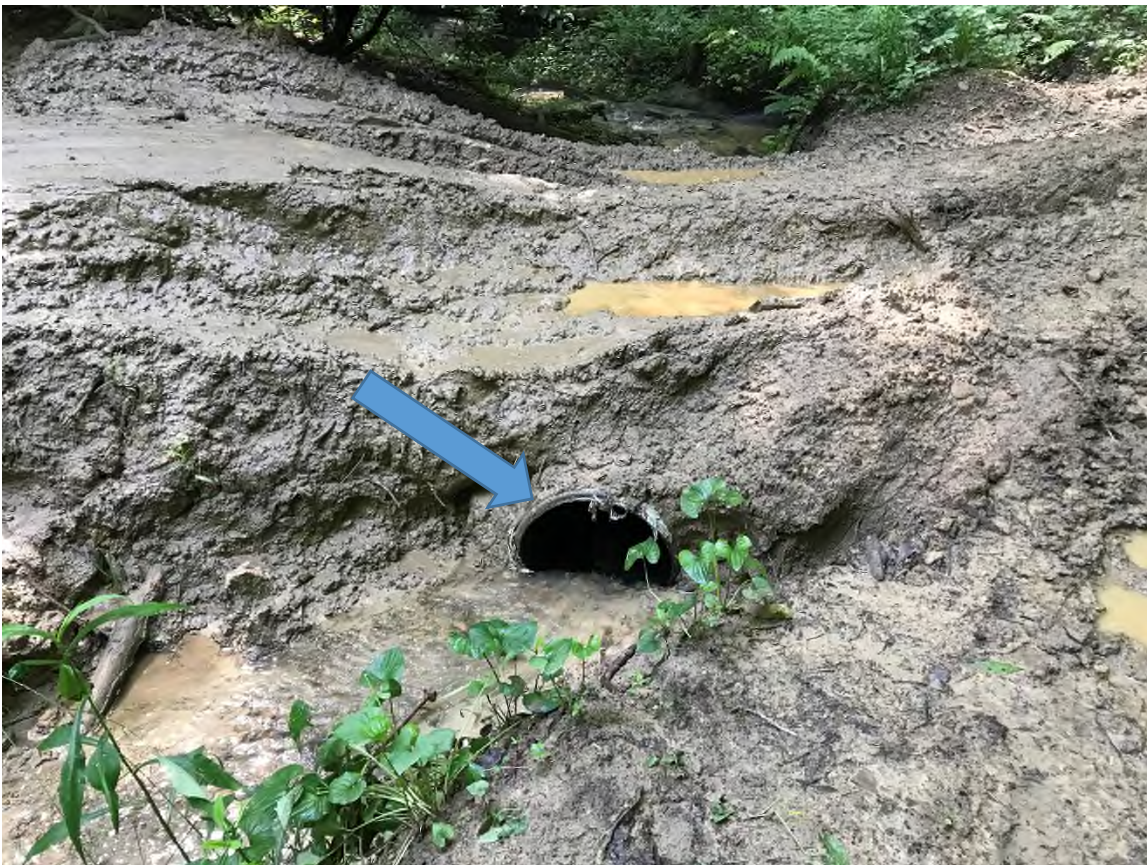
Figure 11 (Trail 16 crossing of unnamed tributary of Laurel Fork; 37.29957° , -81.38358°)

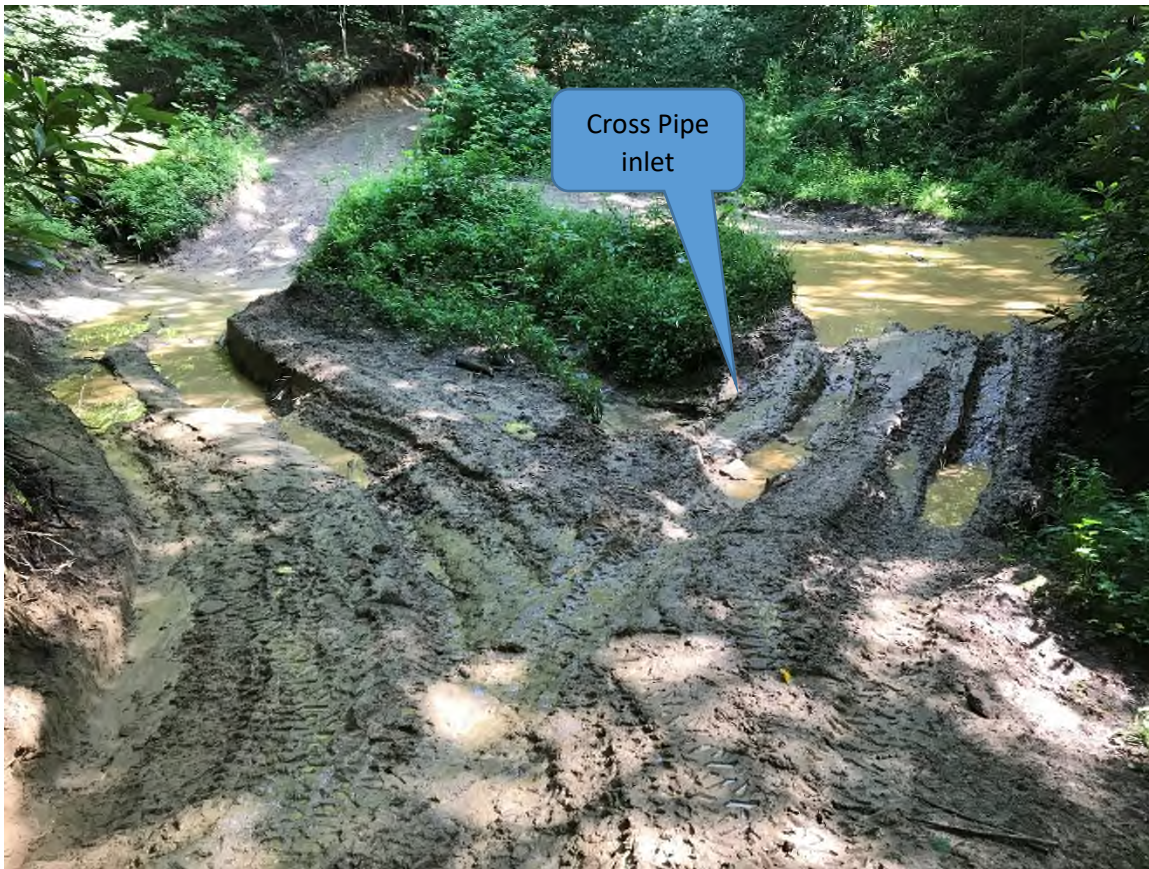
Figure 12 (Sediment deposition observed in unnamed tributary of Laurel Fork downstream of cross pipe at Trail 16 crossing; 37.29957° , -81.38358°)

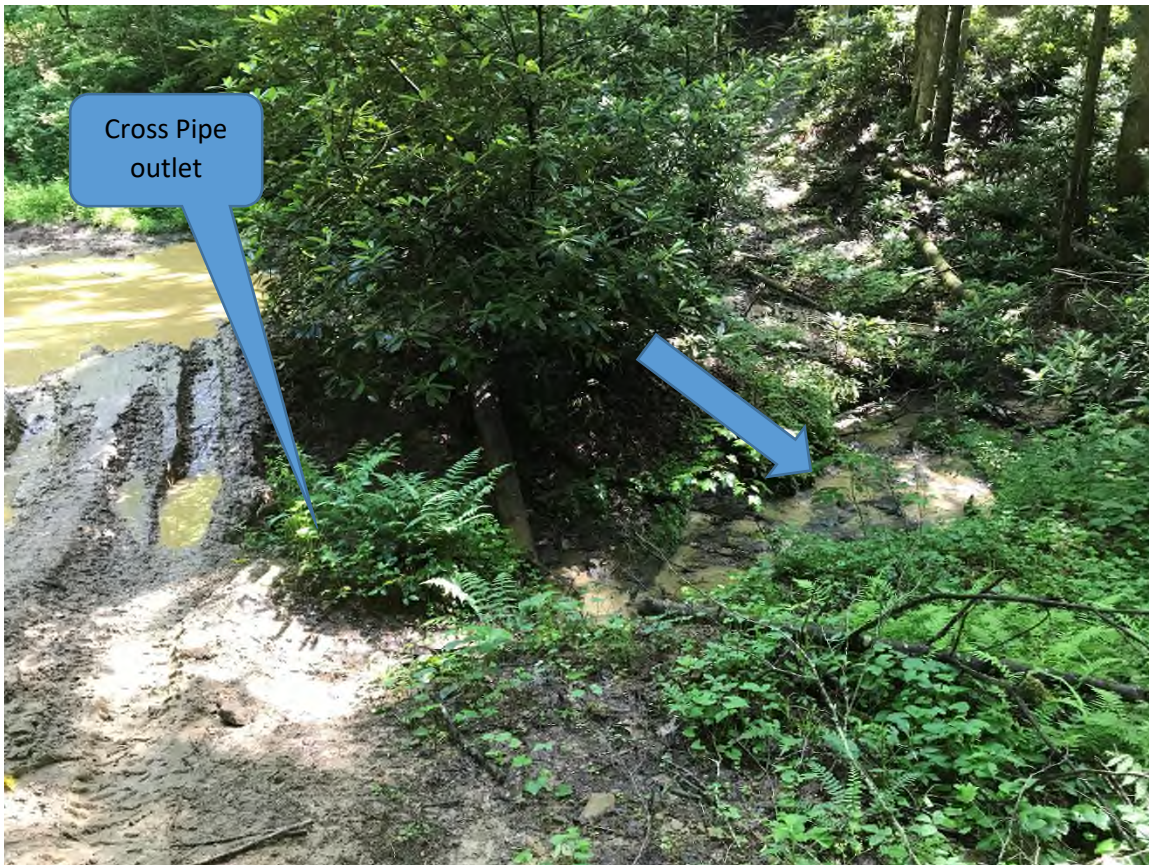
Figure 13 (Sediment deposition observed in unnamed tributary of Laurel Fork downstream of a cross pipe located on a closed section of trail adjacent to Trail 16; 37.29965°, -81.38367°)

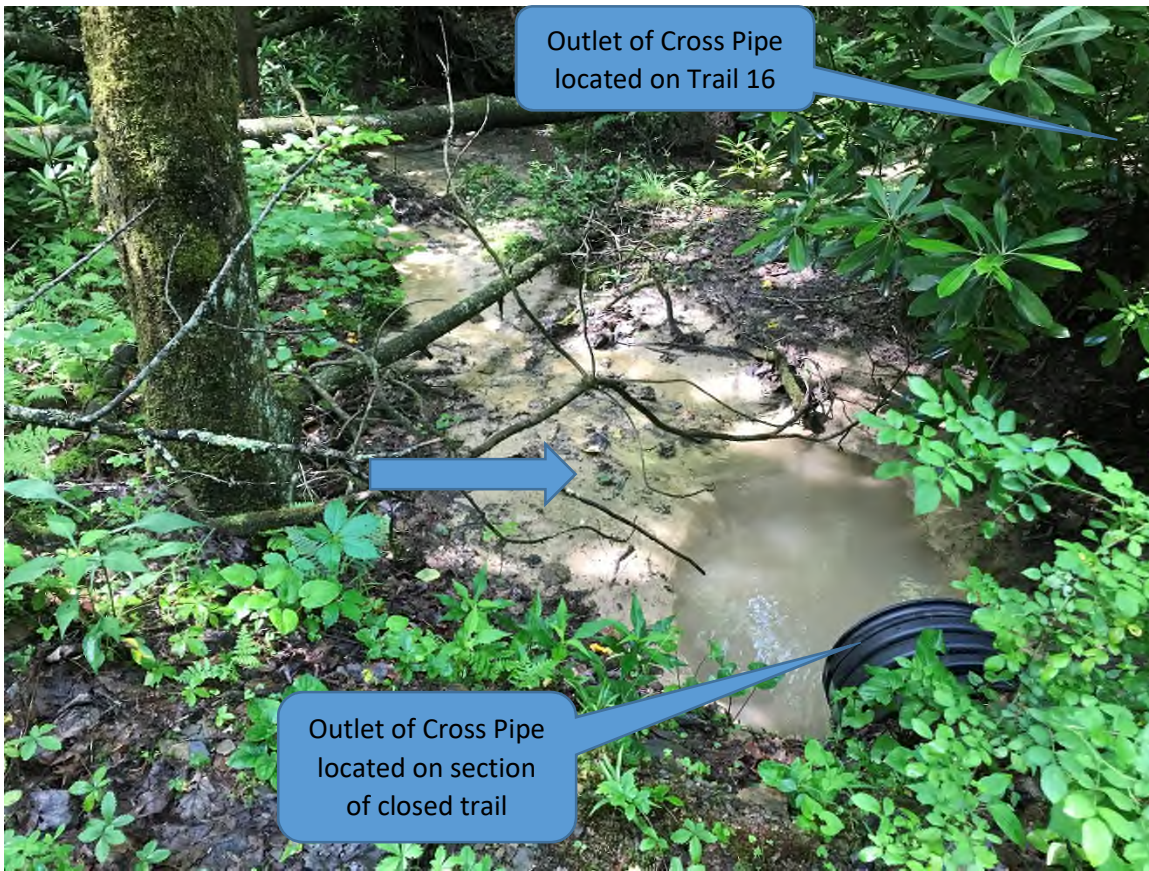
Figure 14 (Up gradient of Trail 61, sediment deposition was observed in an unnamed tributary of Laurel Fork along with remnants of a closed trail which once ran within the unnamed tributary; 37.29668°, -81.37852°)

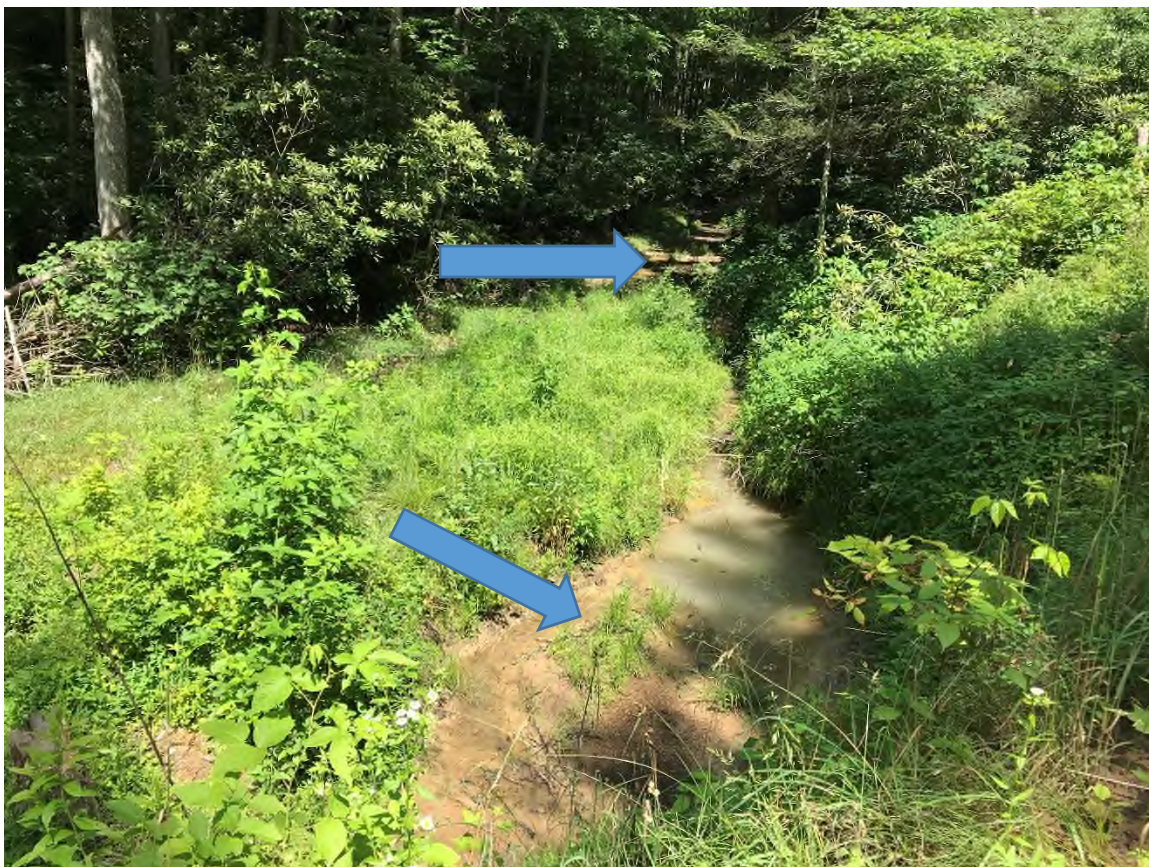
Figure 15 (Sediment deposition observed in drainage swale down gradient of Trail 60 which leads to Laurel Fork; 37.29266°, -81.36940°)

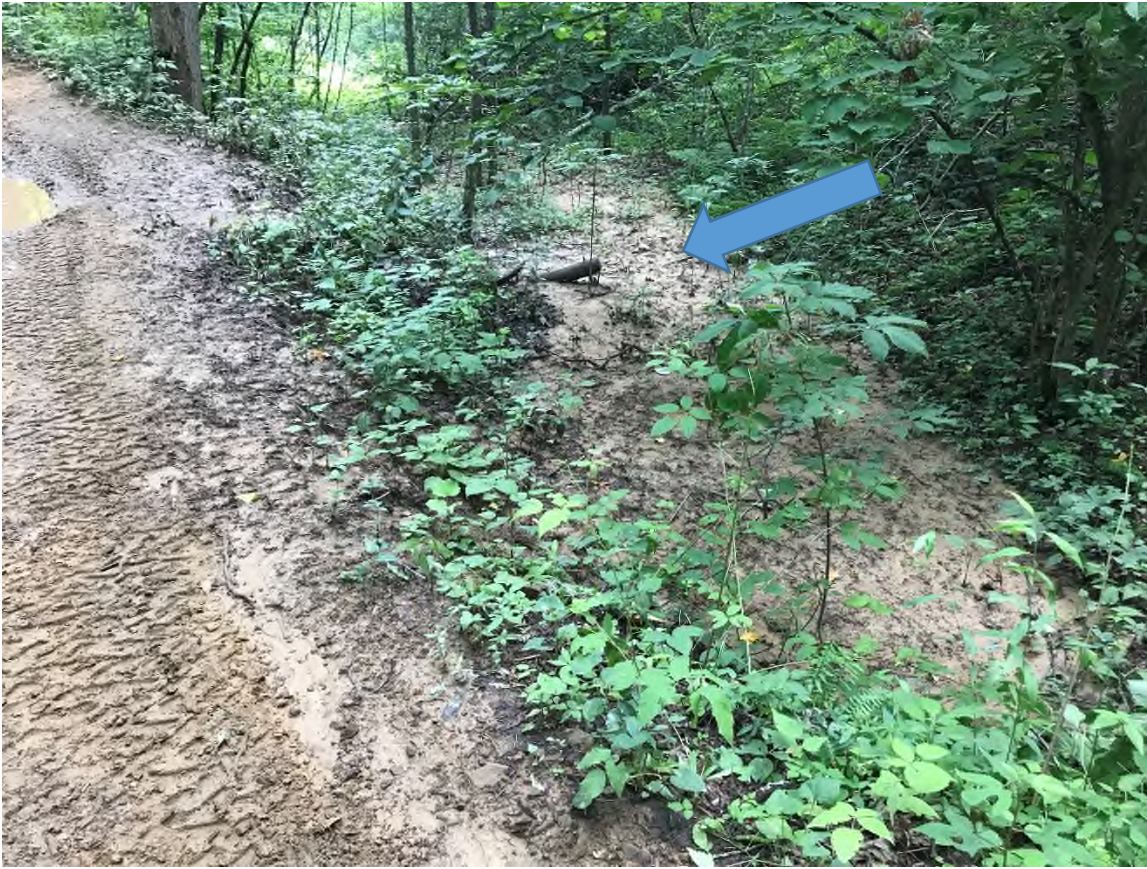
Figure 16 (Mud hole in Trail 14 with overflow discharge observed leading to Laurel Fork; 37.29361°, -81.36843°)

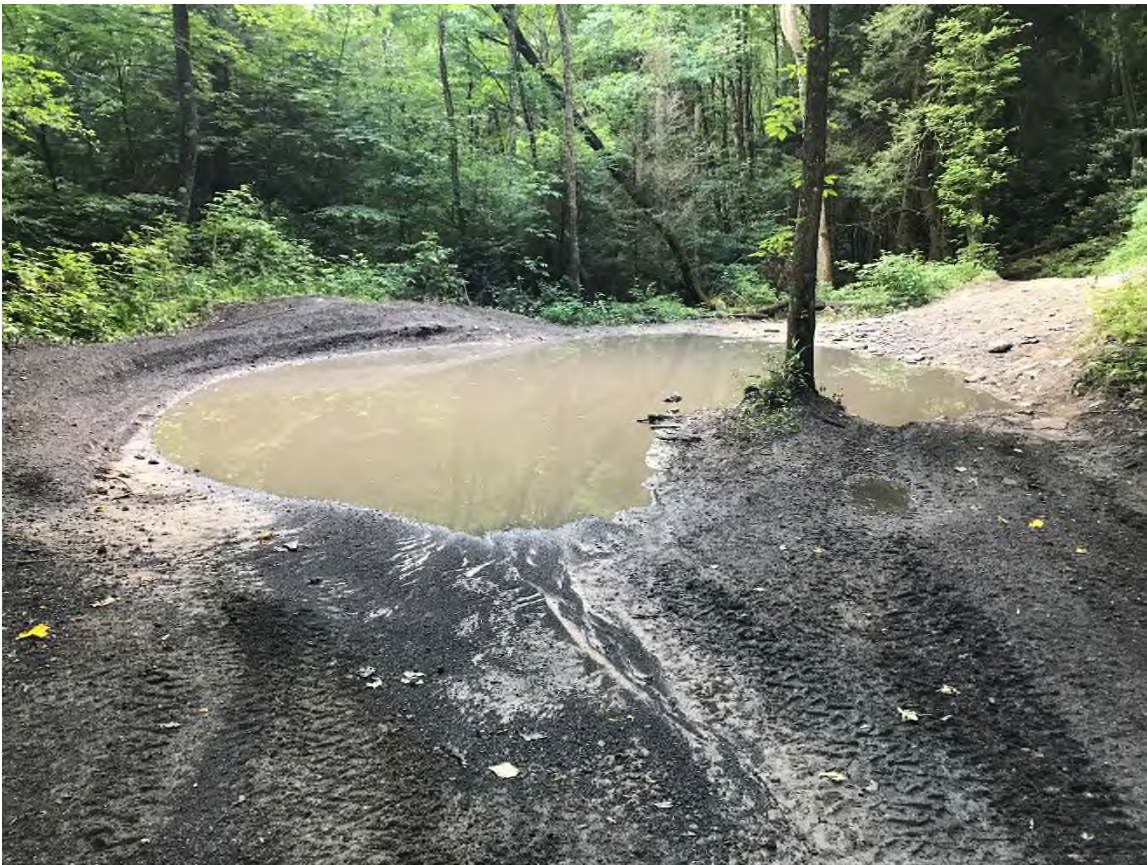
Figure 17 (Trail 14 crossing Laurel Fork; 37.29427°, -81.36954°)

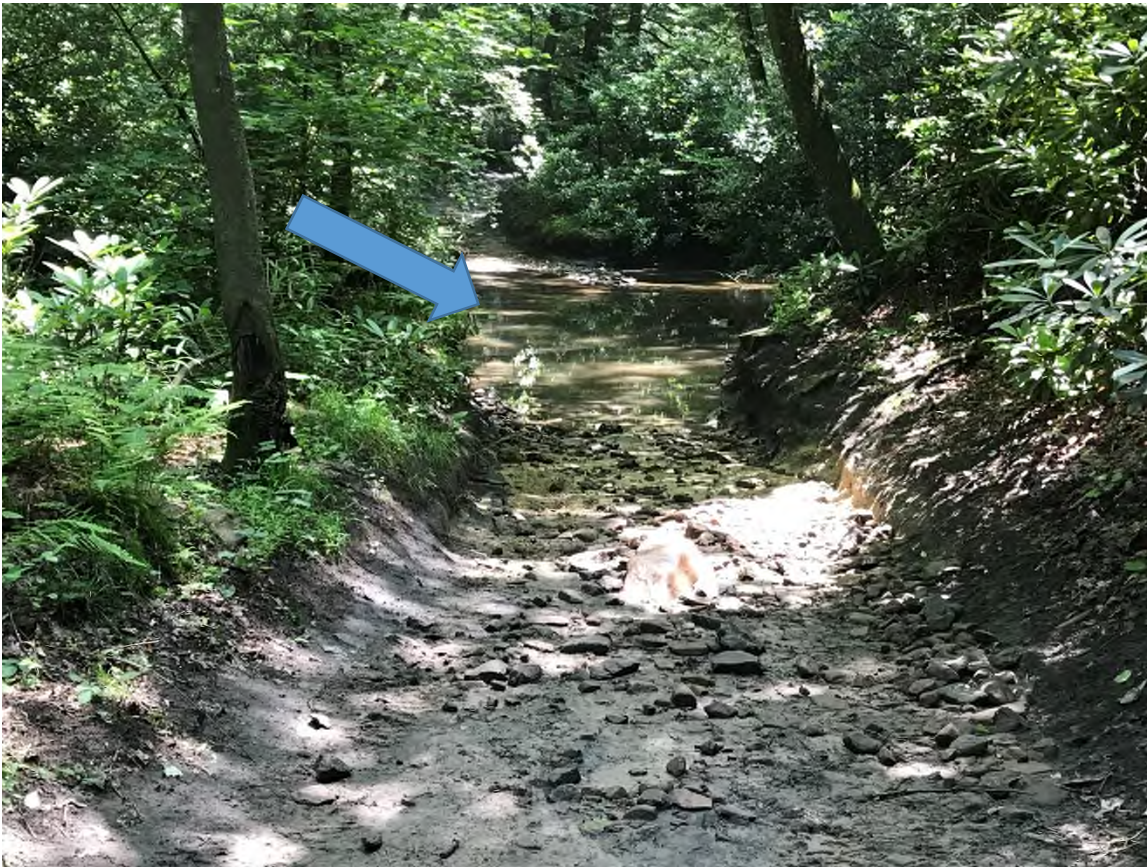
Figure 18 (Trail 14 crossing Laurel Fork with a trail of sediment observed leading to Laurel Fork; 37.29433°, -81.37004°)

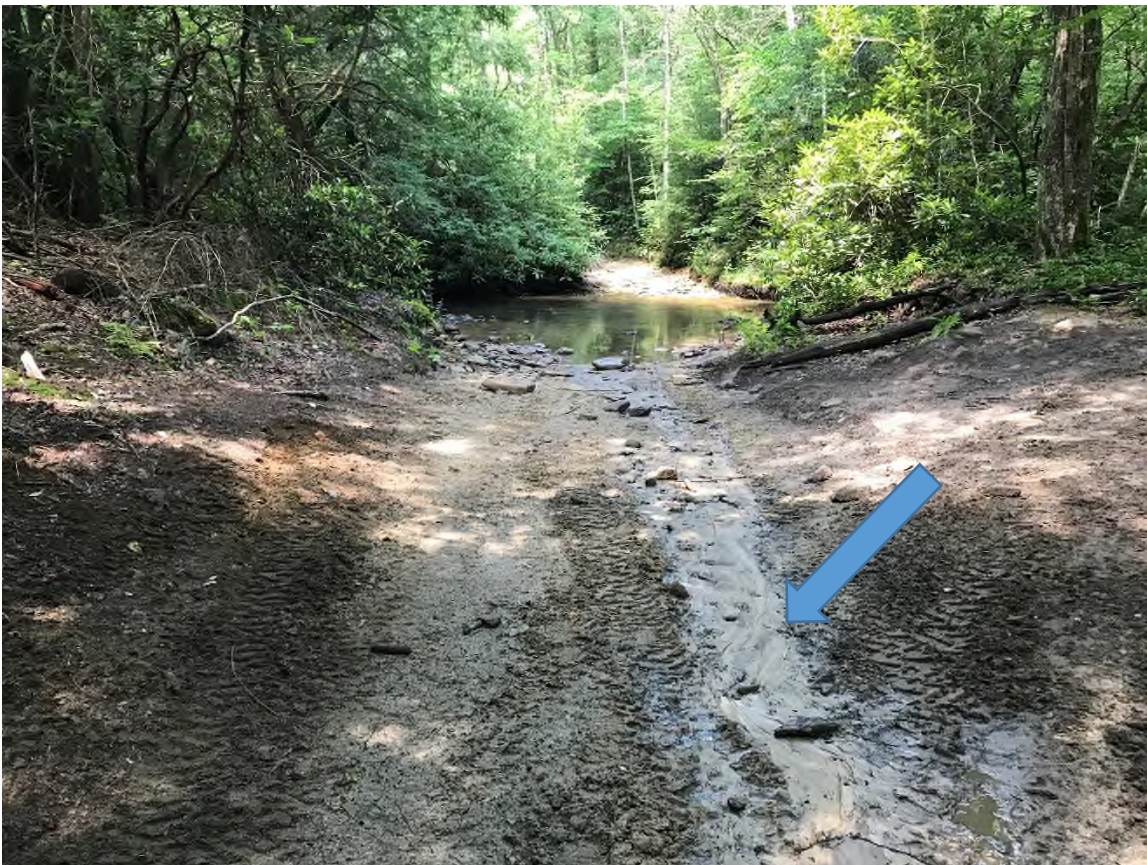
Figure 19 (Trail 14 crossing Haynes Branch with sediment deposition observed down gradient; 37.29491°, -81.37132°)

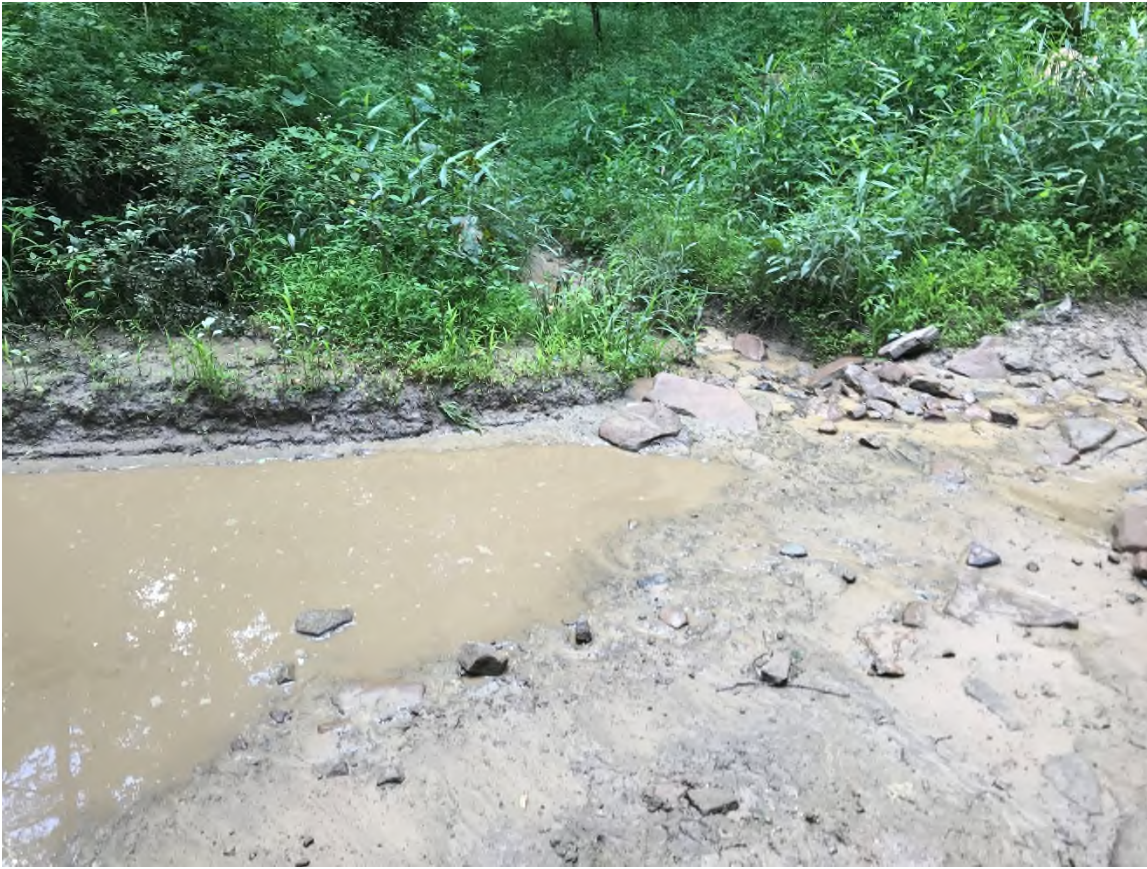
Figure 20 (Section of Trail 14 paralleling Haynes Branch with sediment deposition observed within Haynes Branch; 37.29521°, -81.37177°)

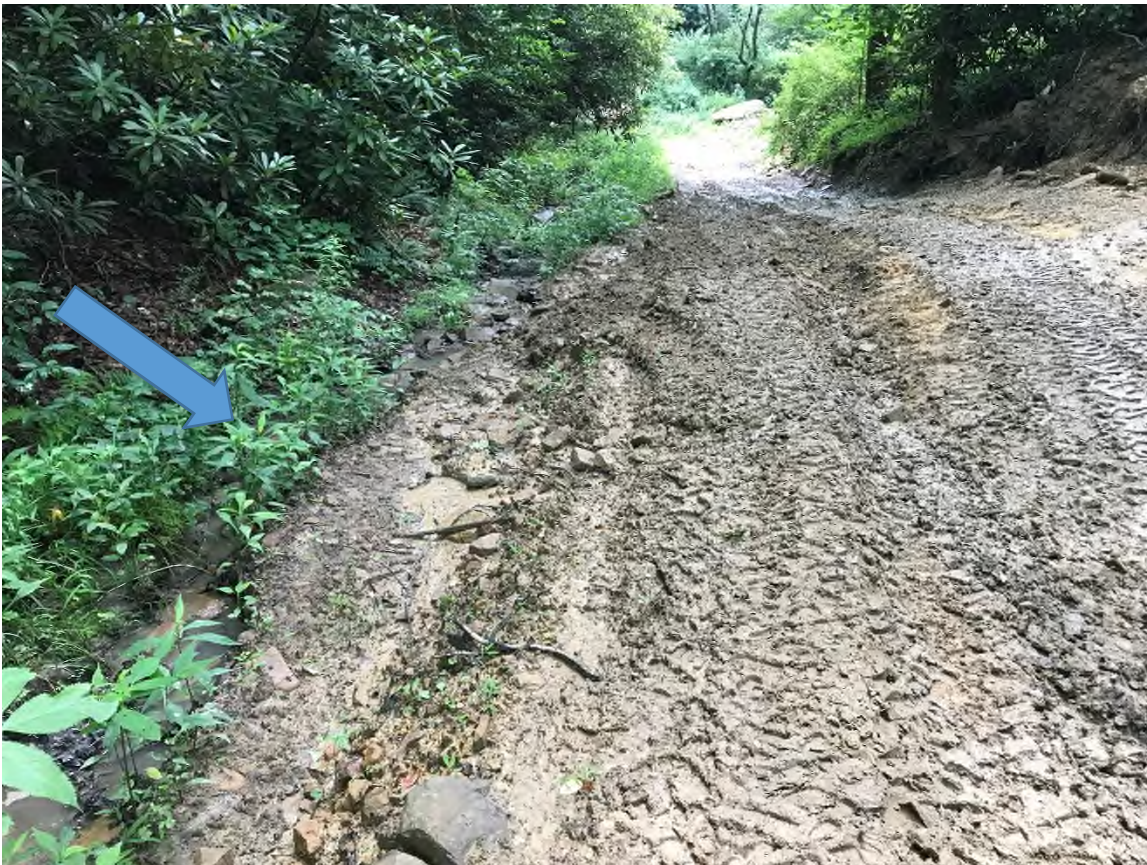
Figure 21 (Trail 14 crossing wet hollow which discharges to Haynes Branch with sediment deposition observed down gradient; 37.29574°, -81.37289°)

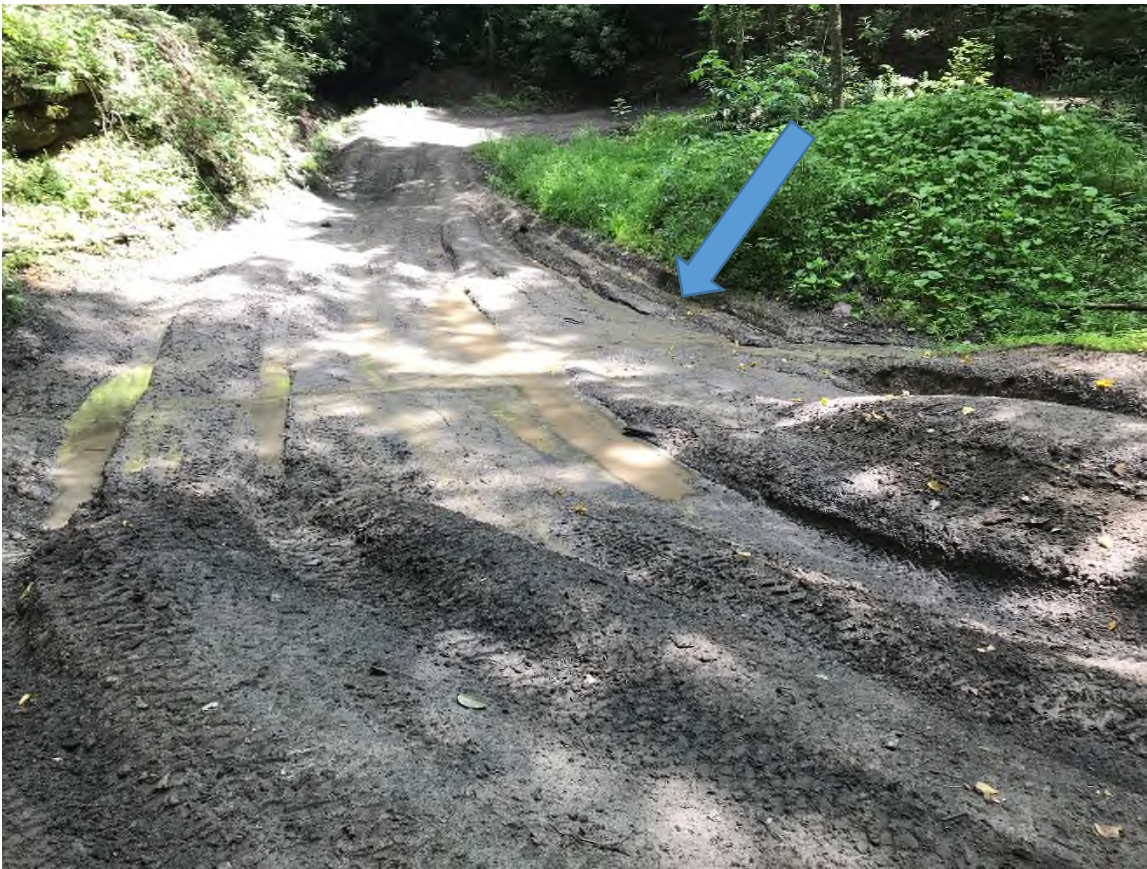
Figure 22 (Trail 14 crossing wet hollow which discharges to Haynes Branch with sediment deposition observed down gradient; 37.29584°, -81.37292°)

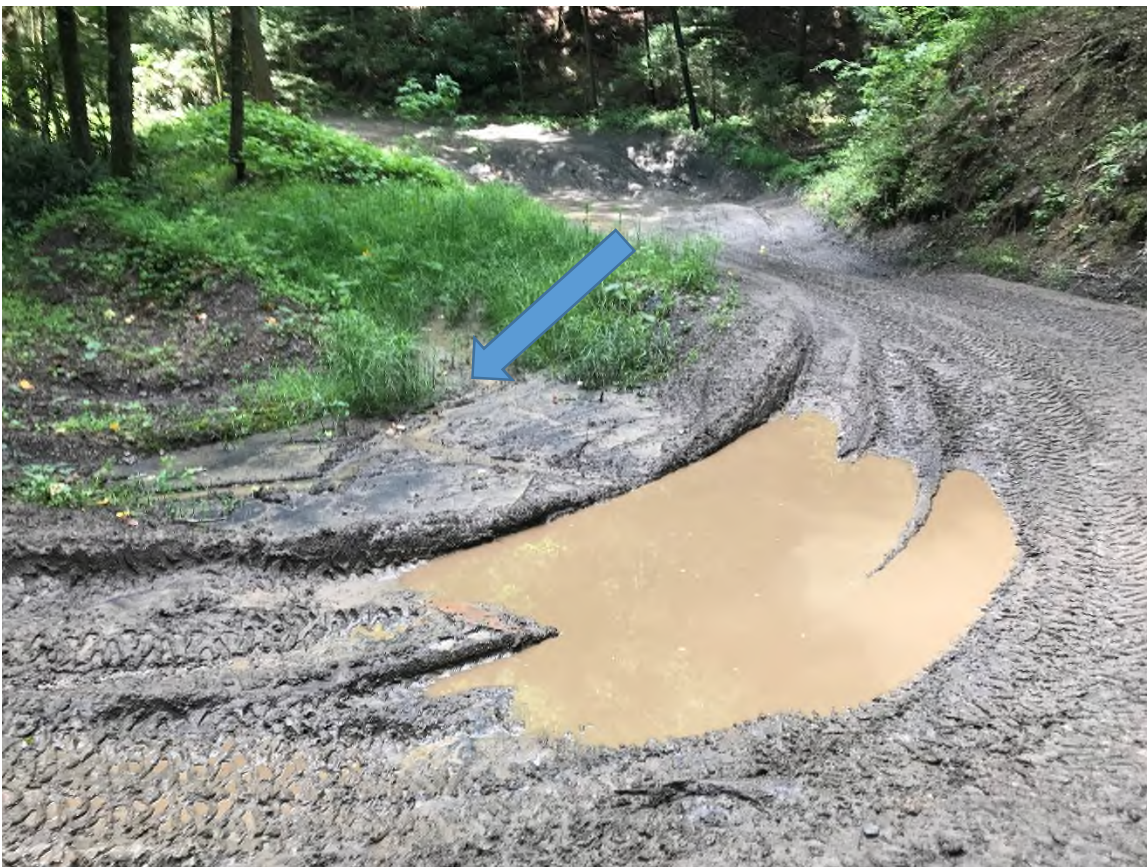
Figure 23 (Trail 14 crossing wet hollow which discharges to Haynes Branch with sediment deposition observed down gradient; 37.29621° , -81.37148°)
