**Spearhead Trials
Original Pocahontas Trail
Pocahontas, VA
Tazewell County**

Complaint Investigation Photo Log

July 1, 2020 by DEQ Staff (Jeff Kite & Jason McCroskey)

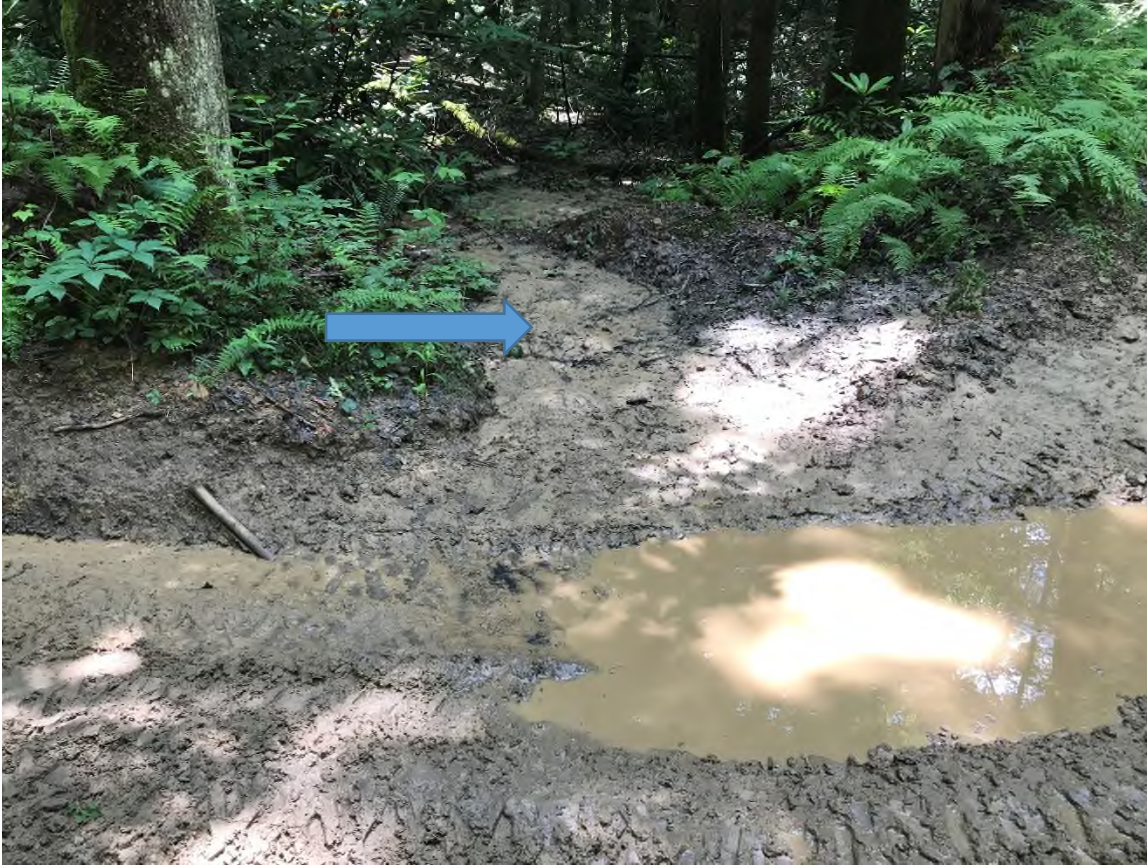
Figure 24 (Section of Trail 14 marked as closed; 37.29748° , -81.37135°)

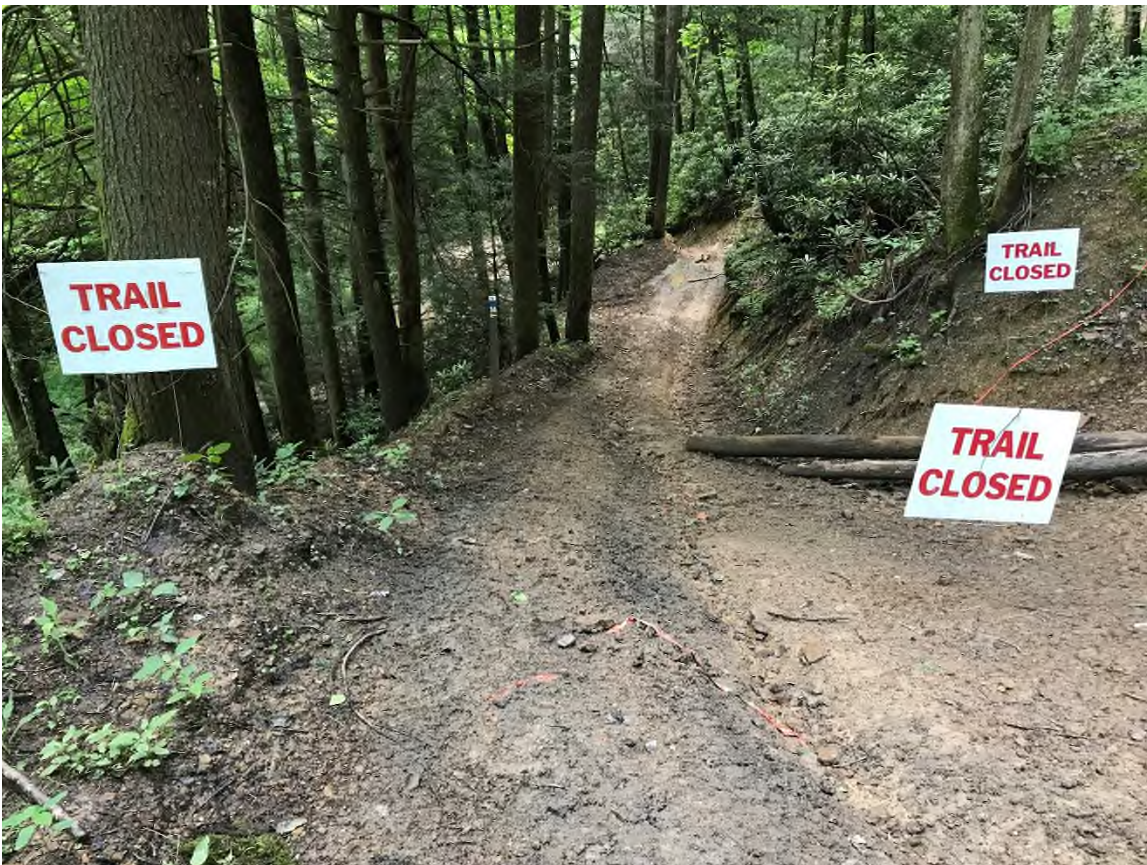
Figure 25 (Erosion observed from section of Trail 14 marked as “closed”; 37.29731°, -81.37115°)

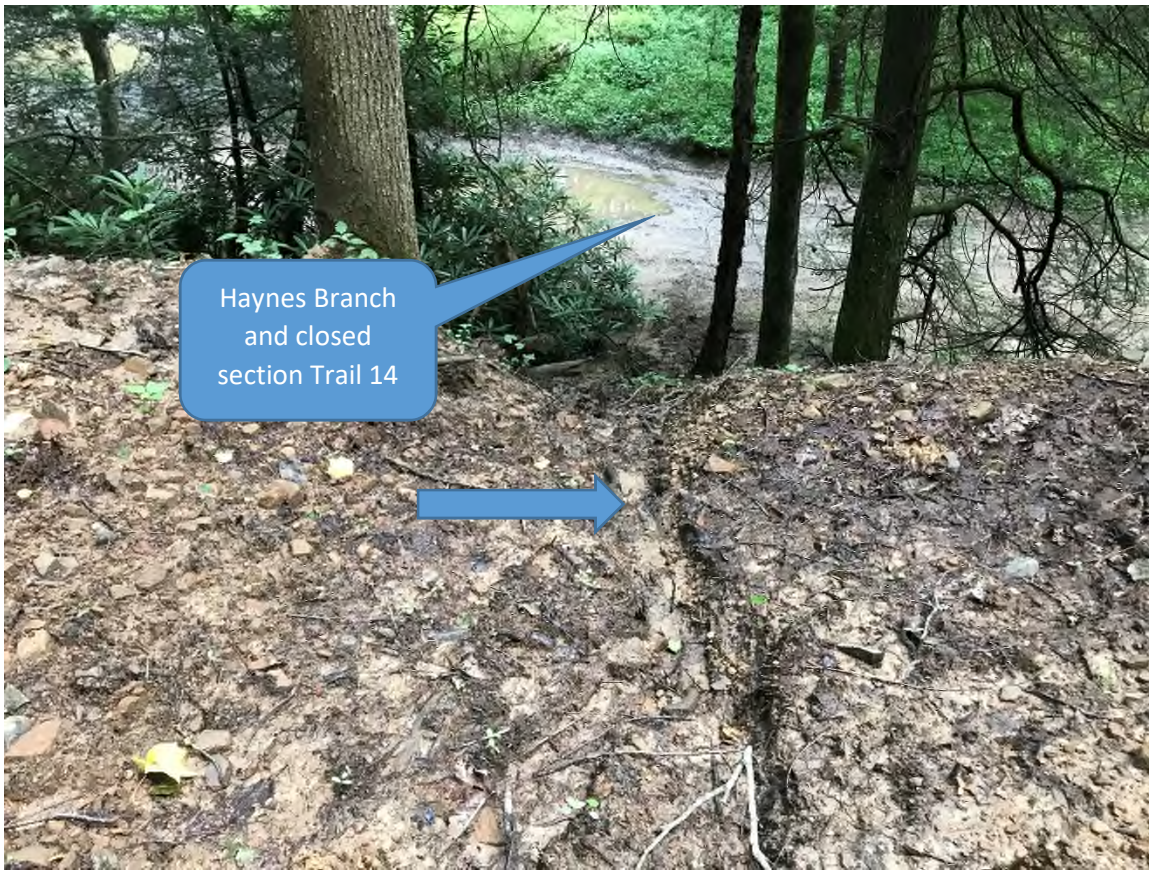
Figure 26 (Section of Trail 14 marked as “closed” which is running within Haynes Branch; 37.29726°, -81.37103°)

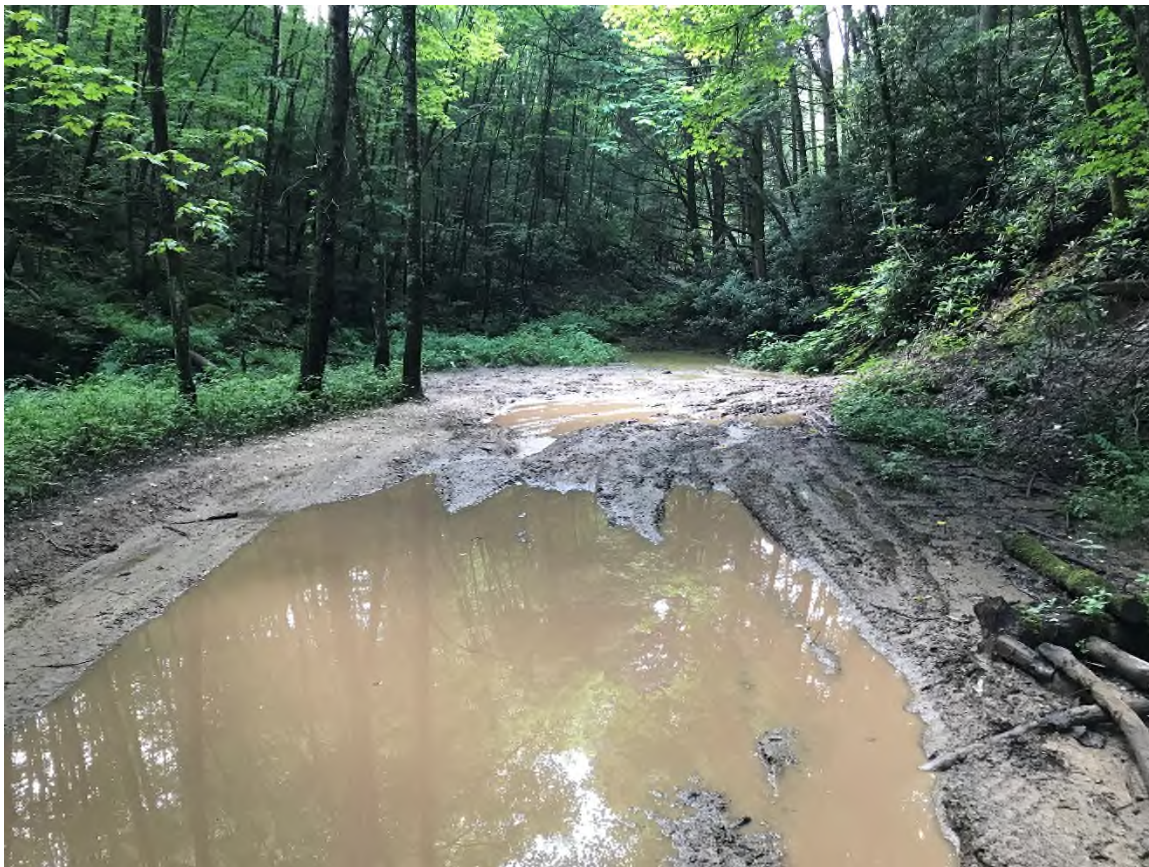
Figure 27 (Section of Trail 14 marked as “closed” which is running within Haynes Branch; 37.29859°, -81.37109°)

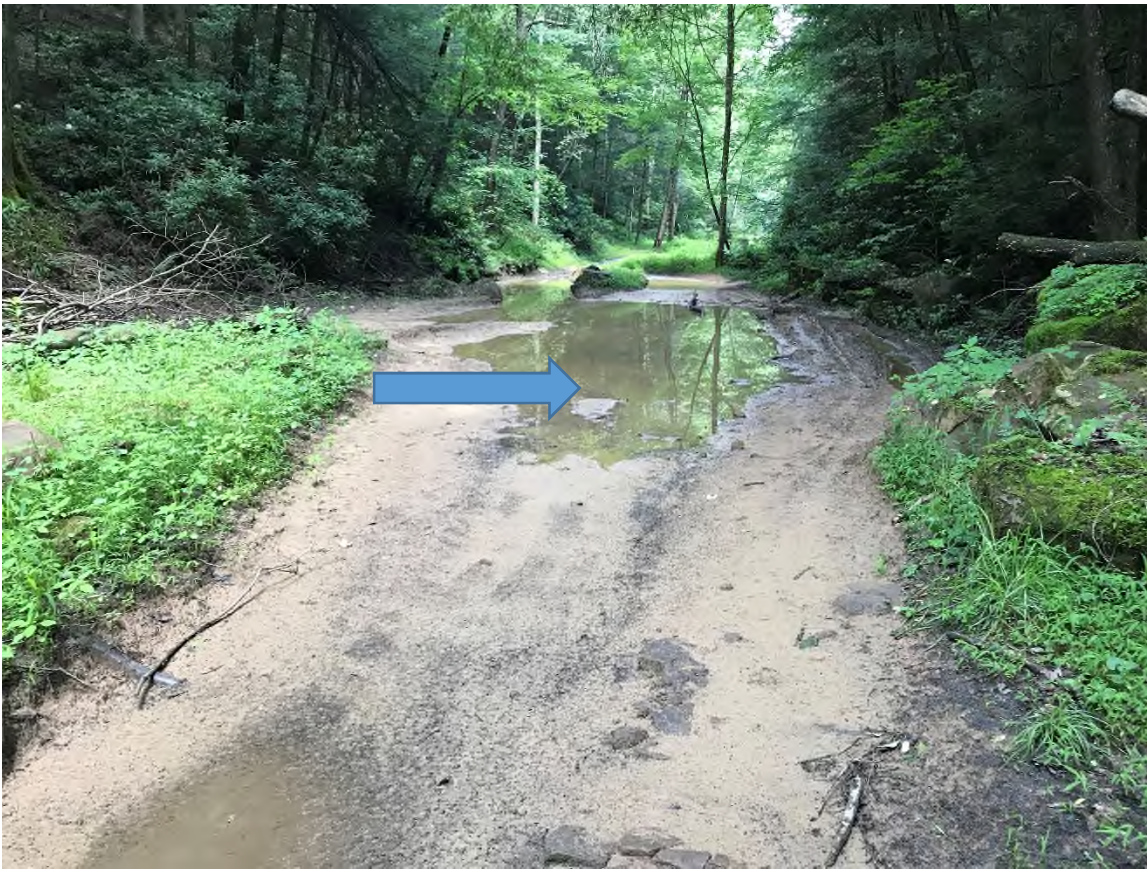
Figure 28 (UTVs observed riding section of Trail 14 marked as “closed” which is running within Haynes Branch; 37.29910°, -81.37128°)

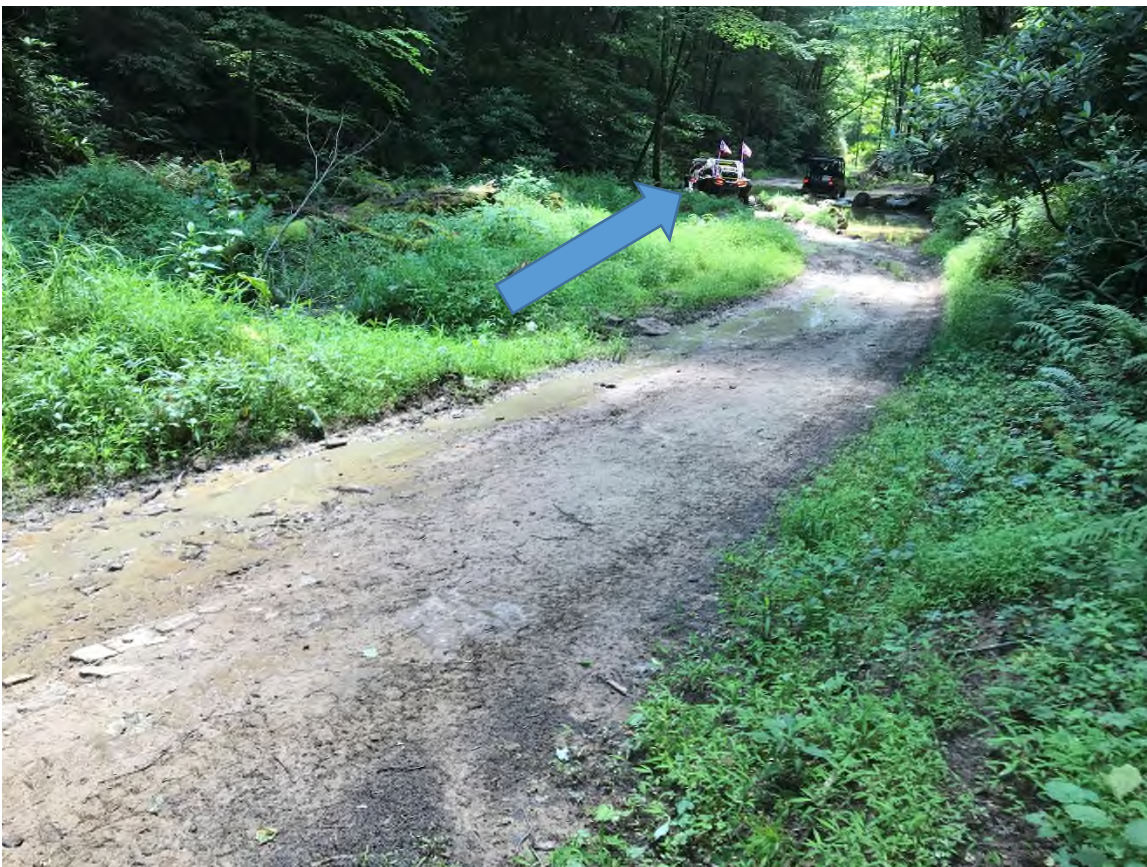
**Figure 29 (Trail 14 crossing Haynes Branch with sediment deposition observed down gradient;
37.30119°, -81.37327°)**

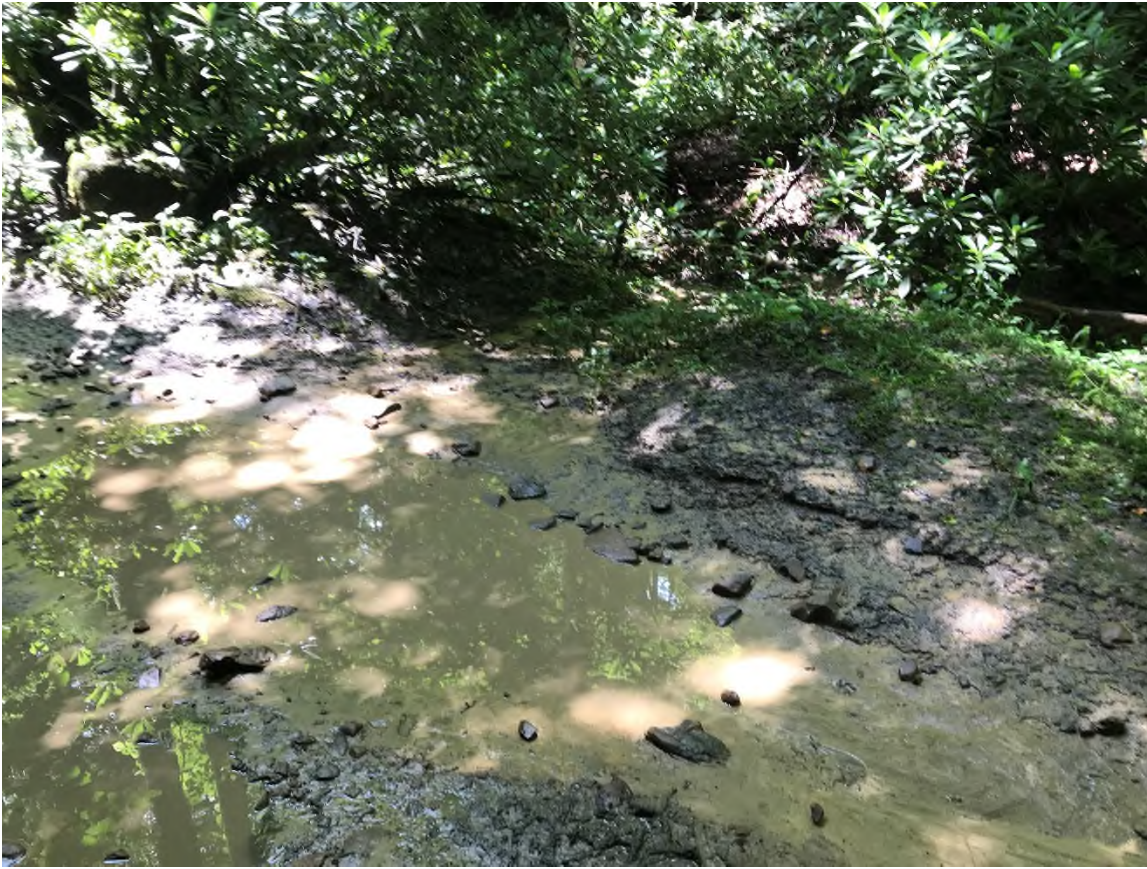
Figure 30 (Sediment deposition observed in Haynes Branch immediately downstream of a Trail 14 crossing; 37.30172°, -81.37354°)

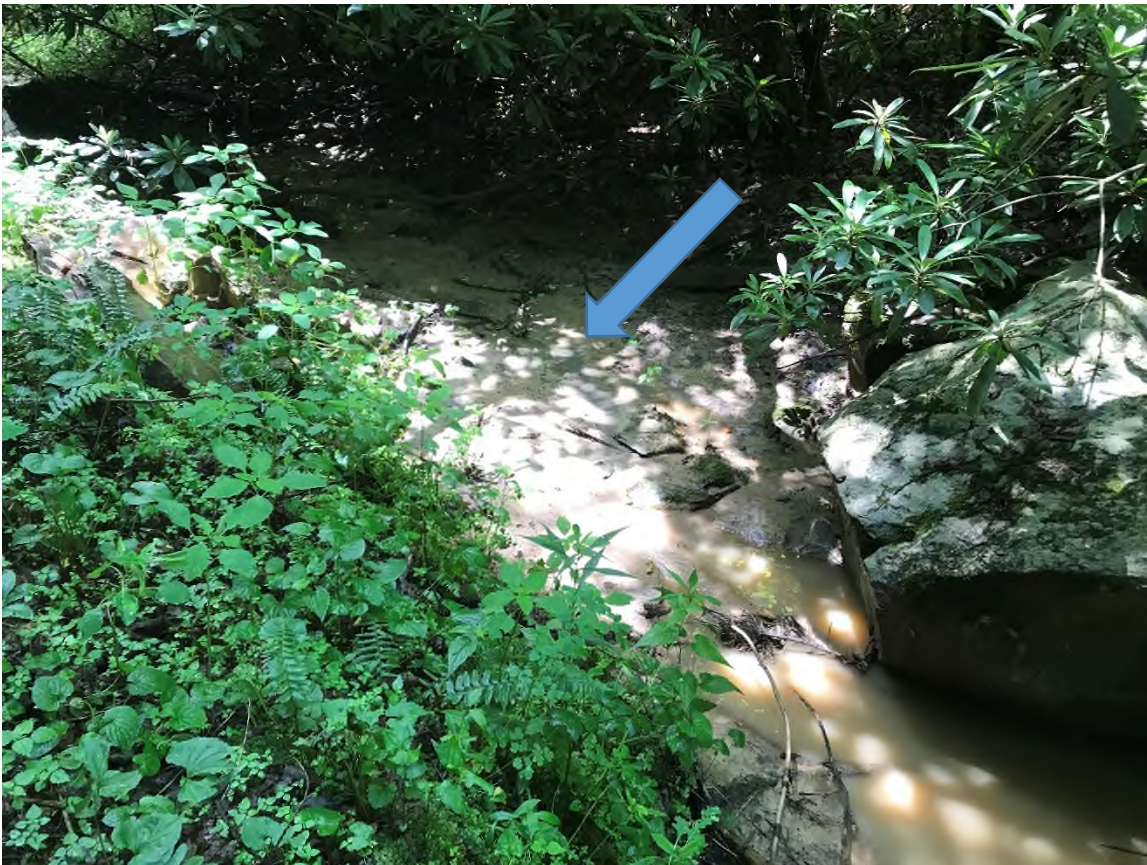
Figure 31 (Section of Trail 14 running within Haynes Branch; 37.30238°, -81.37419°)

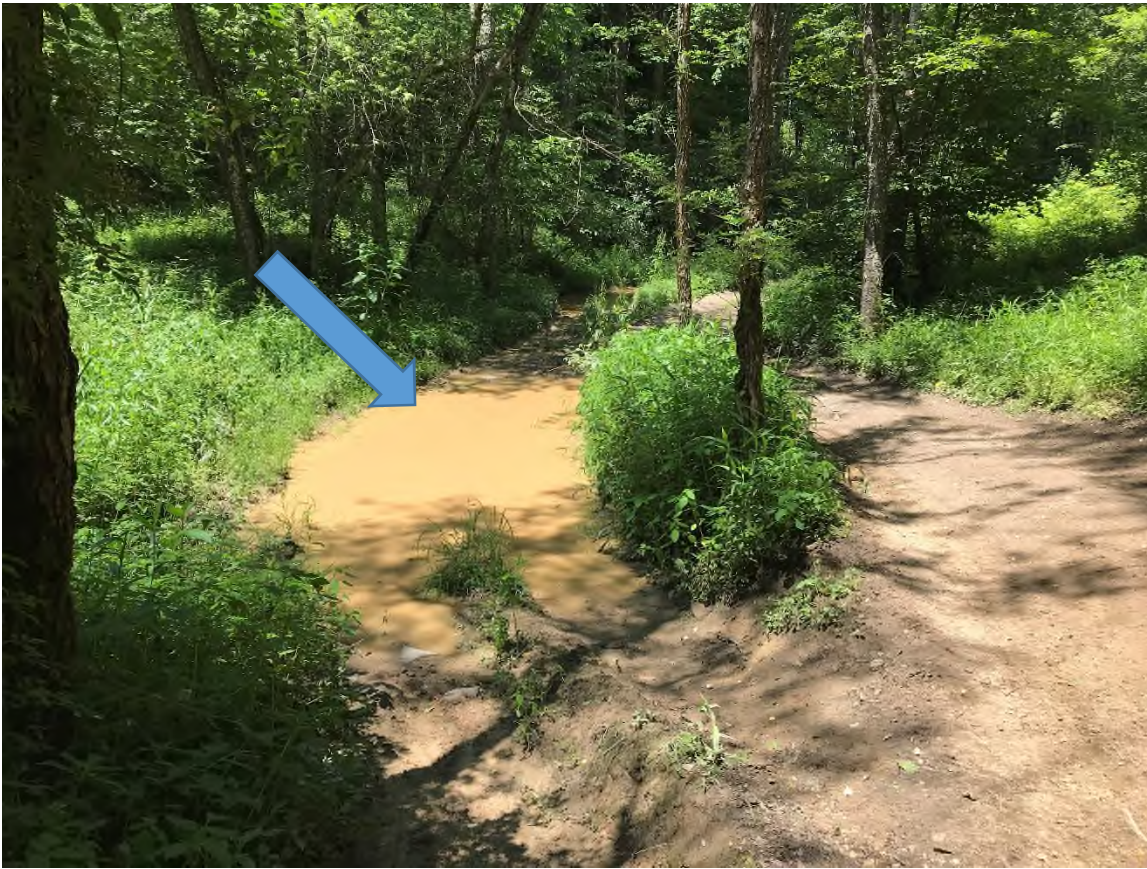
Figure 32 (Section of Trail 14 running within Haynes Branch; 37.30325°, -81.37511°)

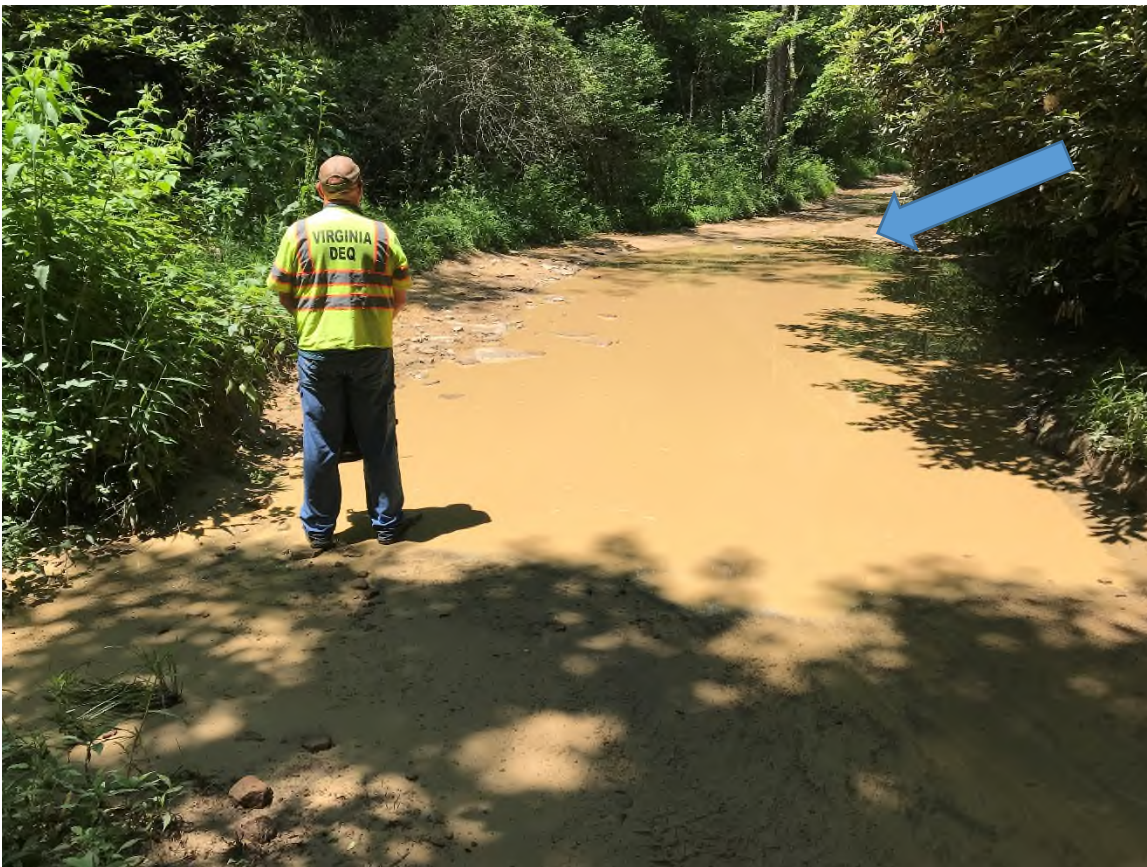
Figure 33 (Sediment deposition observed in Haynes Branch down gradient of a section of Trail 14 in which the trail is running within Haynes Branch; 37.30325°, -81.37516°)

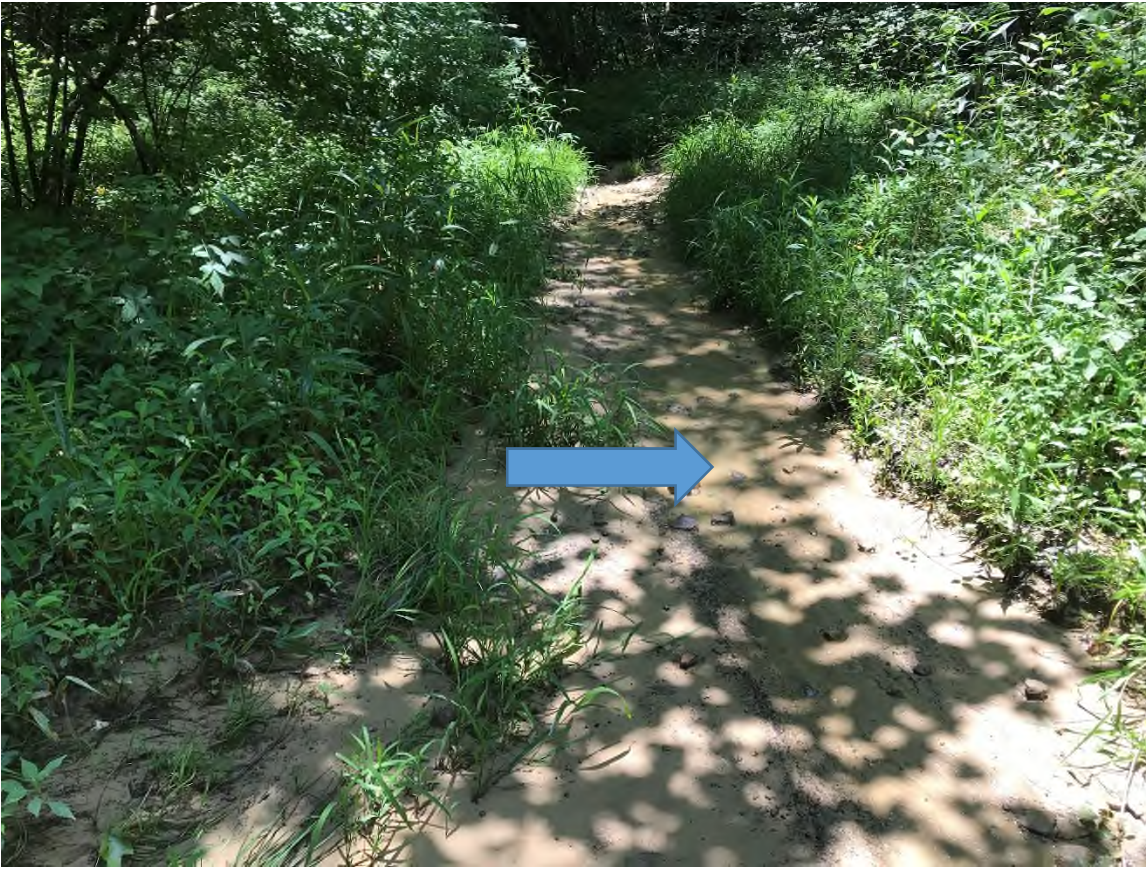
Figure 34 (Intersection of Trails 14 and 44 within Haynes Branch; 37.30402°, -81.37622°)

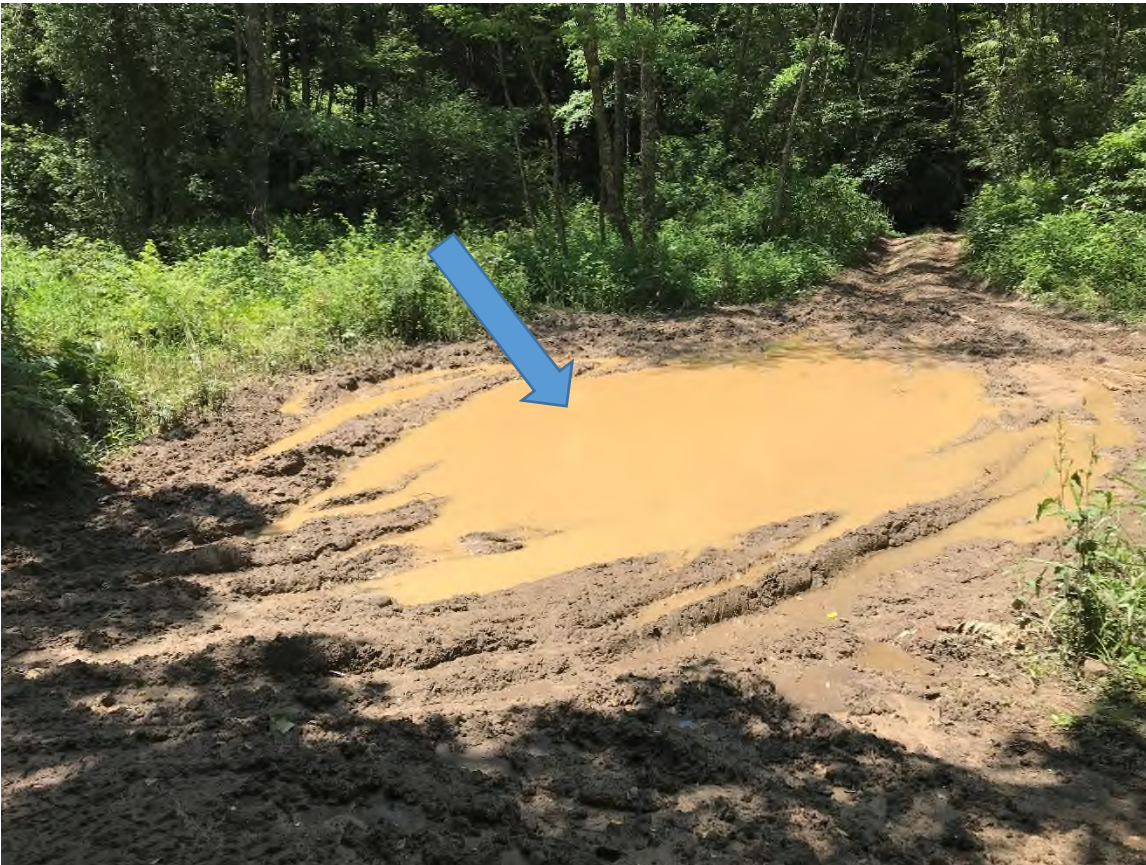
Figure 35 (Trail 44 crossing Haynes Branch with sediment deposition observed down gradient; 37.30421°, -81.37812°)

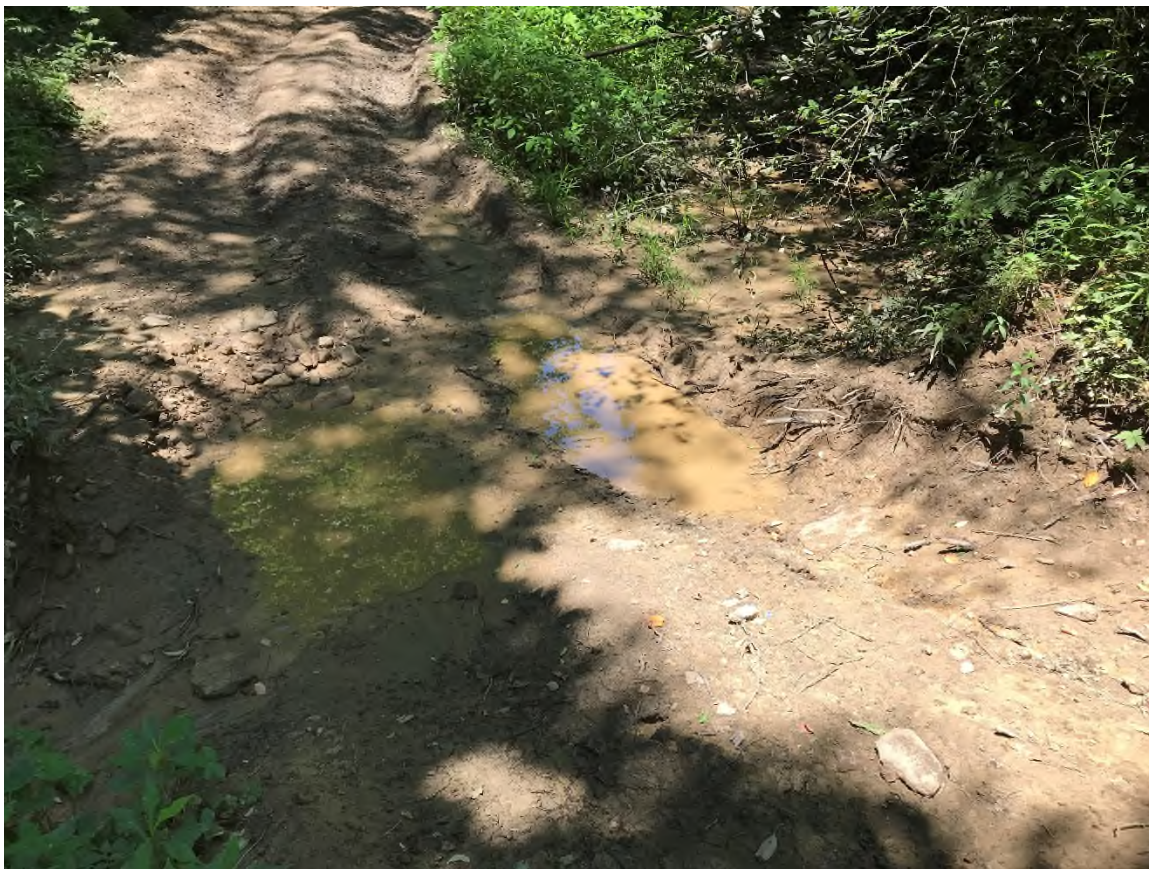
Figure 36 (Sediment from Trail 44 erosion observed discharging into Haynes Branch; 37.30516°, -81.37922°)

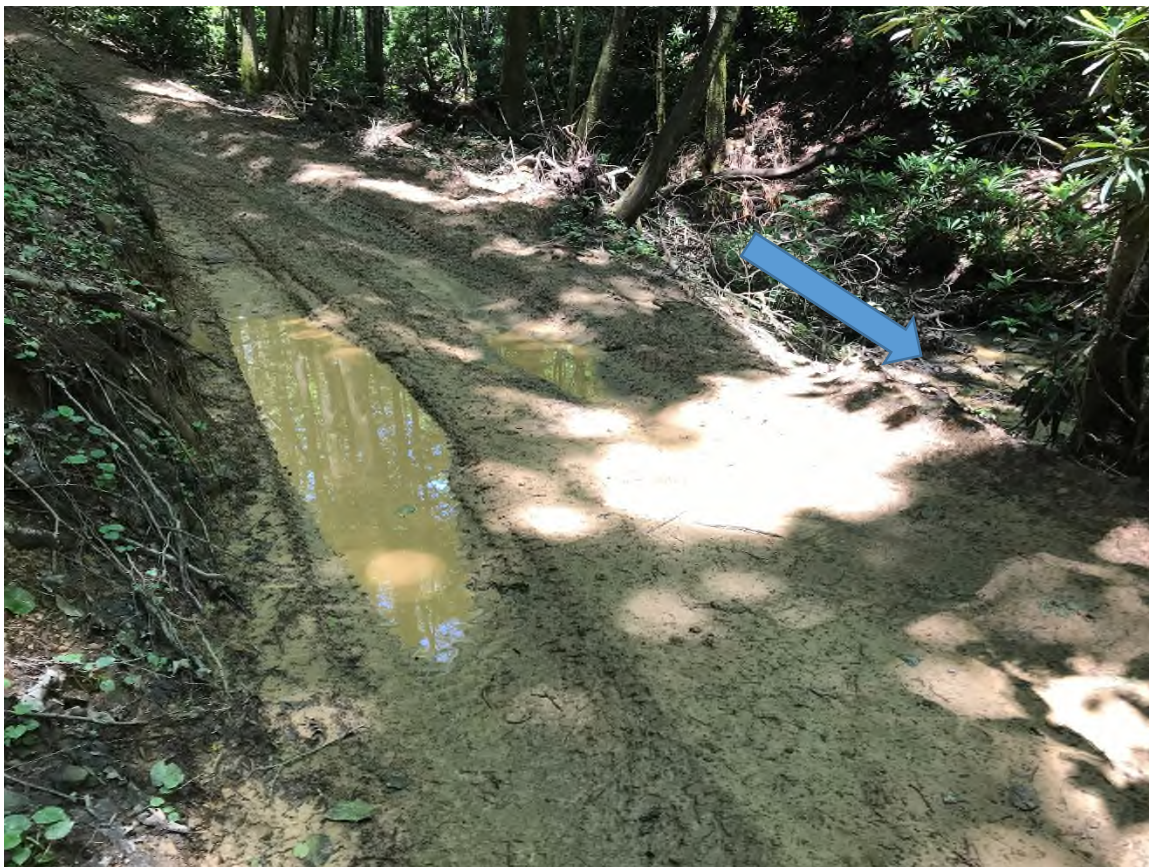
Figure 37 (Trail 44 crossing Haynes Branch with sediment deposition observed down gradient; 37.30579°, -81.37973°)

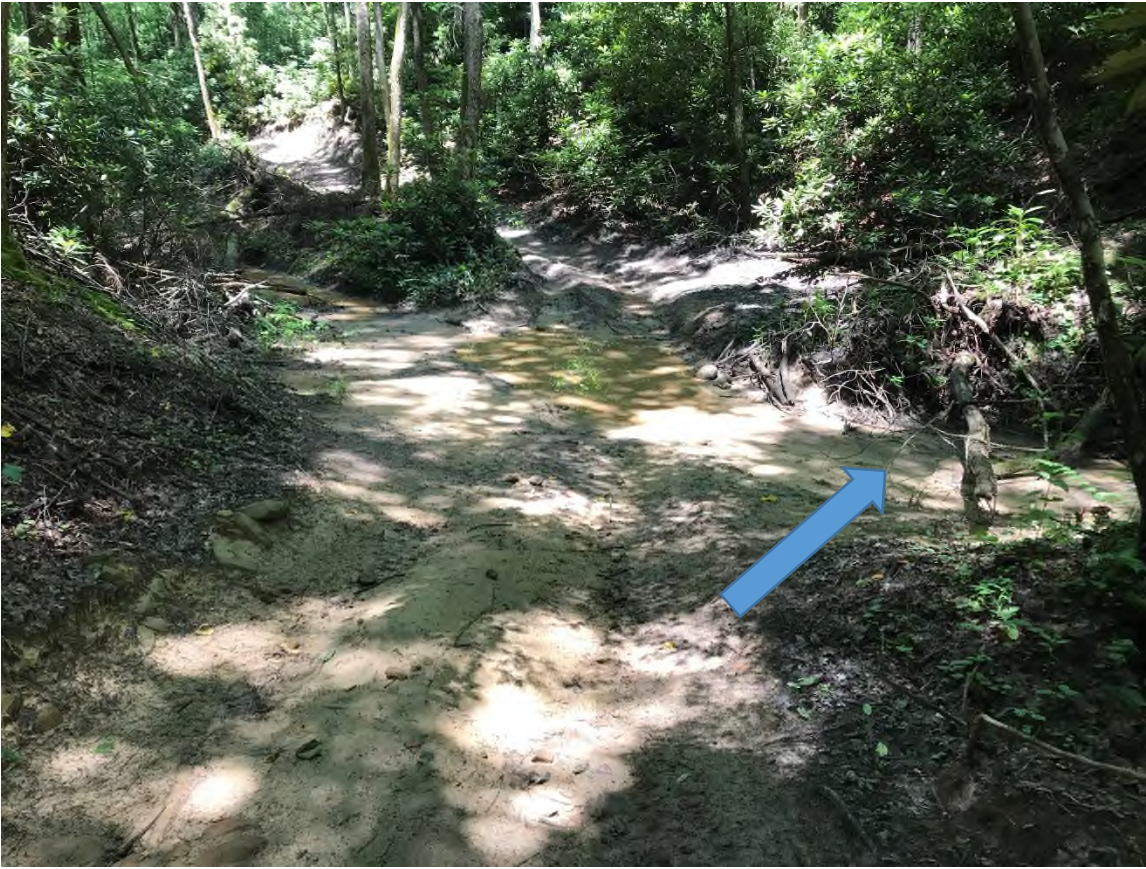
Figure 38 (Sediment deposition observed in Haynes Branch adjacent to Trail 44; 37.30591°, -81.38018°)

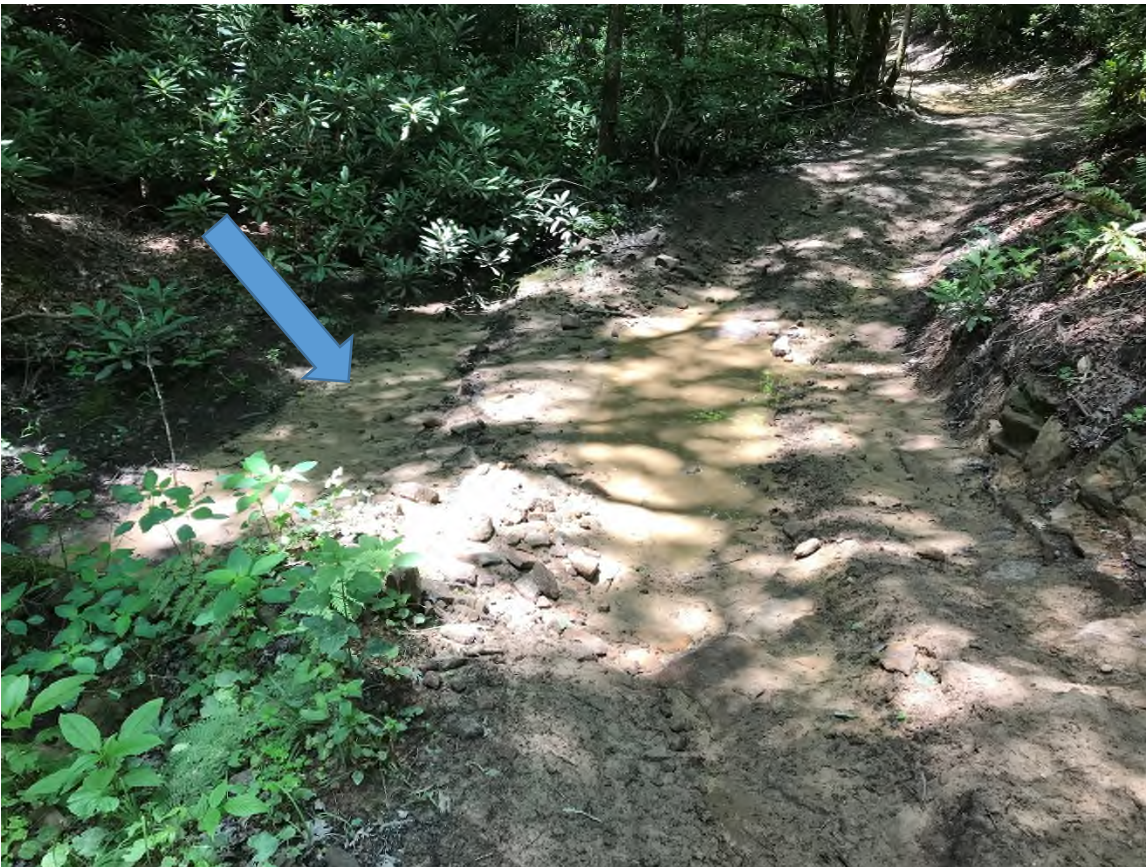
Figure 39 (Trail 44 crossing Haynes Branch with sediment deposition observed down gradient; 37.30685°, -81.38262°)

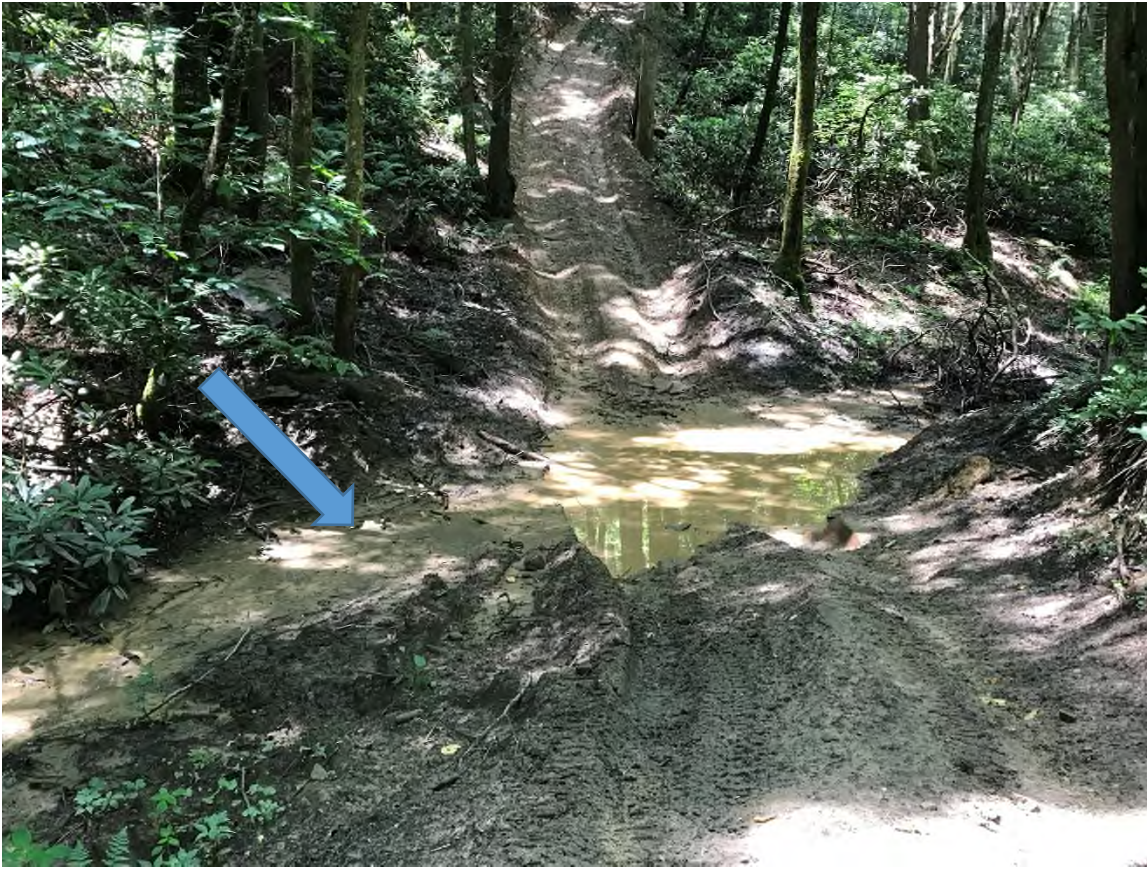
Figure 40 (Sediment deposition observed in Haynes Branch adjacent to Trail 44; 37.30910°, -81.38645°)

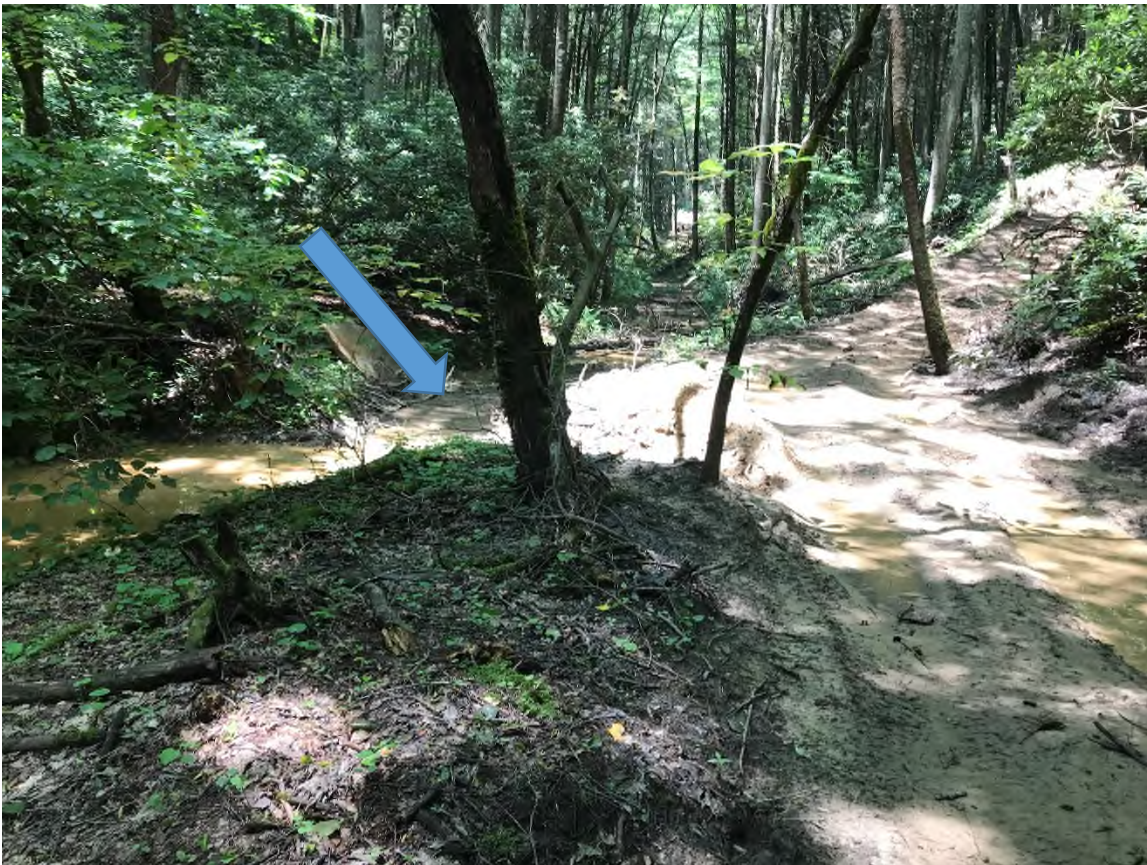
Figure 41 (Sediment deposition observed in Haynes Branch adjacent to Trail 44; 37.30917°, - 81.38644°)

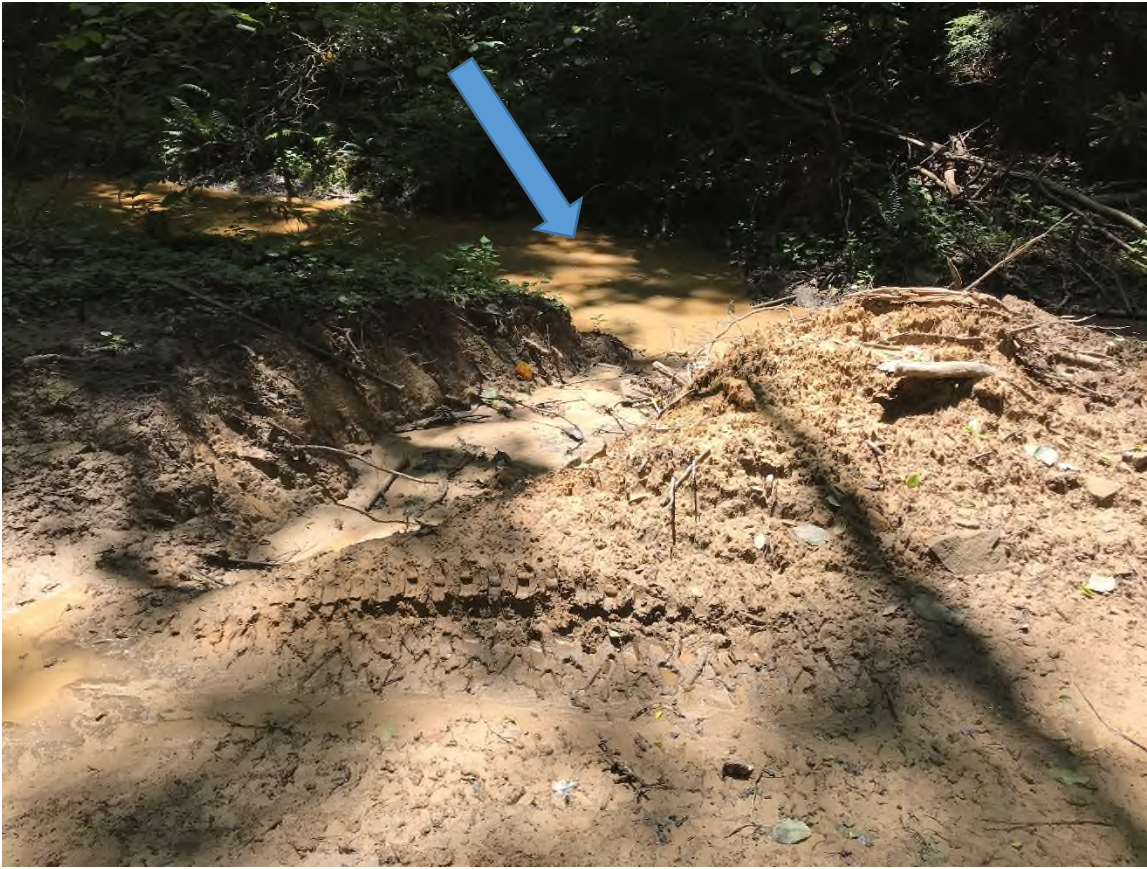
Figure 42 (Section of Trail 44 once running within Haynes Branch but is now closed; 37.30547°, - 81.37935°)

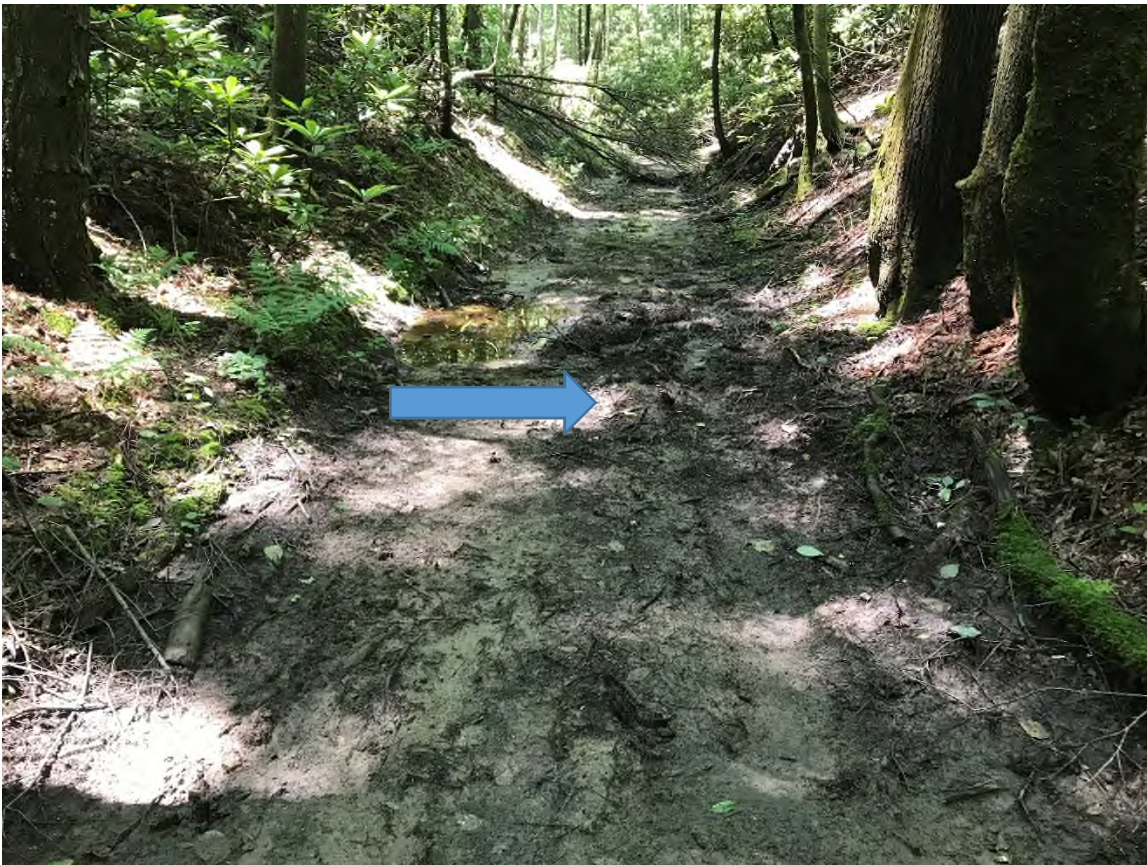
Figure 43 (Section of Trail 14 running within Haynes Branch; 37.30356°, -81.37585°)

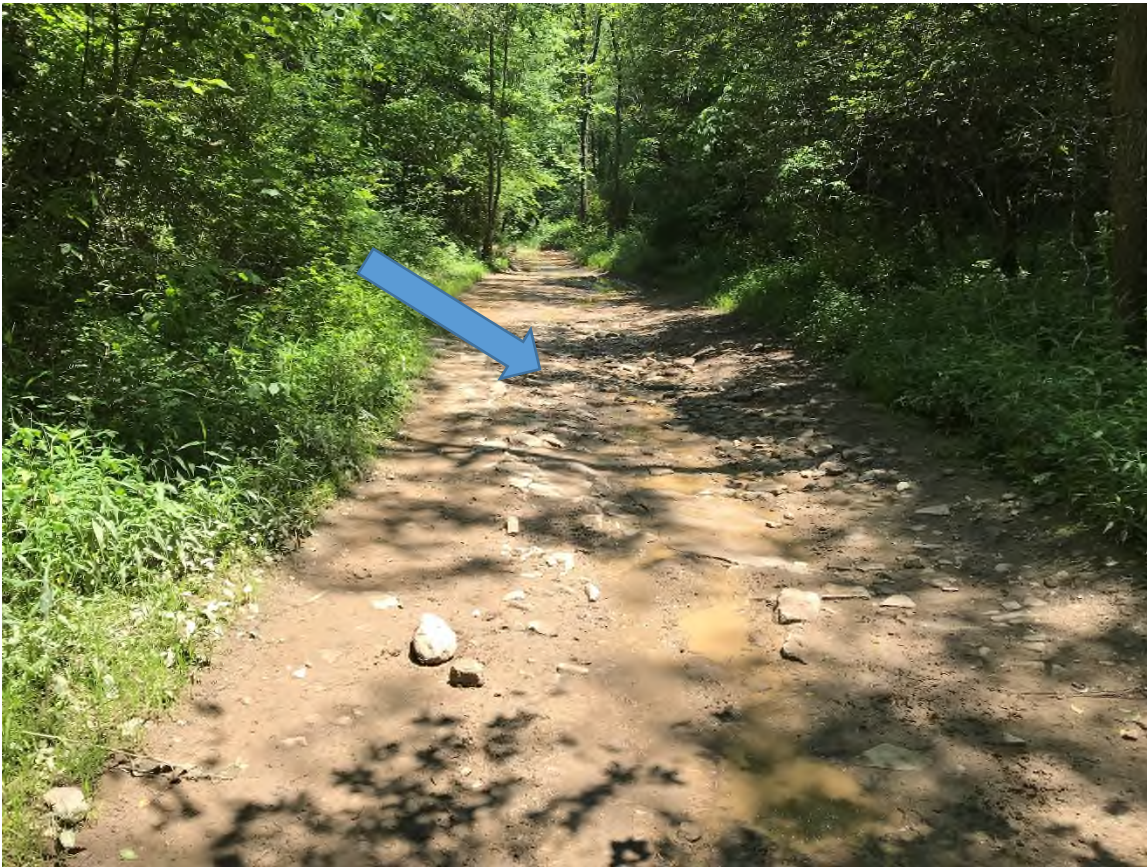
Figure 44 (Section of Trail 16 with a cut allowing unfiltered runoff from the trail to discharge over the slope into a drainage swale leading to Curran Branch; 37.29713°, -81.39059°)

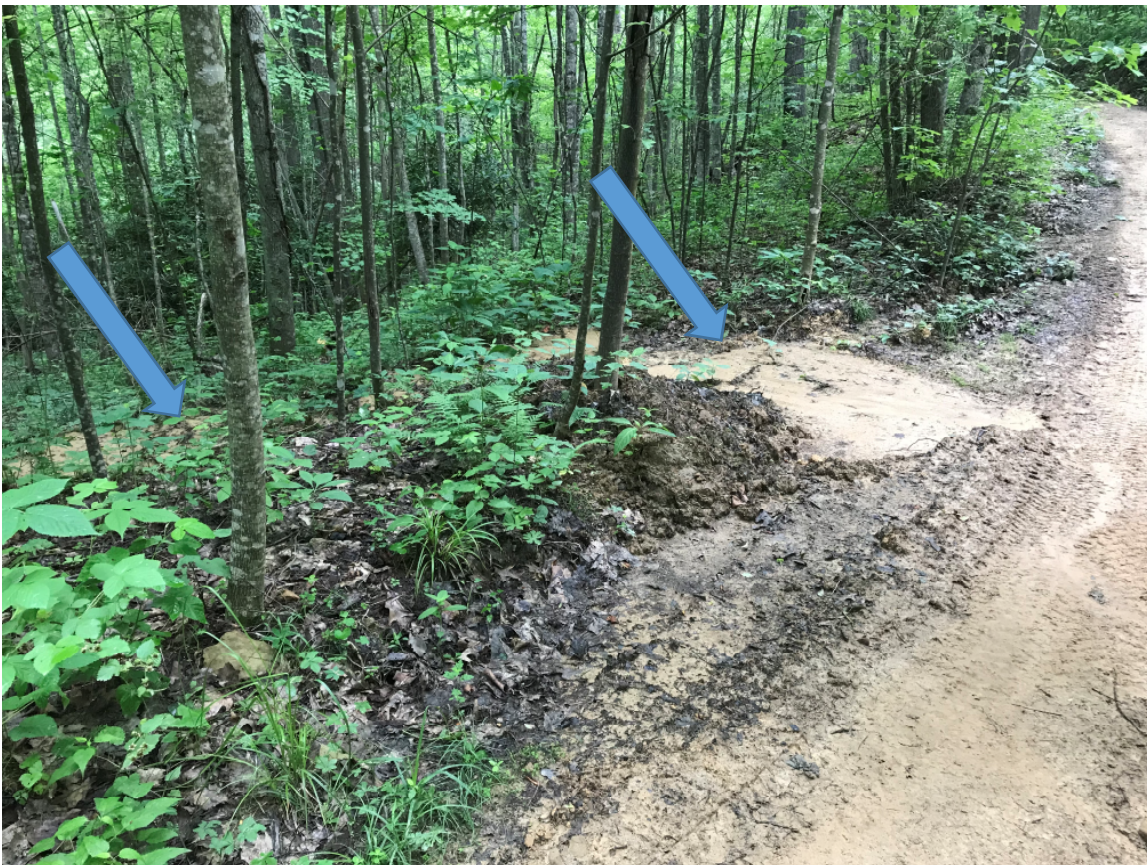
Figure 45 (Section of Trail 16 with a cut allowing unfiltered runoff from the trail to discharge over the slope into a drainage swale leading to Curran Branch; 37.29778°, -81.39041°)
