**Spearhead Trials
Original Pocahontas Trail
Pocahontas, VA
Tazewell County**

Complaint Investigation Photo Log

July 1, 2020 by DEQ Staff (Jeff Kite & Jason McCroskey)

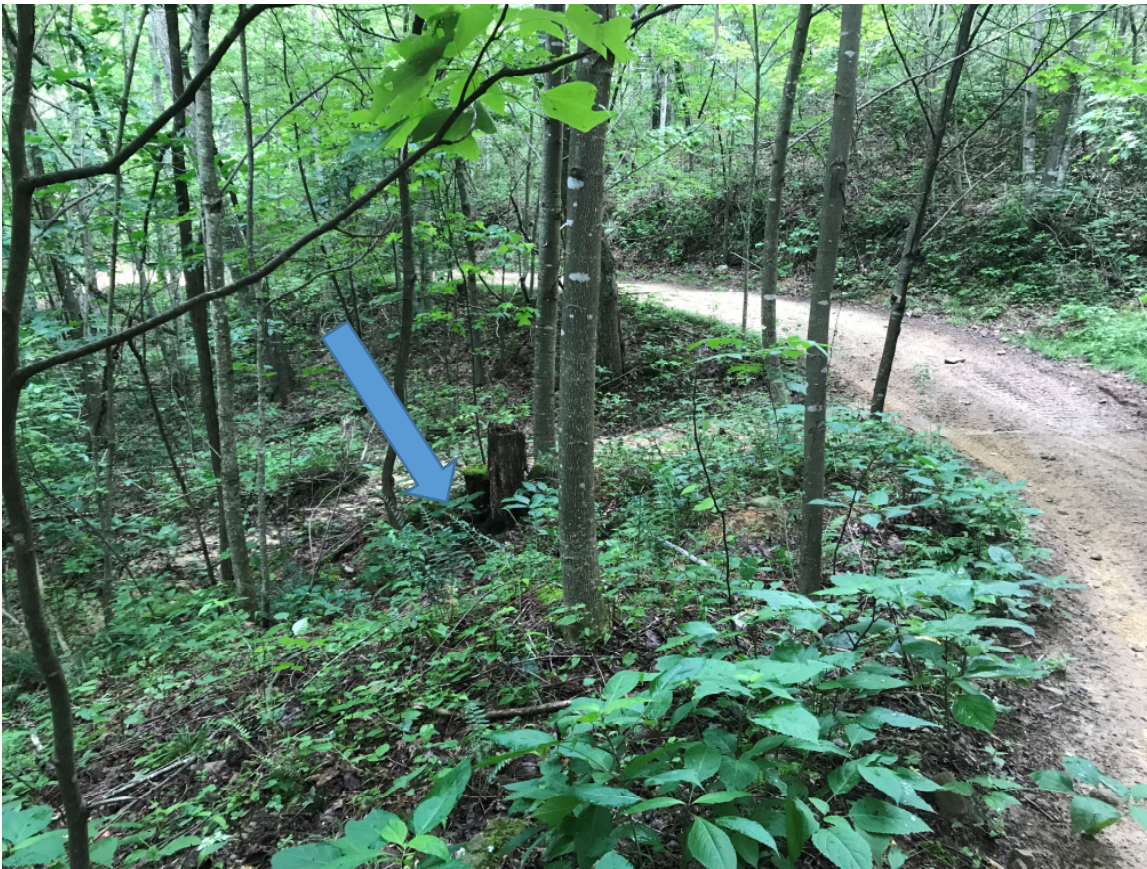
Figure 46 (Section of Trail 16 with a cut allowing unfiltered runoff from the trail to discharge over the slope into a drainage swale leading to Curran Branch; 37.29801°, -81.39059°)

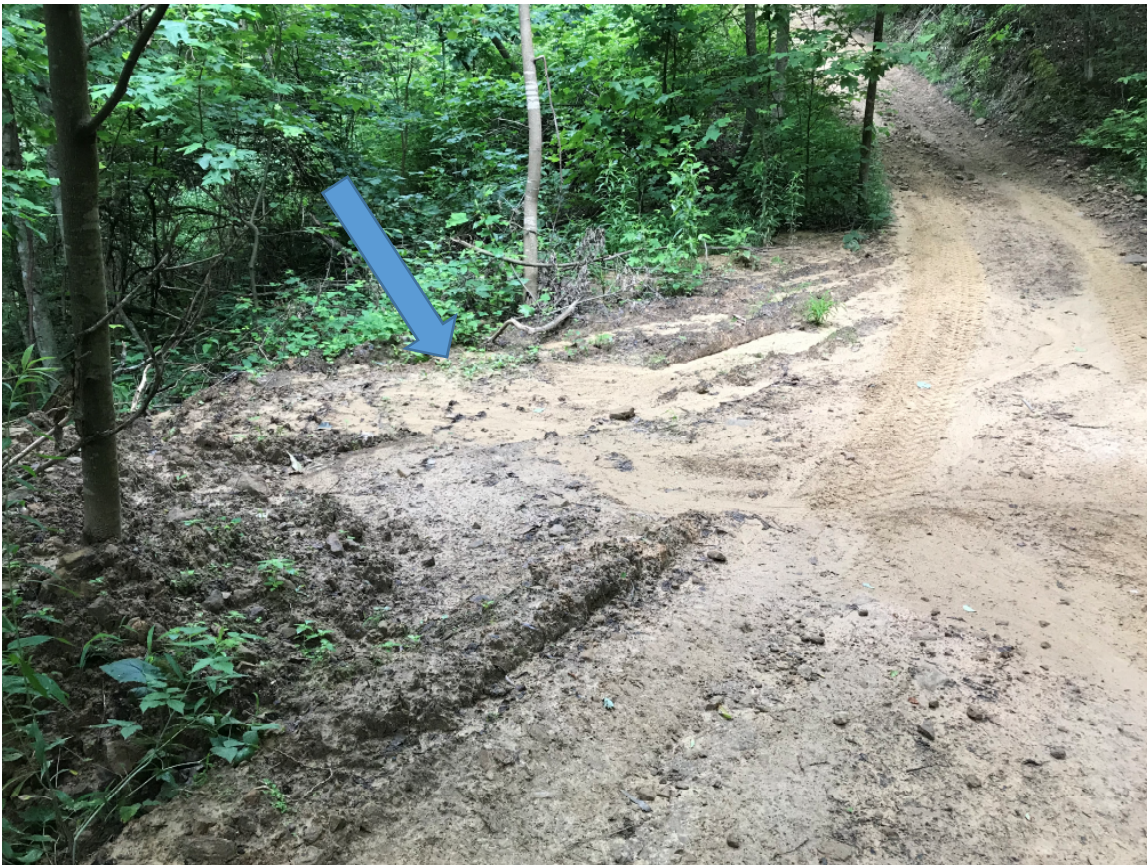
Figure 47 (Section of Trail 16 with mud from ruts being cast into Curran Branch; 37.29708°, -81.39546°)

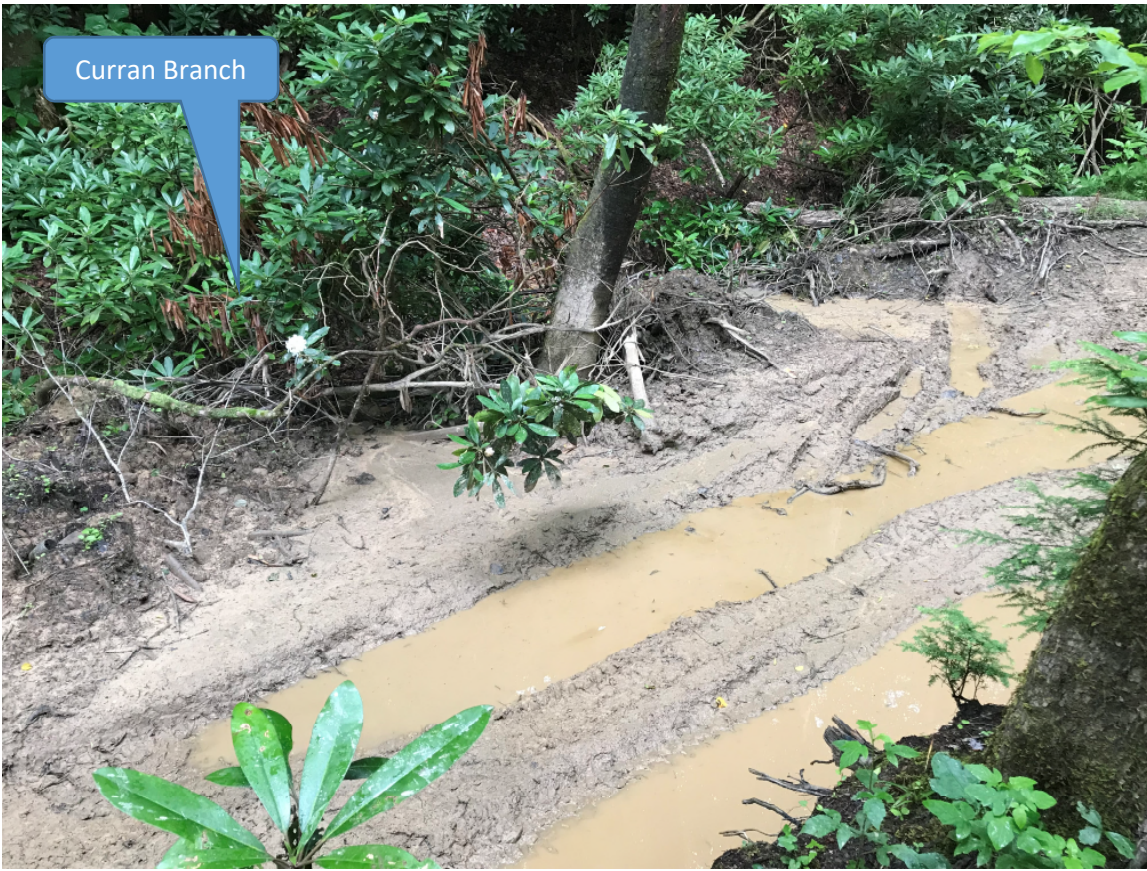
Figure 48 (Cross pipe in Curran Branch on a Section of Trail 67 and sediment deposition observed in Curran Branch from unfiltered runoff from the trail; 37.29746°, -81.39559°)

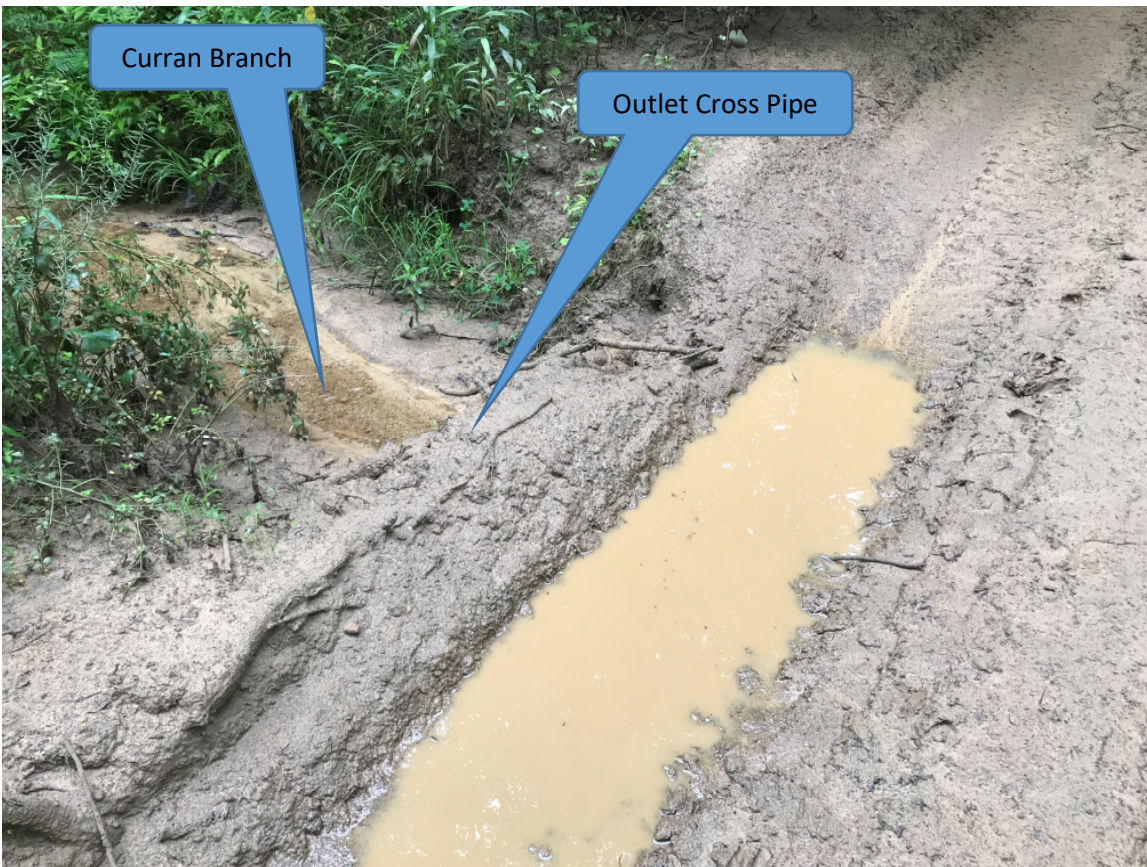
Figure 49 (Cross pipe in Curran Branch on a Section of Trail 67 and sediment deposition observed in Curran Branch from unfiltered runoff from the trail; 37.29746°, -81.39559°)

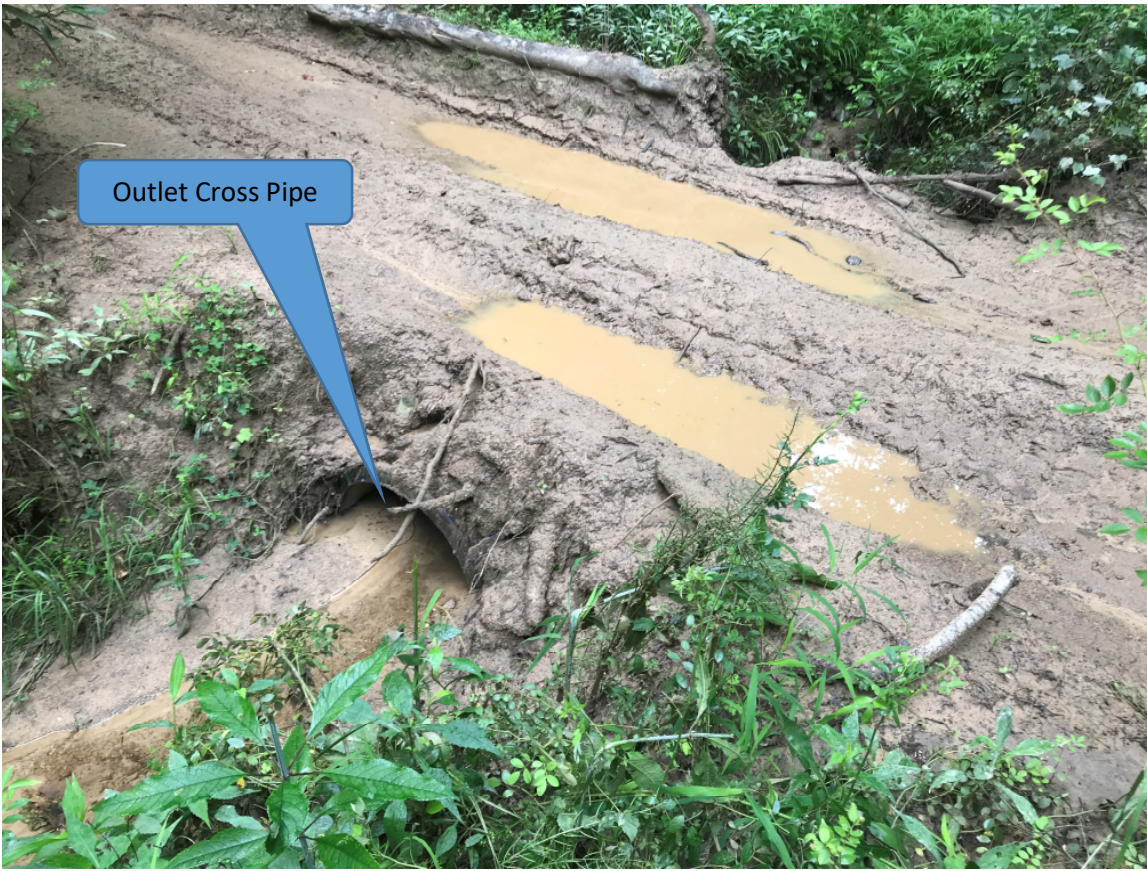
Figure 50 (Cross pipe in Curran Branch on a Section of Trail 67 and sediment deposition observed in Curran Branch from unfiltered runoff from the trail; 37.29746°, -81.39559°)

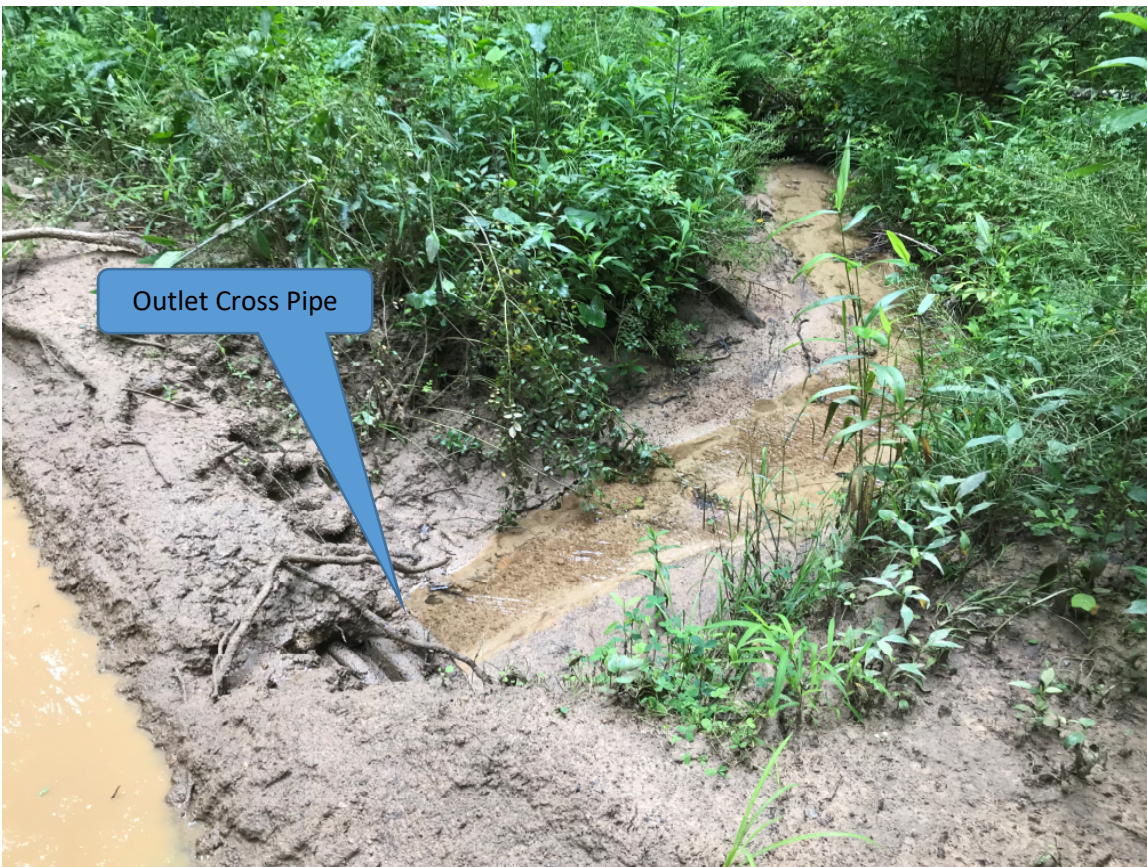
Figure 51 (Cross pipe in Curran Branch on a Section of Trail 67 and sediment deposition observed in Curran Branch from unfiltered runoff from the trail; 37.29746°, -81.39559°)

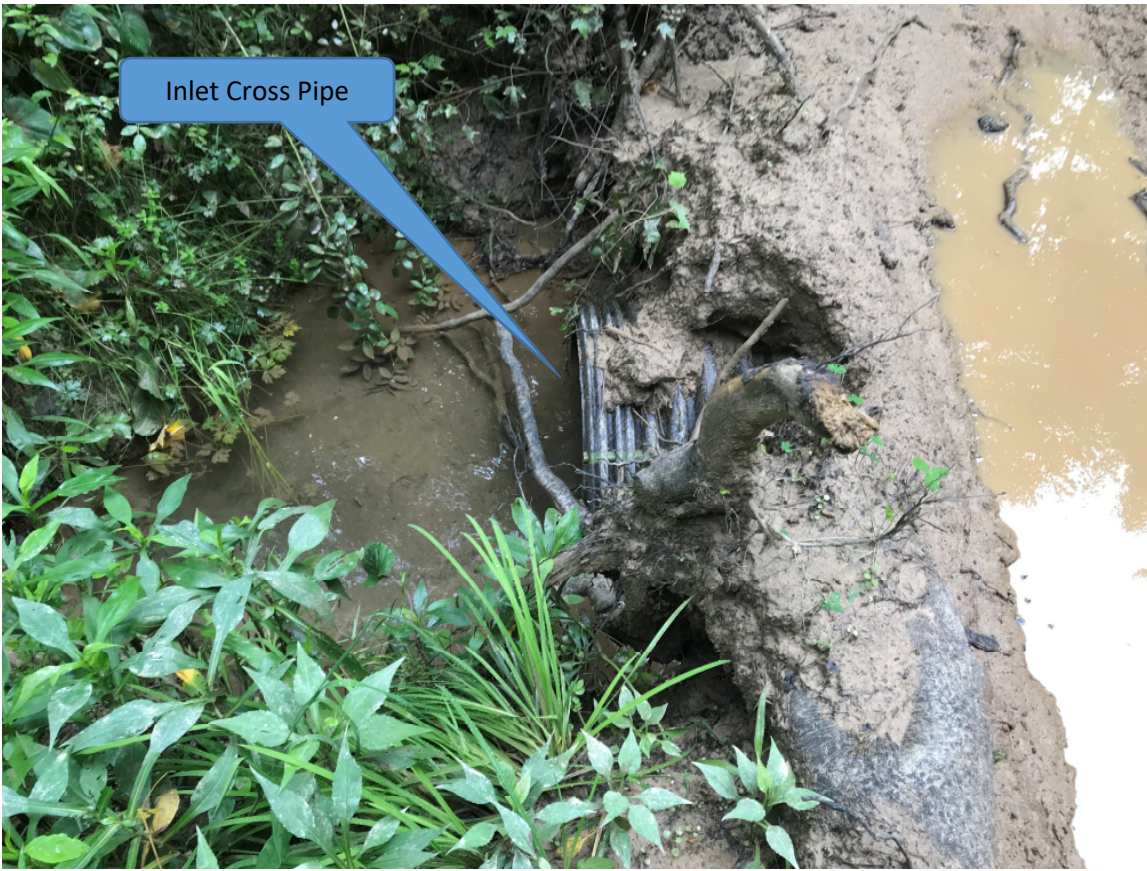
Figure 52 (Cross pipe in Curran Branch on a Section of Trail 16 and sediment deposition observed in Curran Branch from unfiltered runoff from the trail; 37.29664°, -81.39494°)

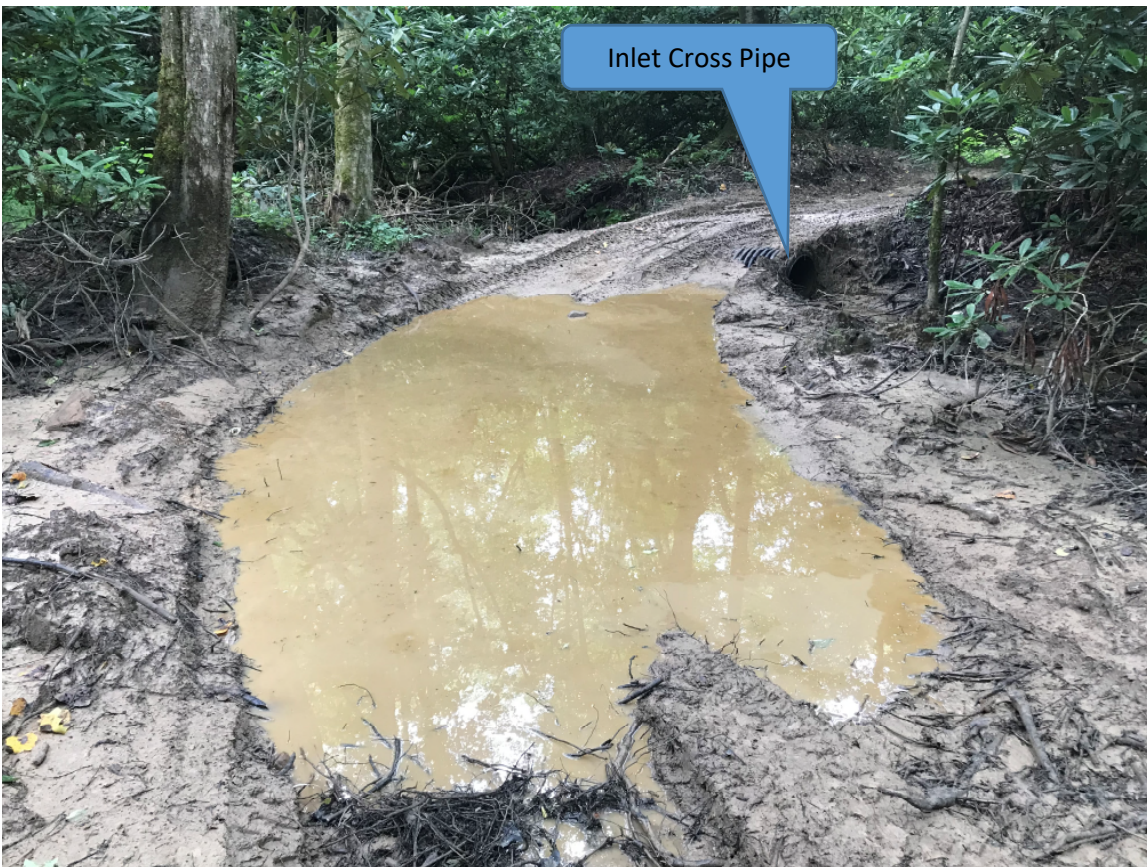
Figure 53 (Cross pipe in Curran Branch on a Section of Trail 16 and sediment deposition observed in Curran Branch from unfiltered runoff from the trail; 37.29664°, -81.39494°)

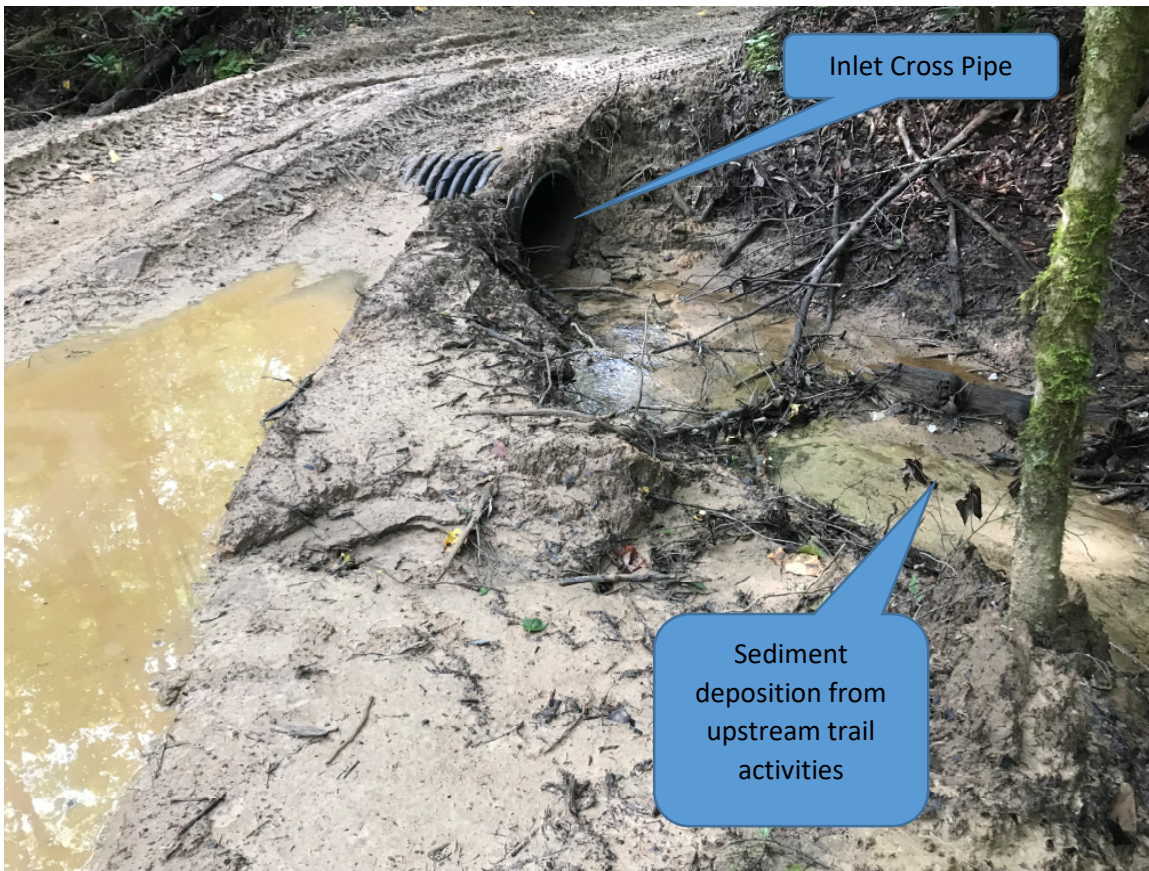
Figure 54 (Cross pipe in Curran Branch on a Section of Trail 16 and sediment deposition observed in Curran Branch from unfiltered runoff from the trail; 37.29664°, -81.39494°)

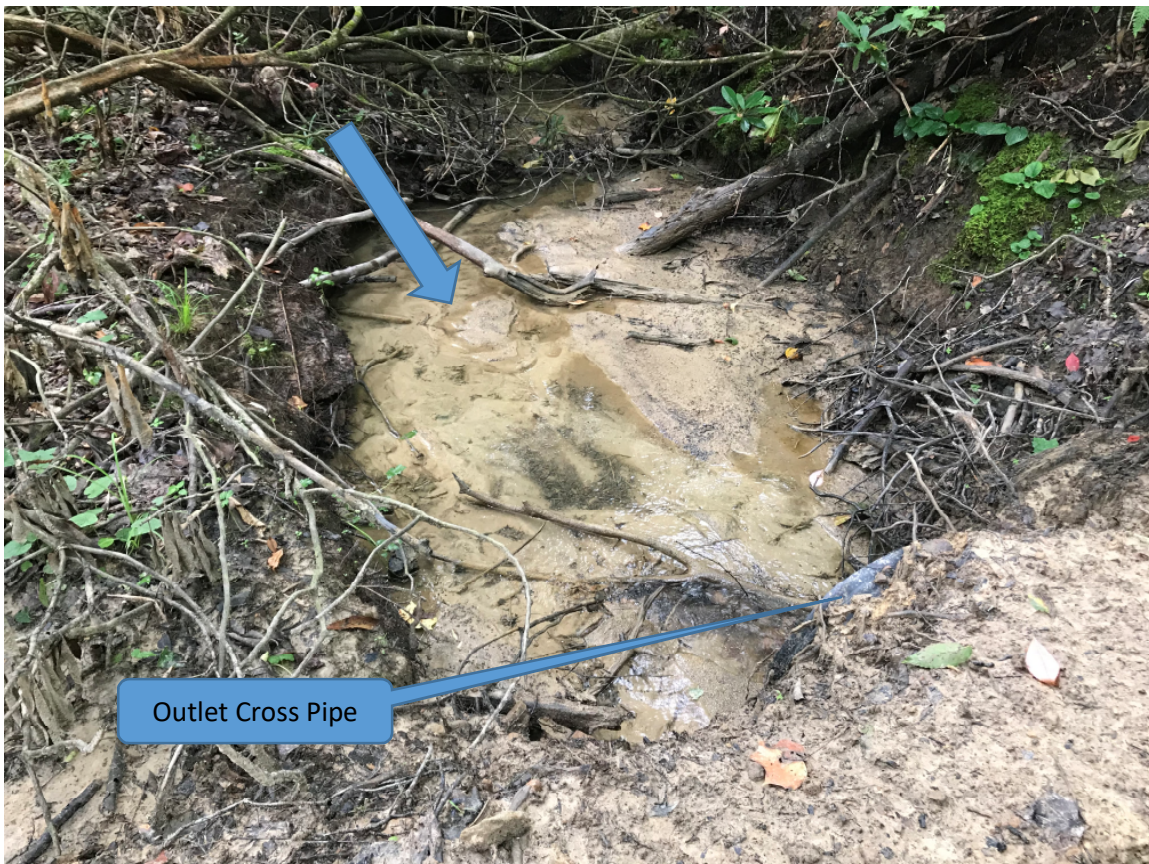
Figure 55 (Cross pipe in Curran Branch on a Section of Trail 16 and sediment deposition observed in Curran Branch from unfiltered runoff from the trail; 37.29664°, -81.39494°)

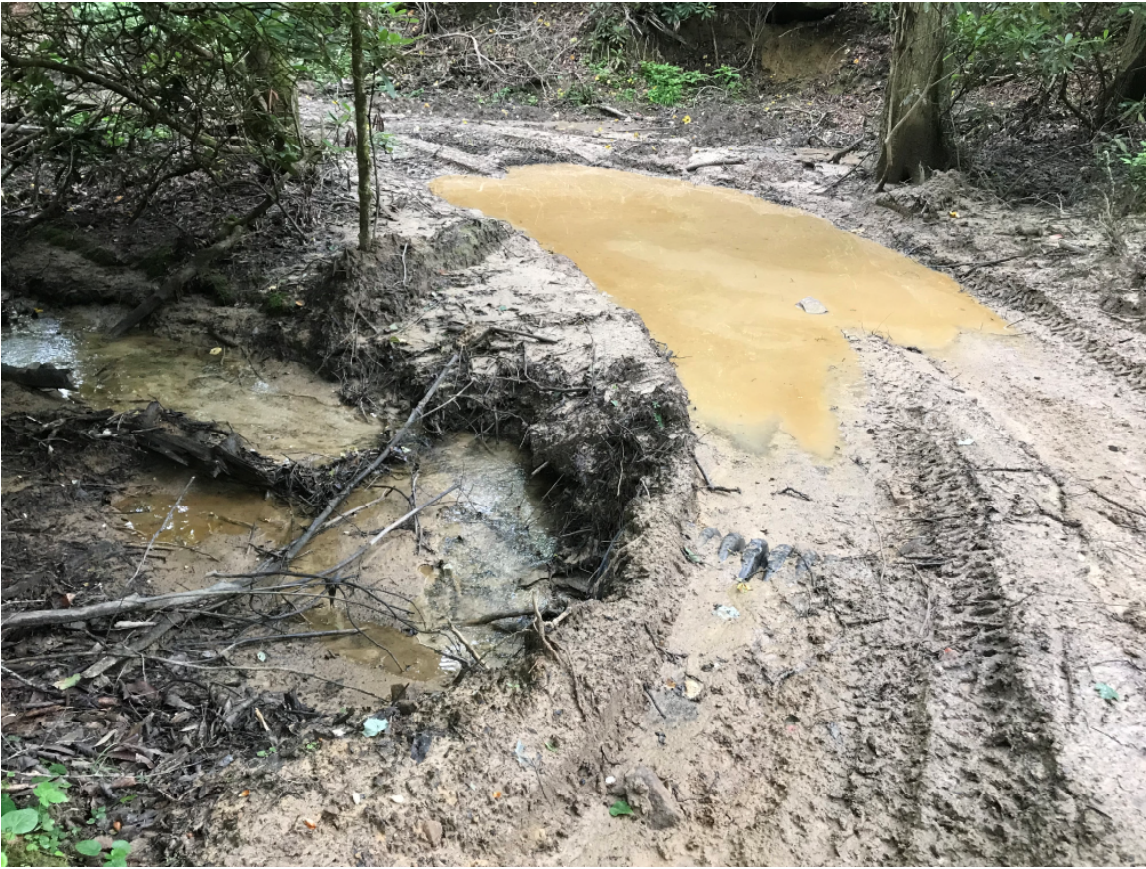
Figure 56 (Section of Trail 67 with a cut allowing unfiltered runoff from the trail to discharge over the slope into a drainage swale leading to Curran Branch; 37.29464°, -81.39353°)

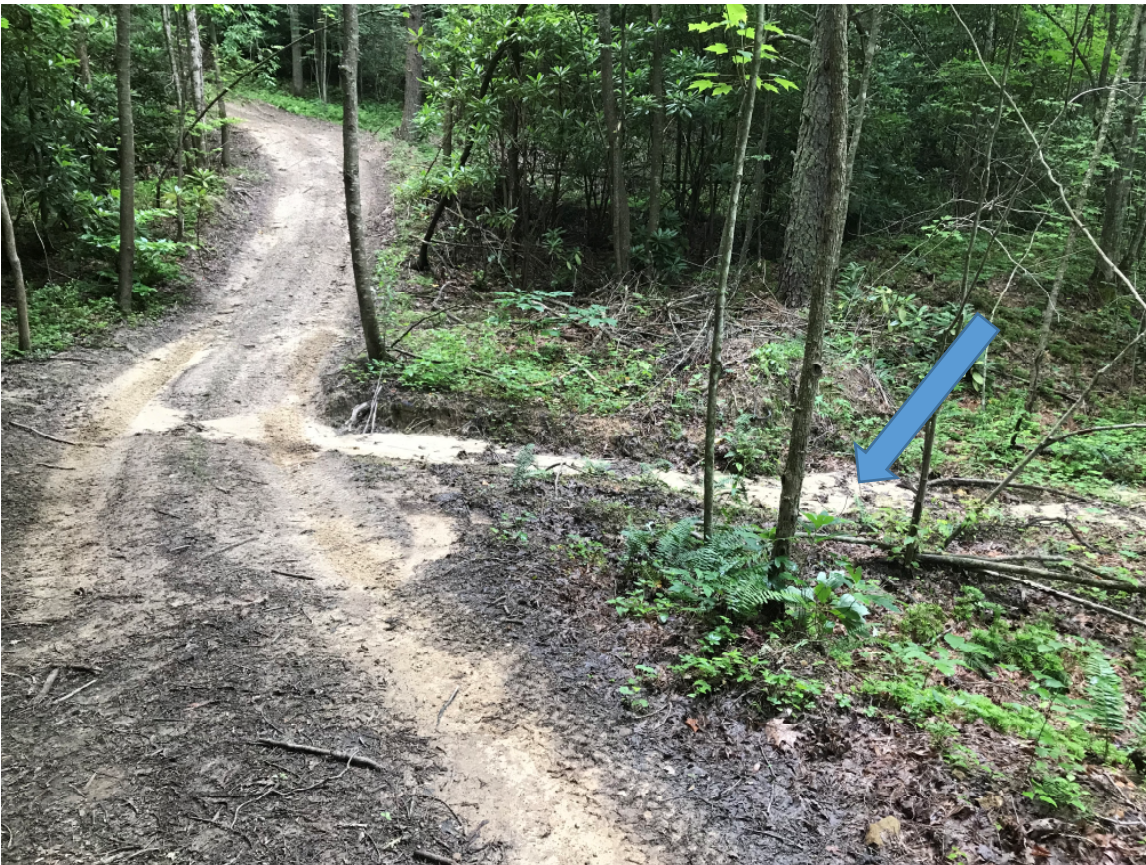
Figure 57 (Sediment deposition observed down gradient of a Section of Trail 67 with a cut allowing unfiltered runoff from the trail to discharge over the slope; 37.29465°, -81.39333°)

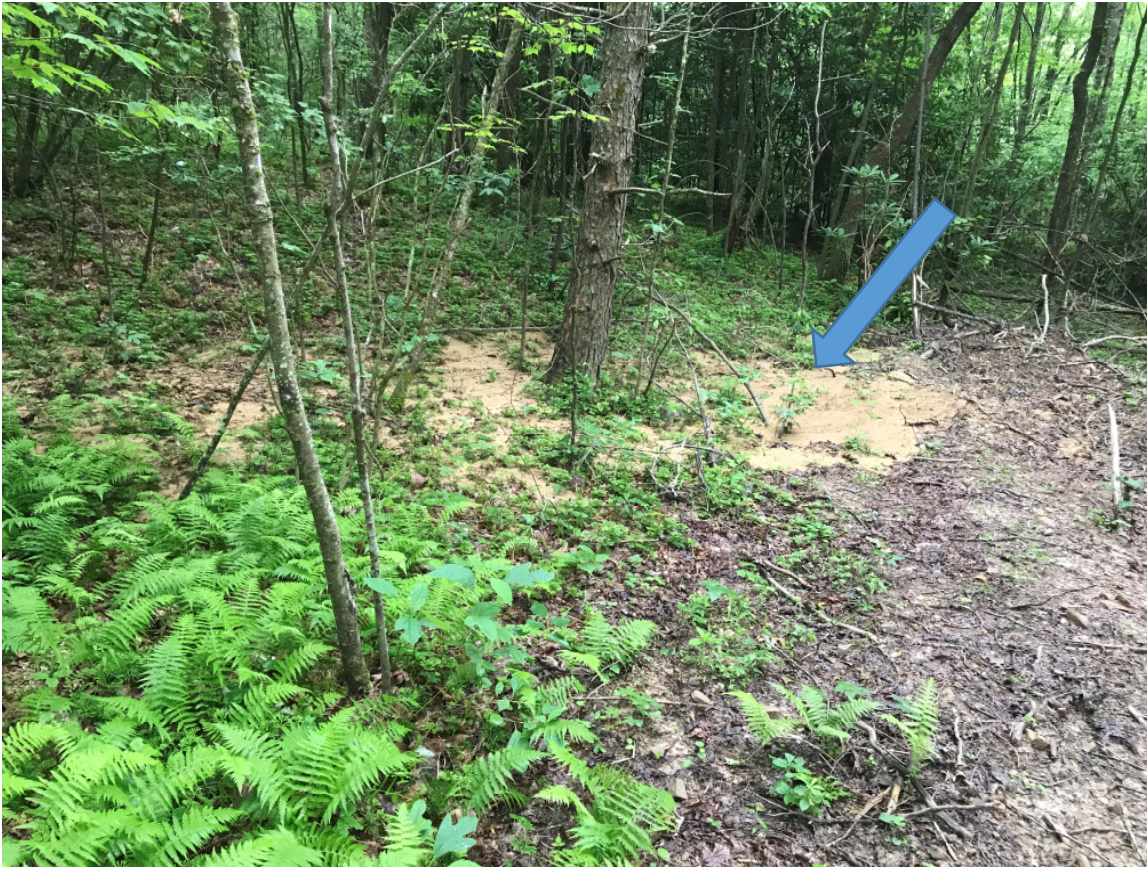
Figure 58 (Un-stabilized land disturbance from what appeared to be a newly constructed section of Trail 67 with trail erosion and sediment deposition observed down gradient; 37.29461°, -81.39249°)

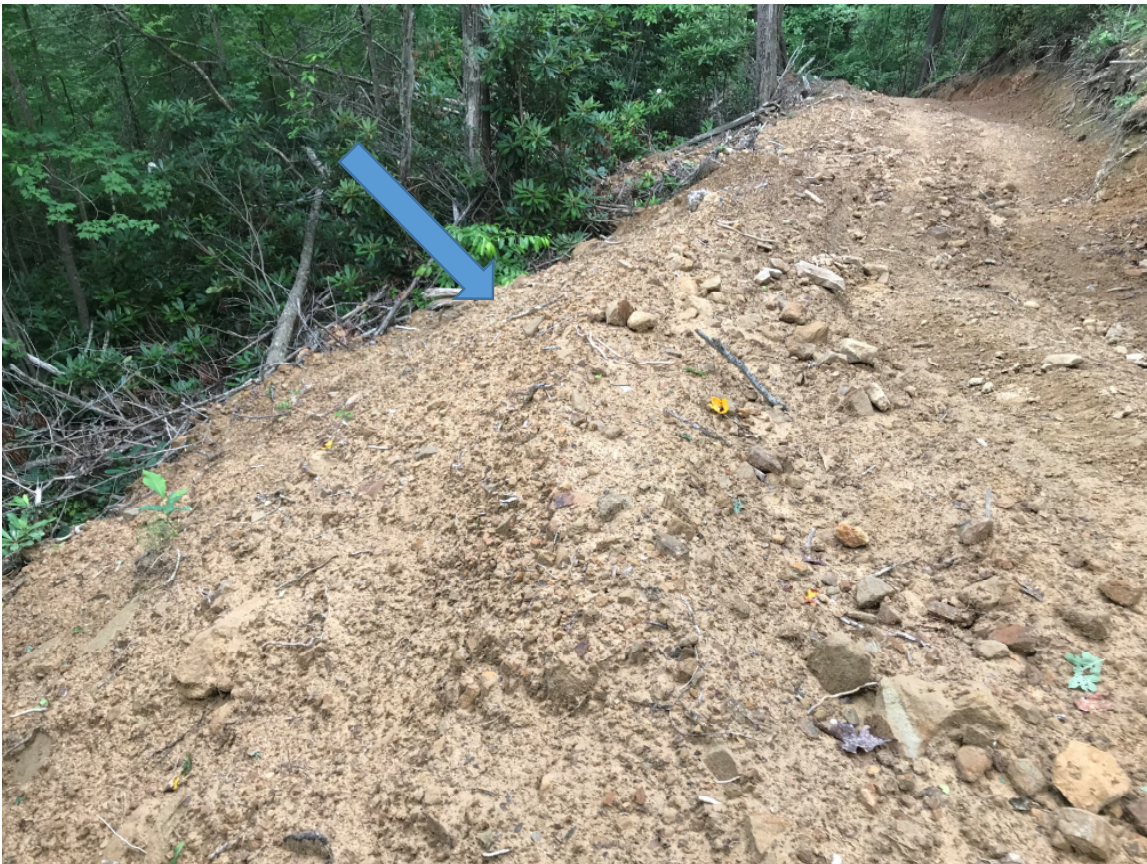
Figure 59 (Un-stabilized land disturbance from what appeared to be a newly constructed section of Trail 67 with trail erosion and sediment deposition observed down gradient; 37.29464°, -81.39236°)

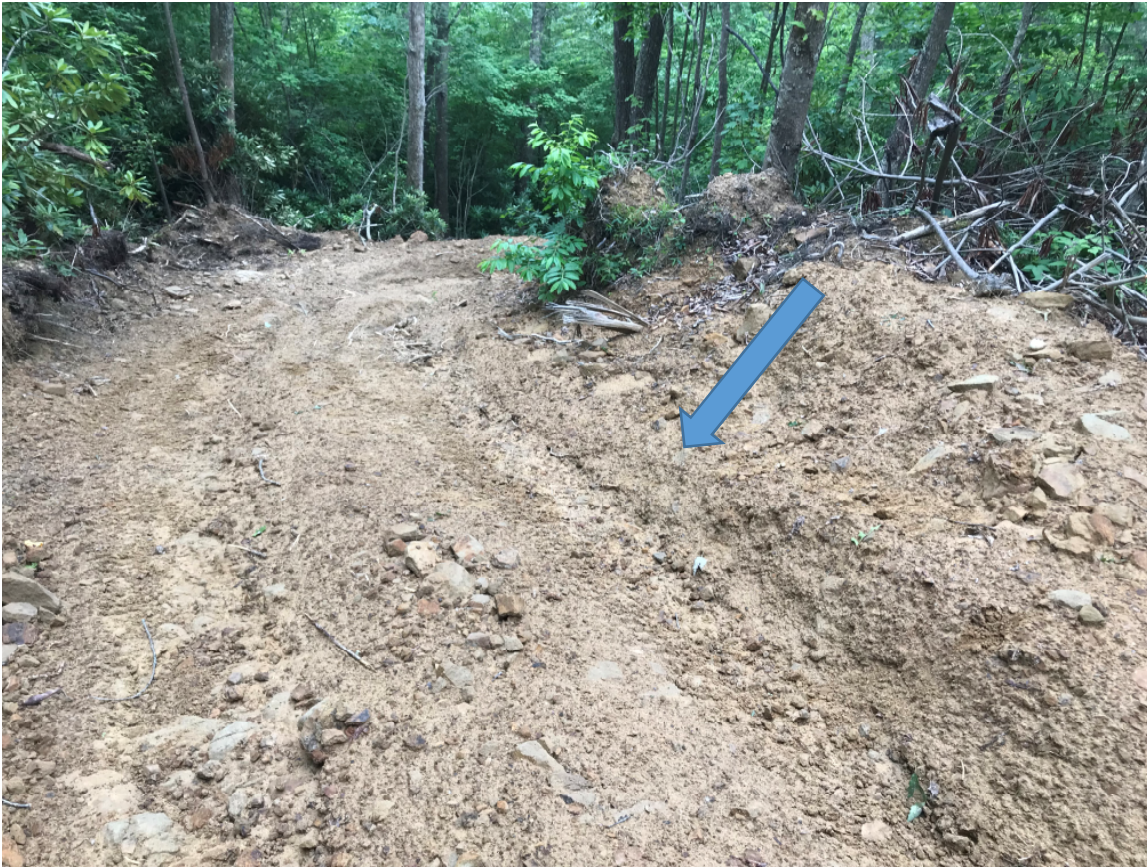
Figure 60 (Section of Trail 67 with a cut allowing unfiltered runoff from the trail to discharge over the slope into a drainage swale leading to Curran Branch; 37.29477°, -81.39217°)
