MEMORANDUM

DEPARTMENT OF ENVIRONMENTAL QUALITY - WATER DIVISION

SUBJECT: Land disturbance associated with Spearhead Trails

SPEARHEAD TRAILS REPRESENTATIVE PHOTO LOG

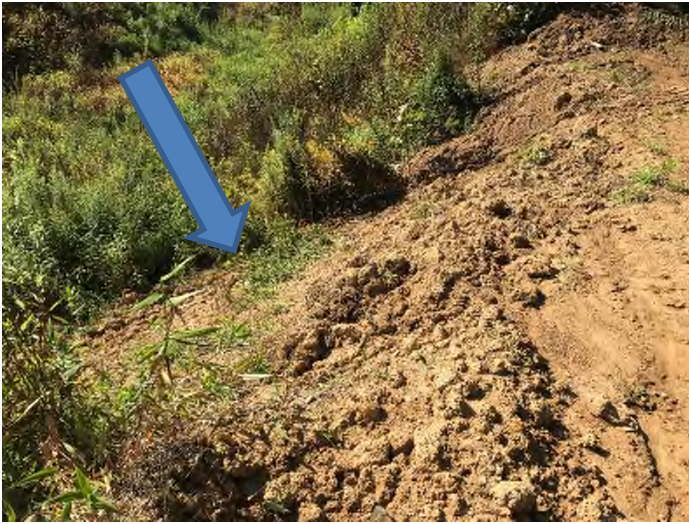
- **Not installing sediment trapping controls (ESC) prior to land disturbing activities** - DEQ-SWRO staff observed areas of land disturbance with no sediment trapping controls in place to filter sediment laden flows prior to discharging from the site. VESC Regulation 9VAC25-840-40(4) states: “Sediment basins and traps, perimeter dikes, sediment barriers and other measures intended to trap sediment shall be constructed as a first step in any land-disturbing activity and shall be made functional before upslope land disturbance takes place.” See Figures 1-2 in the attached Photo Log for representative photos.

Fig. 1
Description: *Lack of sediment trapping controls down gradient of land disturbance*

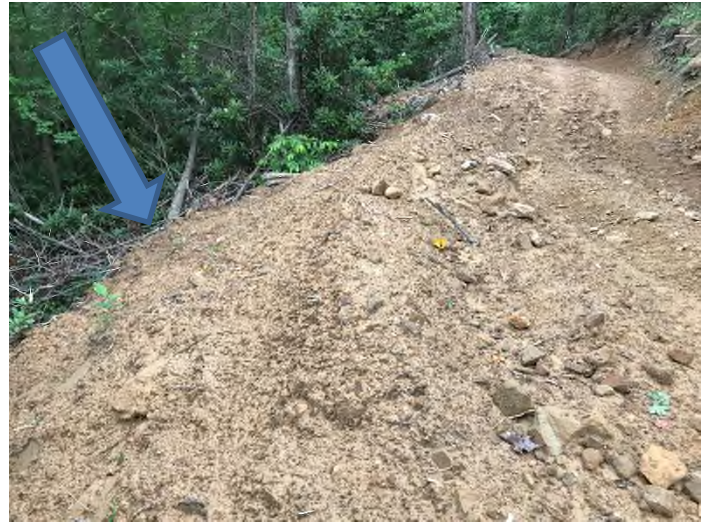
Fig. 2
Description: *Lack of sediment trapping controls down gradient of land disturbance*

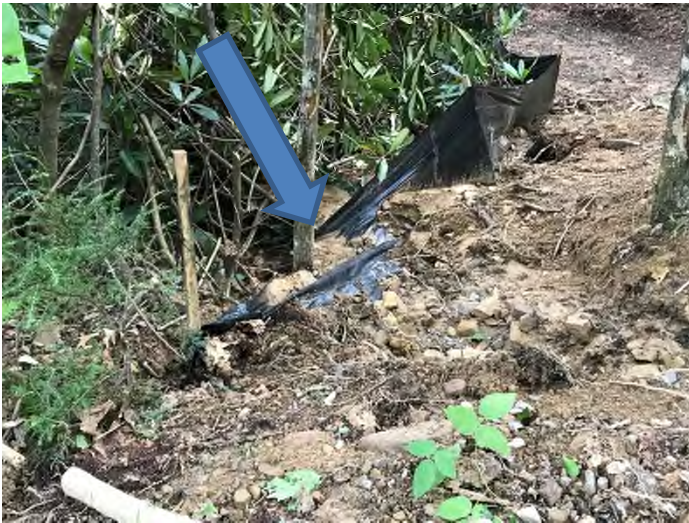
- **Lack of ESC control maintenance** - DEQ-SWRO staff observed erosion and sediment control measures installed in some areas that had not been maintained in an effective operating condition. VESC Regulation 9VAC25-840-60(A) states, in part: “All erosion and sediment control structures and systems shall be maintained, inspected and repaired as needed to insure continued performance of their intended function...” See Figures 3-4 in the attached Photo Log for representative photos.

Fig. 3
Description: *Silt fence not maintained*

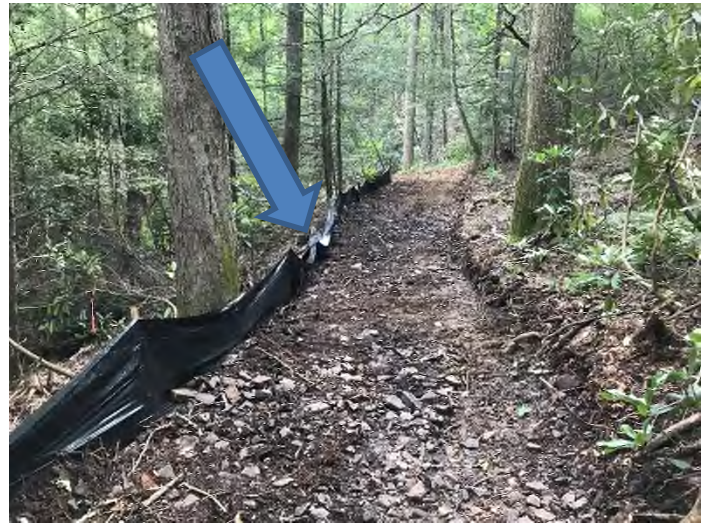
Fig. 4
Description: *Silt fence not maintained*

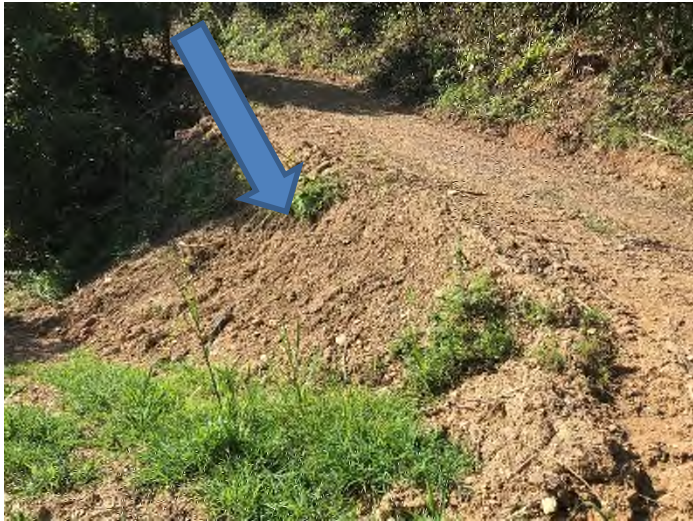
- **Stabilization timeframes exceeded** - DEQ-SWRO staff observed areas of land disturbance which had exceeded the regulatory timeframe for stabilization. VESC Regulation 9VAC25-840-40(1) states: “Permanent or temporary soil stabilization shall be applied to denuded areas within seven days after final grade is reached on any portion of the site. Temporary soil stabilization shall be applied within seven days to denuded areas that may not be at final grade but will remain dormant for longer than 14 days. Permanent stabilization shall be applied to areas that are to be left dormant for more than one year.” See Figures 5-6 in the attached Photo Log for representative photos.

Fig. 5
Description: *Stabilization timeframes exceeded*

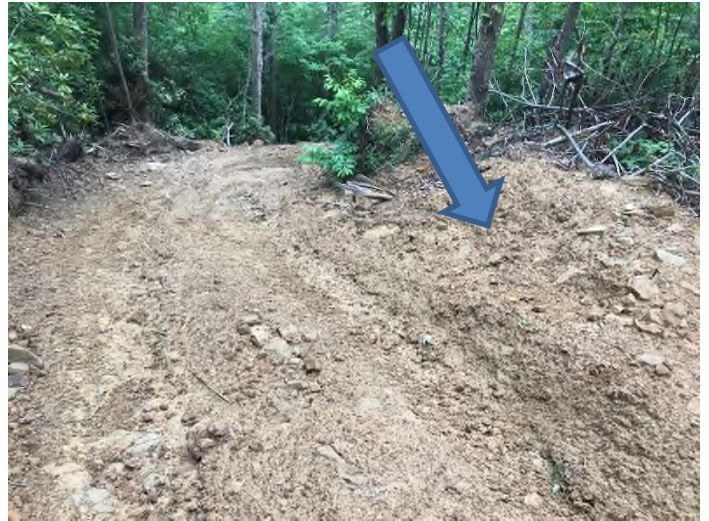
Fig. 6
Description: *Stabilization timeframes exceeded*

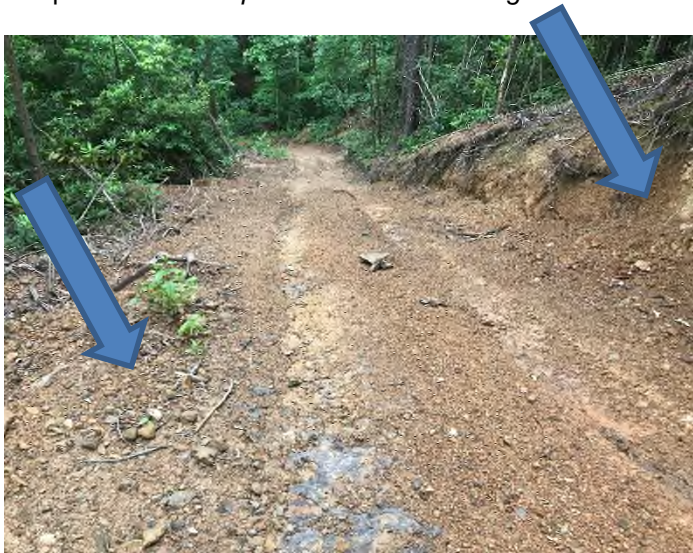
- **Lack of permanent vegetation establishment outside perpetual riding lanes** - DEQ-SWRO staff observed areas of land disturbance outside the travel lane of the trail that lacked a permanent vegetative cover. VESC Regulation 9VAC25-840-40(3) states: “A permanent vegetative cover shall be established on denuded areas not otherwise permanently stabilized. Permanent vegetation shall not be considered established until a ground cover is achieved that is uniform, mature enough to survive and will inhibit erosion.” See Figures 7-8 in the attached Photo Log for representative photos.

Fig. 7
Description: *Lack of a permanent stand of vegetation*

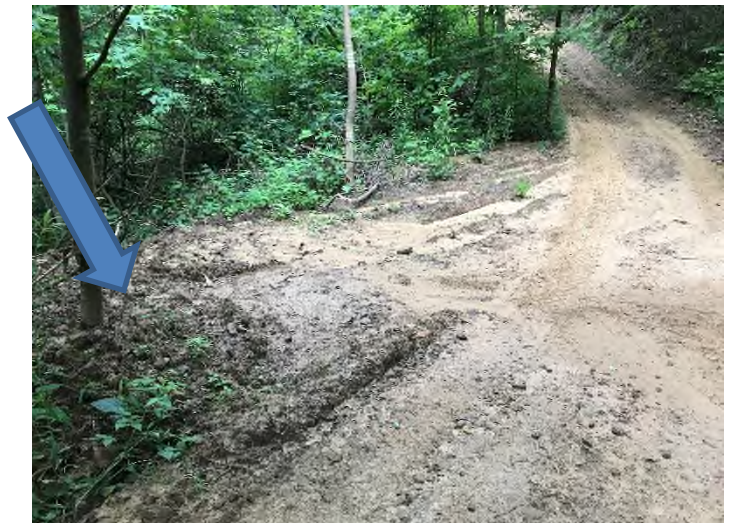
Fig. 8
Description: *Lack of a permanent stand of vegetation*

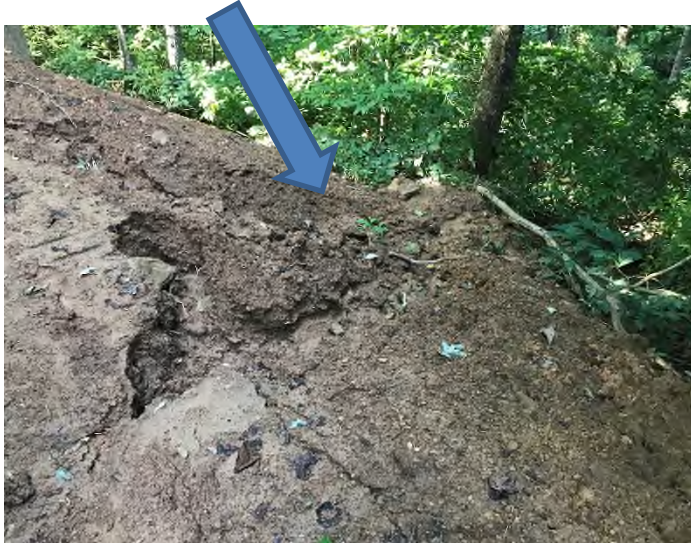
- **Cut and fill slopes not adequately stabilized to prevent or correct excessive erosion** - DEQ-SWRO staff observed areas where cut and fill slopes had not been adequately stabilized to prevent excessive erosion. VESC Regulation 9VAC25-840-40(3) states: “A permanent vegetative cover shall be established on denuded areas not otherwise permanently stabilized. Permanent vegetation shall not be considered established until a ground cover is achieved that is uniform, mature enough to survive and will inhibit erosion.” In addition, VESC Regulation 9VAC25-840-40(7) states: “Cut and fill slopes shall be designed and constructed in a manner that will minimize erosion. Slopes that are found to be eroding excessively within one year of permanent stabilization shall be provided with additional slope stabilizing measures until the problem is corrected.” See Figures 9-10 in the attached Photo Log for representative photos.

Fig. 9
Description: *Fill slope not adequately stabilized to prevent excessive erosion*

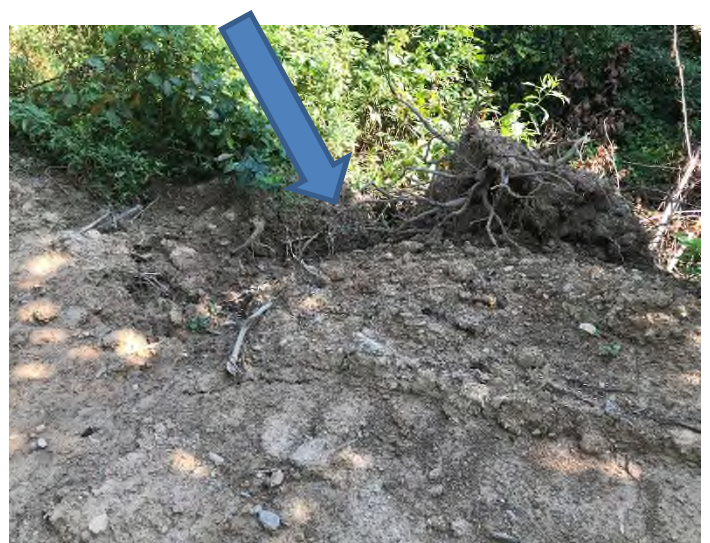
Fig. 10
Description: *Fill slope not adequately stabilized to prevent excessive erosion*

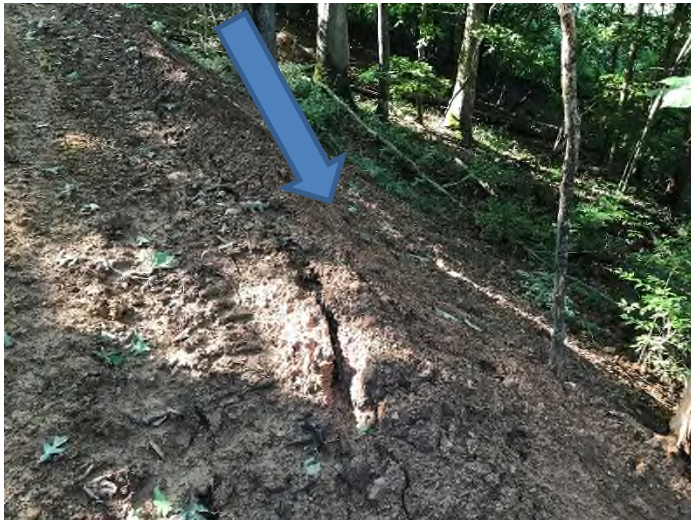
- **Cut and fill slopes not designed/constructed in a manner to minimize erosion** - DEQ-SWRO staff observed areas where cut and fill slopes had not been designed/constructed in a manner to minimize erosion. It was observed that areas of fill material had been pushed over the slope without proper compaction, leading to material sloughing off the slope and promoting erosion. VESC Regulation 9VAC25-840-40(7) states: “Cut and fill slopes shall be designed and constructed in a manner that will minimize erosion. Slopes that are found to be eroding excessively within one year of permanent stabilization shall be provided with additional slope stabilizing measures until the problem is corrected.” See Figures 11-12 in the attached Photo Log for representative photos.

Fig. 11
Description: *Fill slopes not designed/constructed in a manner to minimize erosion (Material pushed over slope with no compaction)*

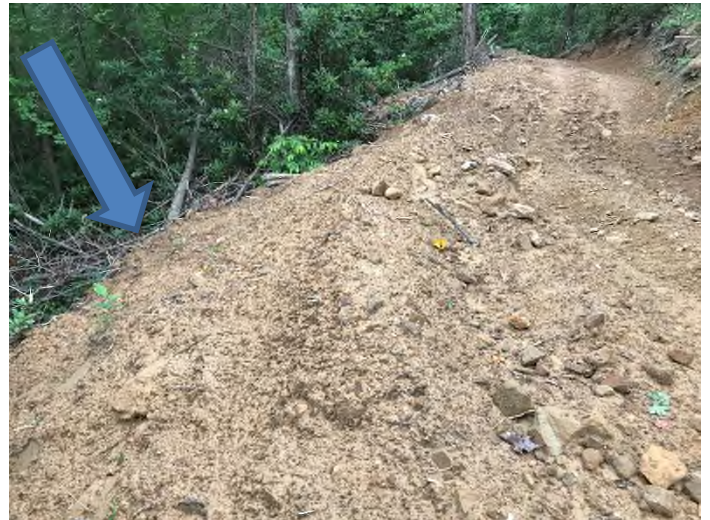
Fig. 12
Description: *Fill slopes not designed/constructed in a manner to minimize erosion (Material pushed over slope with no compaction)*

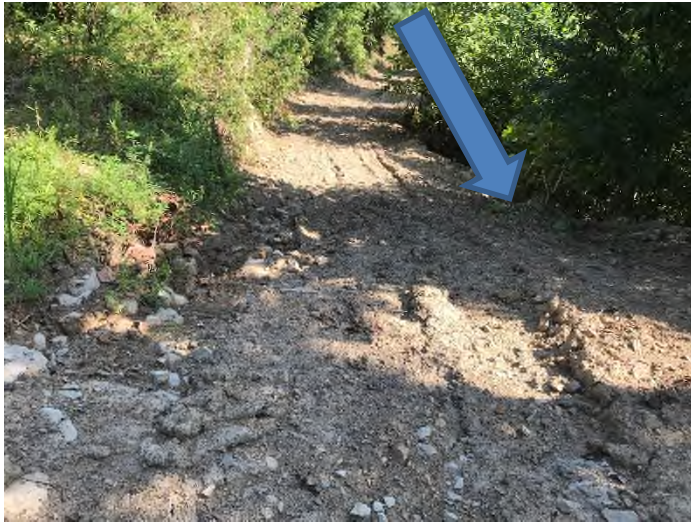
- **Concentrated stormwater runoff not directed to an adequate receiving channel or converted to sheet flow** - DEQ-SWRO staff observed areas where stormwater runoff had been concentrated and not discharged to an adequate receiving channel or returned to a sheet flow condition. Areas resulting in a concentration of flows were observed as the result of ditches, water bars, window cuts, and areas of rill and gully erosion associated with the installation and maintenance of trails. Additionally, in some areas the trails themselves effectively concentrated flows based on the surrounding topography. VESC Regulation 9VAC25-840-40(19) states in part: “Properties and waterways downstream from development sites shall be protected from sediment deposition, erosion and damage due to increases in volume, velocity and peak flow rate of stormwater runoff... a. Concentrated stormwater runoff leaving a development site shall be discharged directly into an adequate natural or man-made receiving channel, pipe or storm sewer system...”. See Figures 13-14 in the attached Photo Log for representative photos.

Fig. 13
Description: *Concentrated stormwater runoff not directed to an adequate receiving channel or converted to sheet flow*

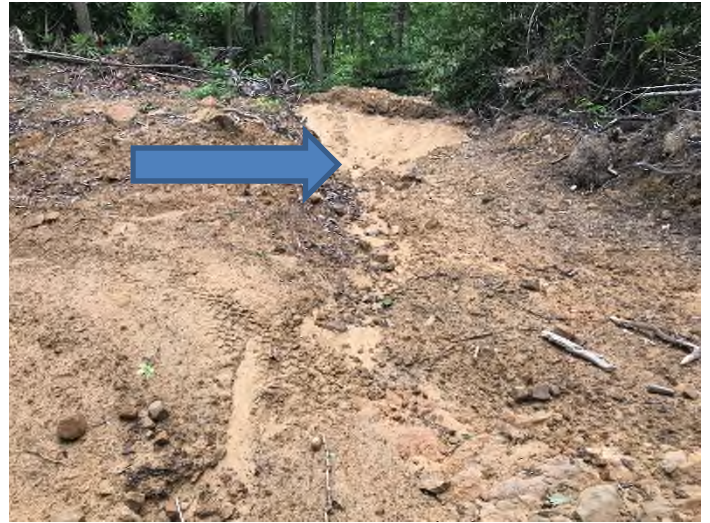
Fig. 14
Description: *Concentrated stormwater runoff not directed to an adequate receiving channel or converted to sheet flow*

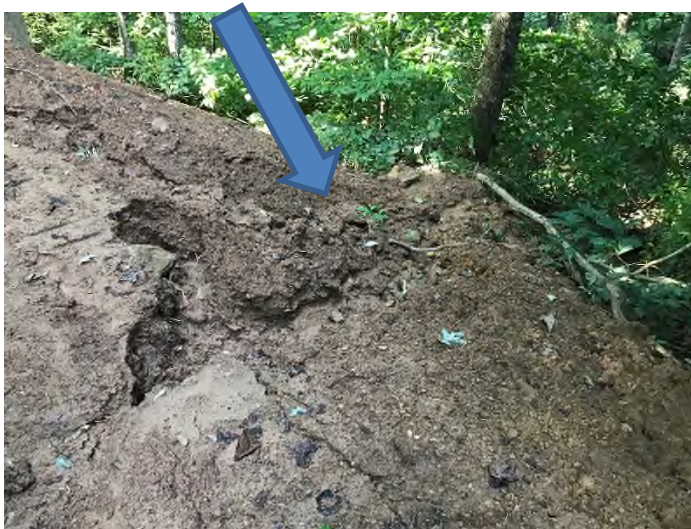
- **Concentrated stormwater runoff directed down fill slopes and not contained within an adequate slope conveyance resulting in slope erosion and off-site sediment loss** - DEQ-SWRO staff observed areas where concentrated stormwater runoff discharged down fill slopes not contained in an adequate conveyance. Areas resulting in a concentration of flows were observed as a result of ditches, water bars, window cuts, and areas of rill and gully erosion associated with the installation and maintenance of trails. VESC Regulation 9VAC25-840-40(8) states: “Concentrated runoff shall not flow down cut or fill slopes unless contained within an adequate temporary or permanent channel, flume or slope drain structure.” See Figures 15-16 in the attached Photo Log for representative photos.

Fig. 15
Description: *Concentrated stormwater runoff directed down fill slope and not contained within an adequate slope conveyance resulting in slope erosion and off-site sediment loss*

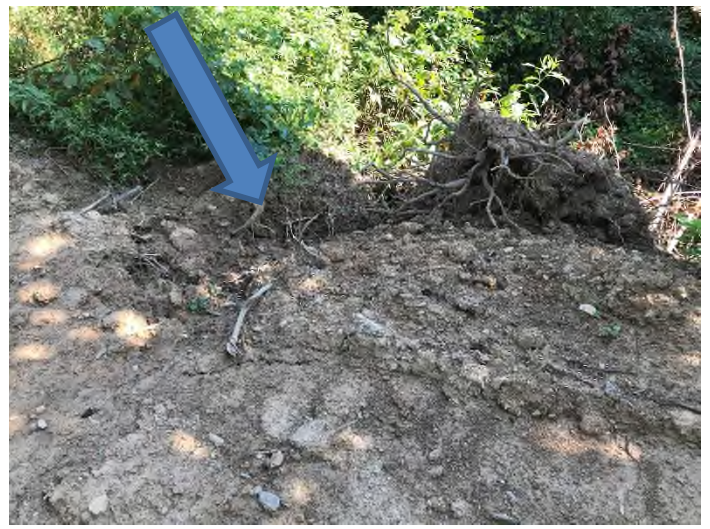
Fig. 16
Description: *Concentrated stormwater runoff directed down fill slope and not contained within an adequate slope conveyance resulting in slope erosion and off-site sediment loss*

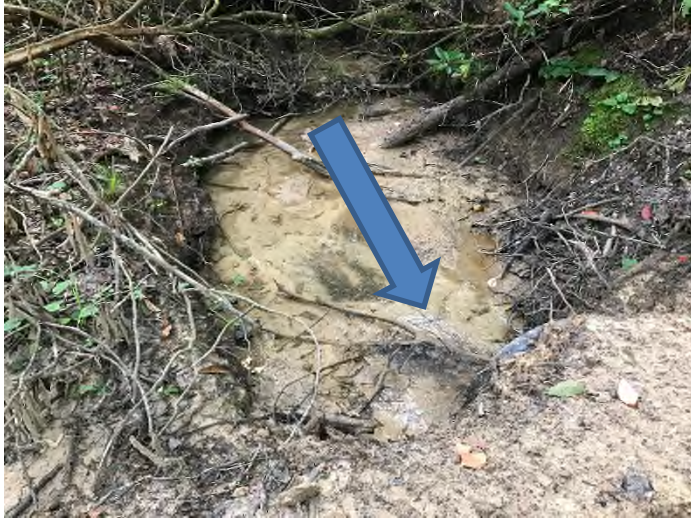
- **Lack of outlet protection and permanent ditch linings** - DEQ-SWRO staff observed stormwater conveyances that did not have adequate outlet protection installed to prevent erosion. Additionally, ditches were observed that did not have permanent ditch linings installed to prevent erosion. VESC Regulation 9VAC25-840-40(11) states: “Before newly constructed stormwater conveyance channels or pipes are made operational, adequate outlet protection and any required temporary or permanent channel lining shall be installed in both the conveyance channel and receiving channel.” See Figures 17-18 in the attached Photo Log for representative photos.

Fig. 17
Description: *Lack of outlet protection for culvert installed*

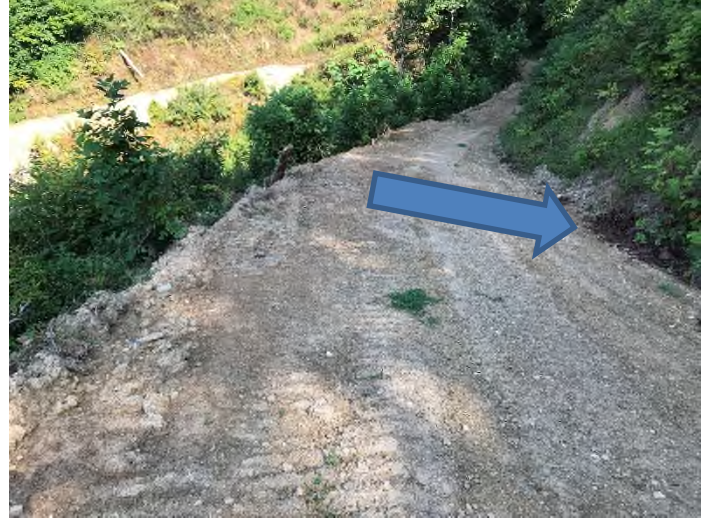
Fig. 18
Description: *Cut ditch with no lining and ongoing erosion*

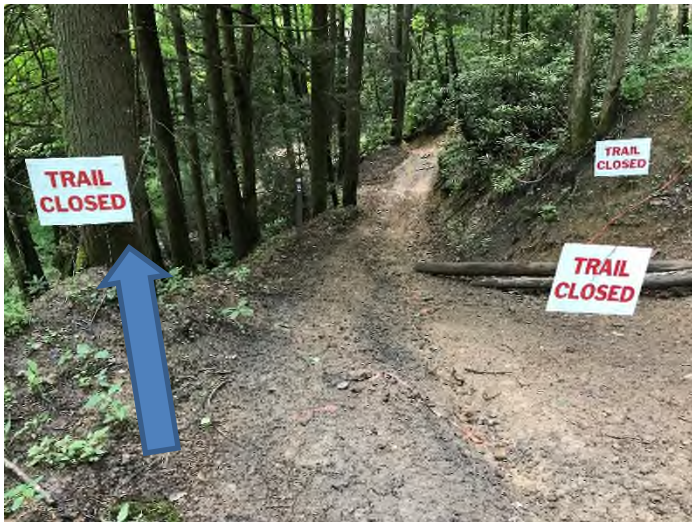
- **Inadequate trail closures allowing riders to access closed trails** - DEQ-SWRO staff observed trail users on a section of trail that was marked on both ends with “Trail Closed” signs. While the signs were present, there were no physical barriers across the trail to prohibit riders from accessing the trail. When trails are found to be located within the streambed, and closures are necessary to prevent further impacts, a more robust and effective means of trail closure should be utilized. See Figures 19-20 in the attached Photo Log for representative photos.

Fig. 19
Description: *Inadequate trail closures allowing riders to access closed trails*

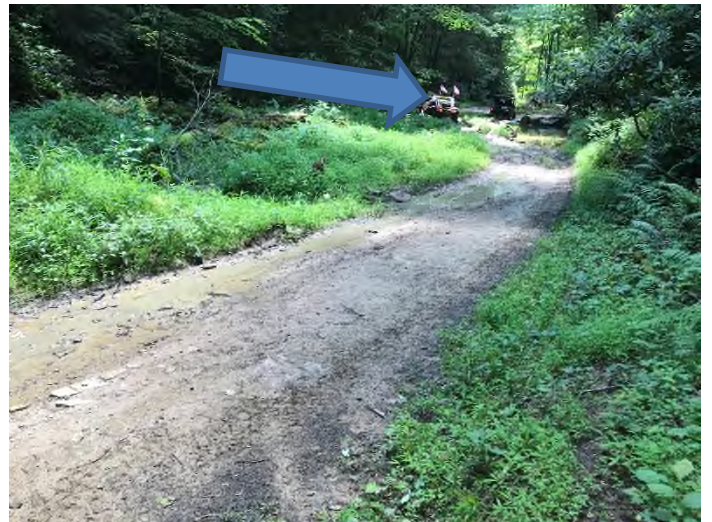
Fig. 20
Description: *Riders on a trail marked as closed in Fig.23. The trail is located within a potential jurisdictional stream*

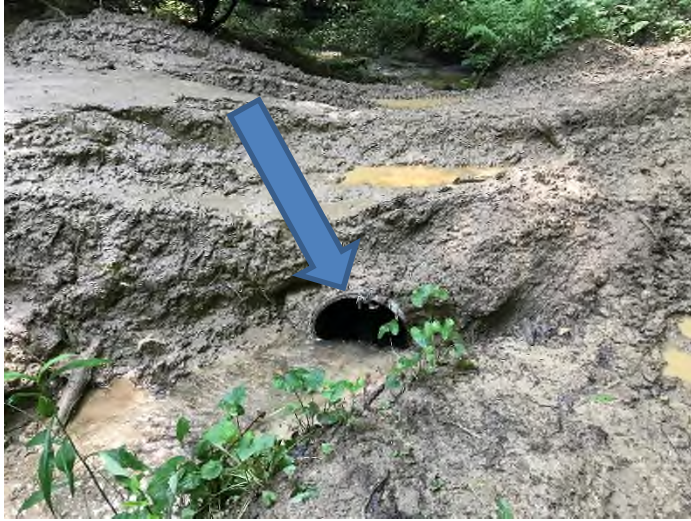
- **Lack of USACOE/VWP Permits**- DEQ-SWRO staff observed areas of trails where culverts had been installed. Based on conversations with SRRA staff, DEQ staff, and USACOE, no record of applicable permits could be found regarding the installation of said culverts in these potentially jurisdictional waters. Additionally, DEQ-SWRO staff is not aware of any jurisdictional determinations being performed which would indicate that these permits are not required. 9VAC25-210-50 of the Virginia Water Protection Permit Program Regulation states “except in compliance with a VWP permit, unless the activity is otherwise exempted or excluded, no person shall dredge, fill, or discharge any pollutant into, or adjacent to surface waters; withdraw surface water; otherwise alter the physical, chemical, or biological properties of state waters regulated under this chapter and make them detrimental to the public health, to animal or aquatic life, or to the uses of such waters for domestic or industrial consumption, for recreation, or for other uses; excavate in wetlands...”. See Figures 21-24 in the attached Photo Log for representative photos.

- **Improper culvert installation** - DEQ-SWRO staff observed culvert installations that were not countersunk and did not contain outlet protection in accordance to VWP Regulations. 9VAC25-680-100, Part I.B.2 states that “...Pipes and culverts placed in streams must be installed to maintain low flow conditions and shall be countersunk at both inlet and outlet ends of the pipe or culvert, unless specifically

approved by the Department of Environmental Quality on a case-by-case basis...” In addition, 9VAC25-680-100, Part I.E.2 states “Riprap aprons for all outfalls shall be designed in accordance with the Virginia Erosion and Sediment Control Handbook, Third Edition, 1992.” See Figures 21-24 in the attached Photo Log for representative photos.

Fig. 21
Description: *Culvert installation without appropriate permits, culvert not countersunk, and no outlet protection*

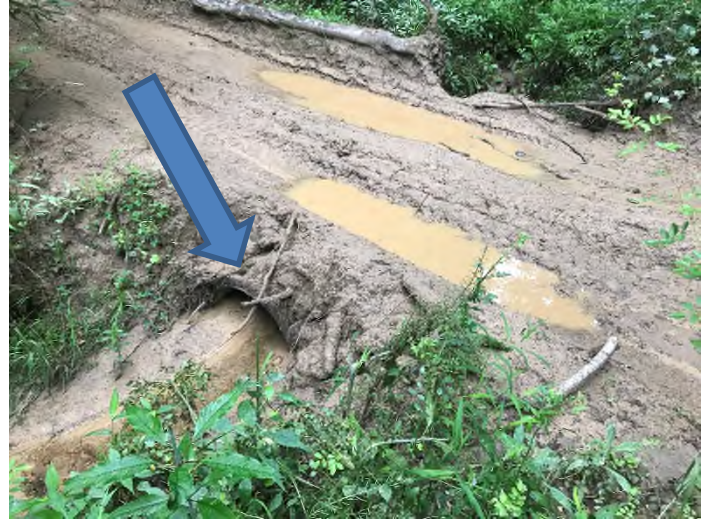
Fig. 22
Description: *Culvert installation without appropriate permits, culvert not countersunk, and no outlet protection*

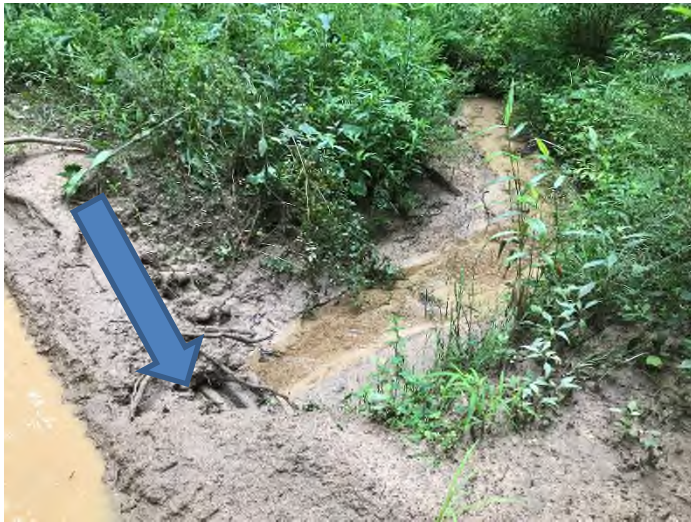
Fig. 23
Description: *Culvert installation without appropriate permits, culvert not countersunk, and no outlet protection*

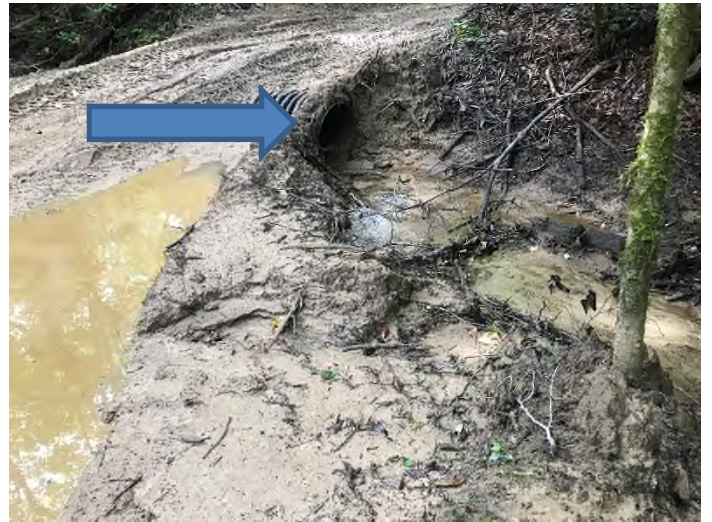
Fig. 24
Description: *Culvert installation without appropriate permits, culvert not countersunk, and no outlet protection*

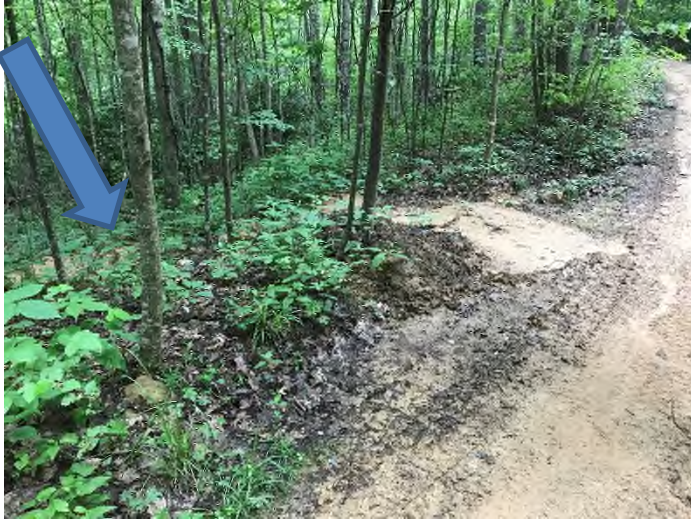
- **Sediment deposition onto down gradient properties** - DEQ-SWRO staff observed sediment deposition outside the footprint of the trail on down gradient properties. Primary contributors of sediment appeared to be the lack of sediment trapping controls, lack of stabilization, trail erosion as a result of perpetual riding, and discharge of concentrated stormwater flows without being contained in an adequate conveyance. VESC Regulation 9VAC25-840-40(19) states in part: “Properties and waterways downstream from development sites shall be protected from sediment deposition...” See Figures 25-28 in the attached Photo Log for representative photos.

Fig. 25
Description: *Off-site Sediment Loss onto down gradient properties from trail erosion due to the lack of sediment trapping controls*

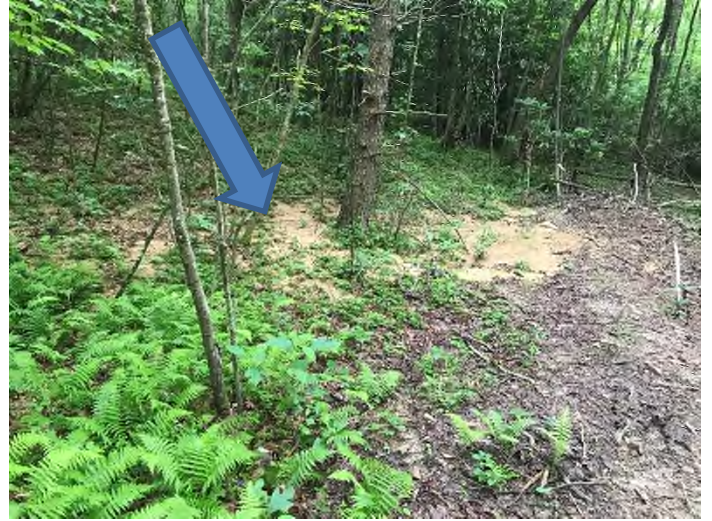
Fig. 26
Description: *Off-site Sediment Loss onto down gradient properties from trail erosion due to the lack of sediment trapping controls*

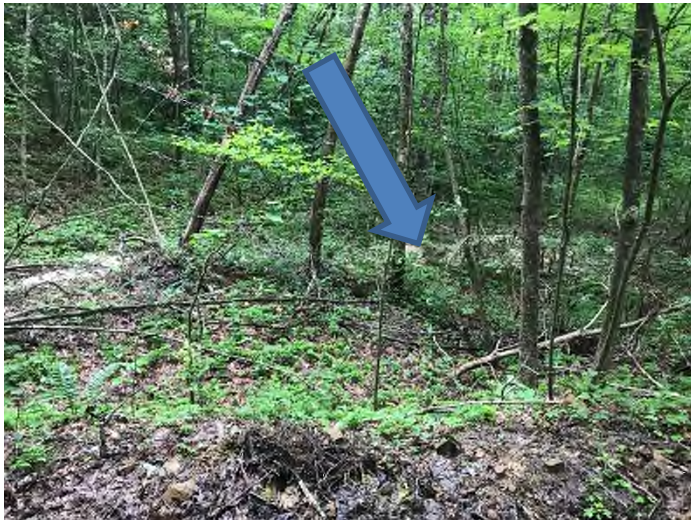
Fig. 27
Description: *Off-site Sediment Loss onto down gradient properties from trail erosion due to the lack of sediment trapping controls*

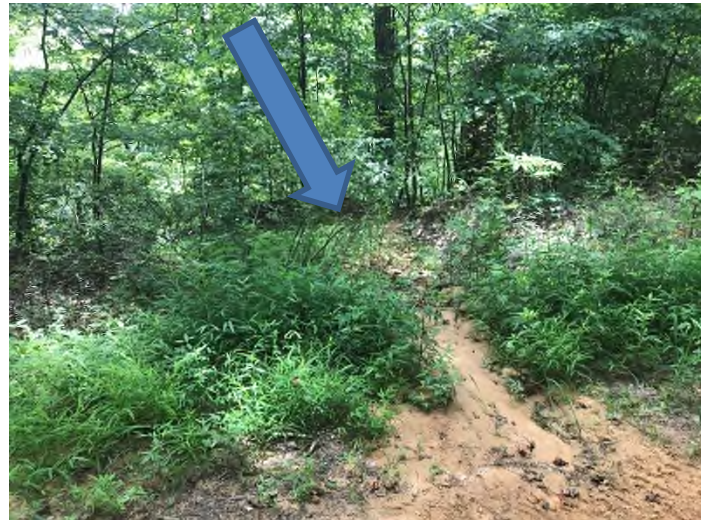
Fig. 28
Description: *Off-site Sediment Loss onto down gradient properties from trail erosion due to the lack of sediment trapping controls*

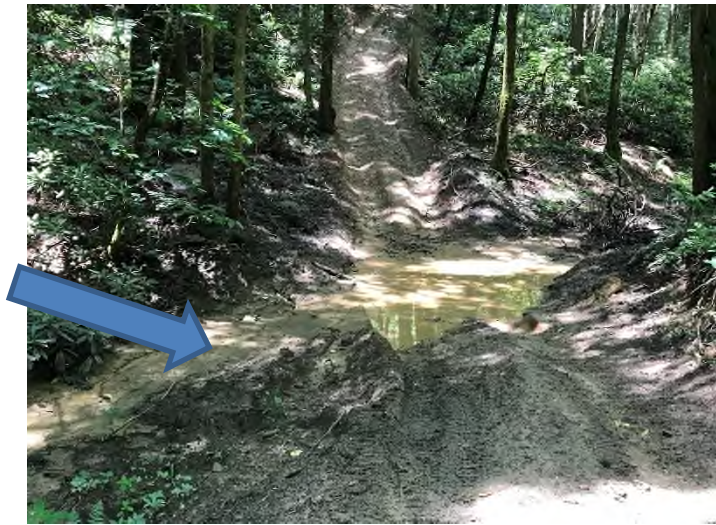
- **Sediment deposition into potential jurisdictional streams** - DEQ-SWRO staff observed sediment laden stormwater runoff from the trails being discharged directly into potential jurisdictional streams without first being filtered to remove deleterious materials. Primary contributors of sediment appeared to be the lack of sediment trapping controls, lack of stabilization, trail erosion as a result of perpetual riding, discharge of concentrated stormwater flows without being contained in an adequate conveyance, fording streams without the installation of culverts/bridges, and the utilization of stream beds as trails. VESC Regulation 9VAC25-840-40(19) states in part: “Properties and waterways downstream from development sites shall be protected from sediment deposition...” Va. Code § 62.1-44.5(A) states, in part: “Except in compliance with a certificate or permit issued by the Board or other entity authorized by the Board to issue a certificate or permit pursuant to this chapter, it shall be unlawful for any person to...5. Discharge stormwater into state waters from...land disturbing activities.” VESC Regulation 9VAC25-870-310(A) states, in part: “Except in compliance with a state permit issued by the board pursuant to the Virginia Stormwater Management Act, it shall be unlawful for any person to discharge stormwater into state waters from...land disturbing activities. See Figures 29-36 in the attached Photo Log for representative photos.

Fig. 29
Description: *Sediment impacts to potential jurisdictional stream due to trail erosion from perpetual riding, lack of sediment trapping controls, lack of stabilization, and fording the stream without the installation of culverts/bridges*

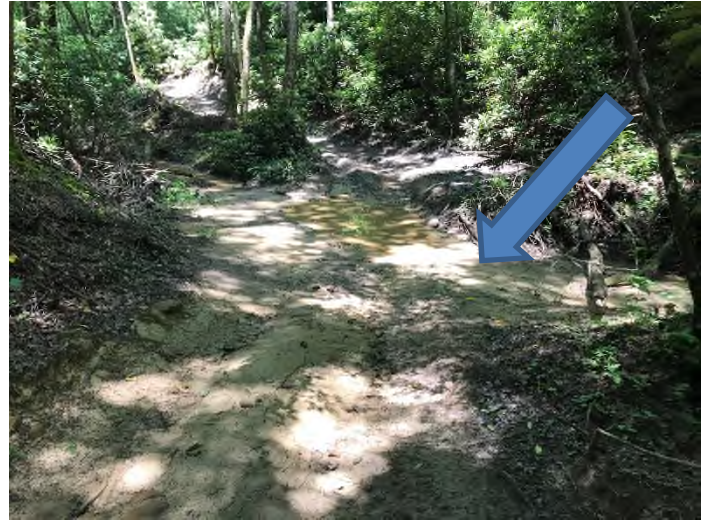
Fig. 30
Description: *Sediment impacts to potential jurisdictional stream due to trail erosion from perpetual riding, lack of sediment trapping controls, lack of stabilization, and fording the stream without the installation of culverts/bridges*

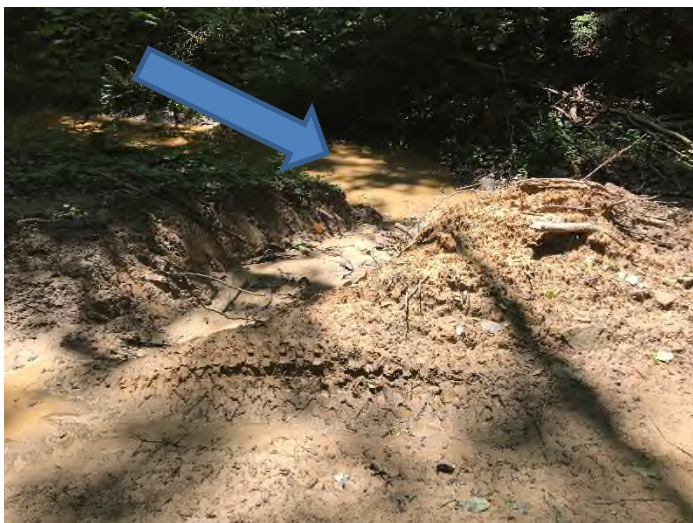
Fig. 31
Description: *Sediment impacts to potential jurisdictional stream due to trail erosion from perpetual riding, lack of sediment trapping controls, and lack of stabilization*

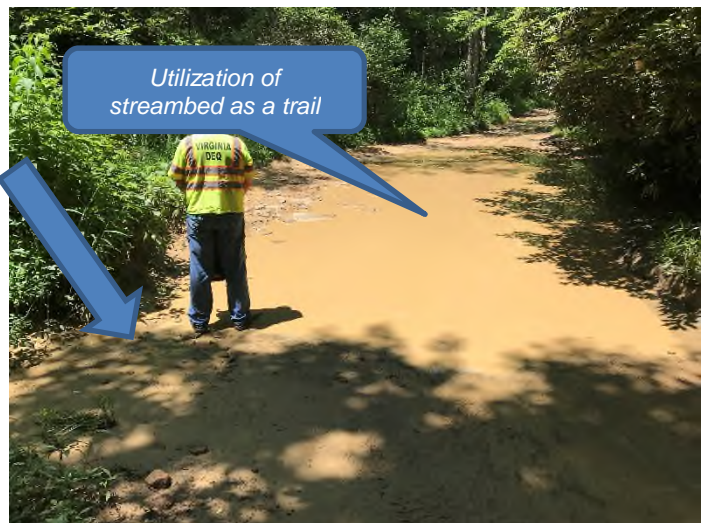
Fig. 32
Description: *Sediment impacts to potential jurisdictional stream due to the utilization of the streambed as a trail*

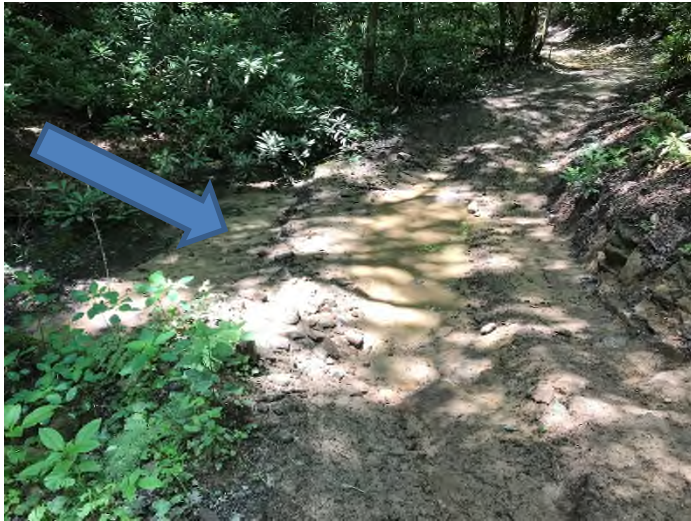
Fig. 33

Description: *Sediment impacts to potential jurisdictional stream due to trail erosion from perpetual riding, lack of sediment trapping controls, and lack of stabilization*

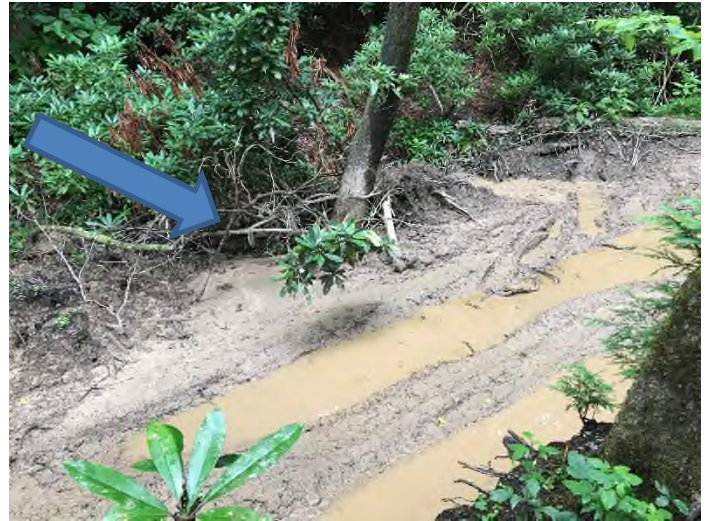
Fig. 34

Description: *Sediment impacts to potential jurisdictional stream due to trail erosion from perpetual riding, lack of sediment trapping controls, and lack of stabilization*

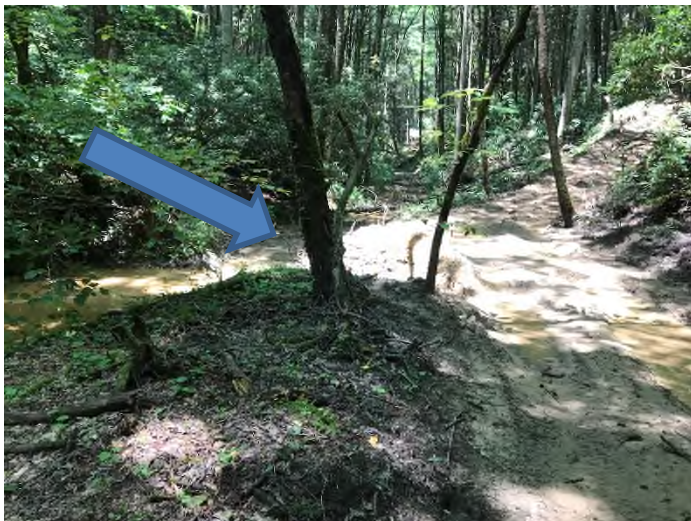
Fig. 35

Description: *Sediment impacts to potential jurisdictional stream due to trail erosion from perpetual riding, lack of sediment trapping controls, and lack of stabilization*

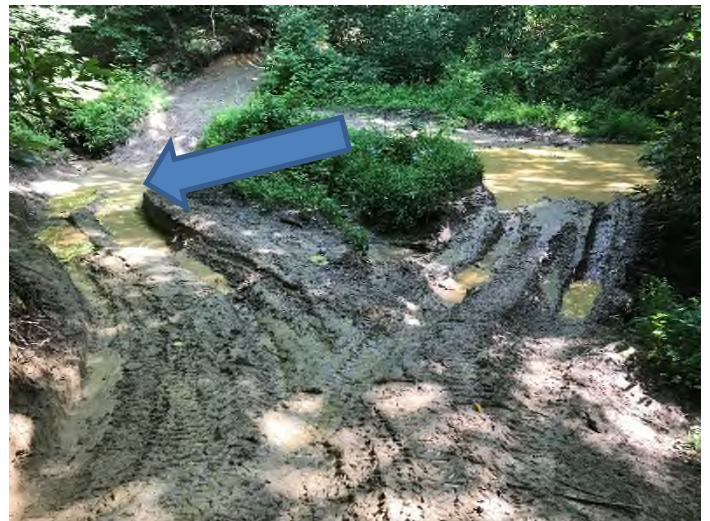
Fig. 36

Description: *Sediment impacts to potential jurisdictional stream due to trail erosion from perpetual riding, lack of sediment trapping controls, lack of stabilization, and fording the stream without the installation of culverts/bridges*
